**Tools to Improve PCC Pavement
Smoothness During Construction
(R06E)**

FIELD REPORT: TEXAS EQUIPMENT LOAN

The equipment loan was performed in August 2015 on a project in Houston, TX. Table 1 summarizes the pertinent project details.

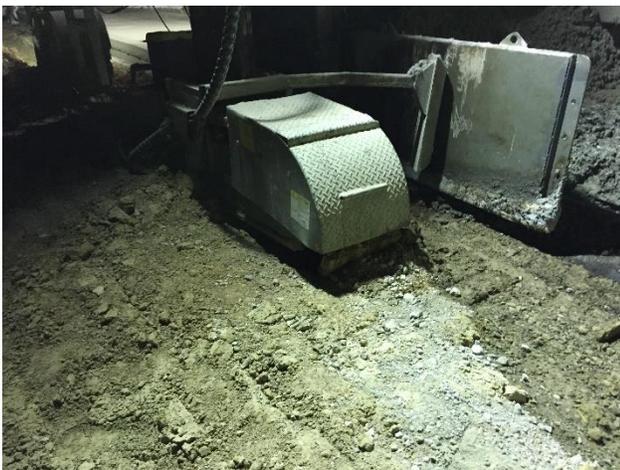
- Non-uniformity of concrete delivered to the paver
- Consistent delivery of concrete to the paver
- Concrete workability
- Highly variable concrete head
- Lack of timely quality control profiling following each day's paving
- Rough and unstable paver trackline

Figure 5. Unstable Paver Trackline

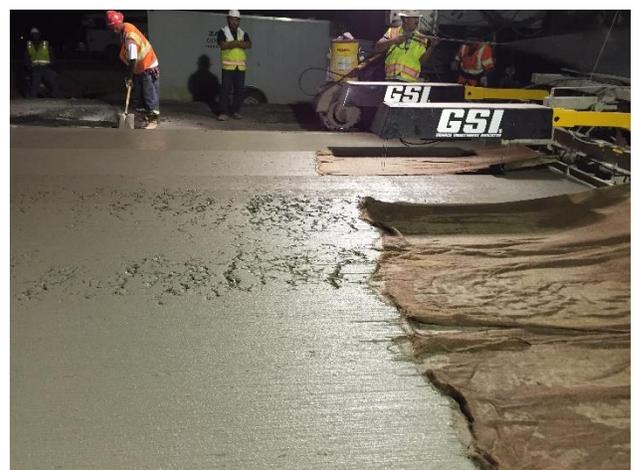
Figure 6. Non-Uniformity of Concrete

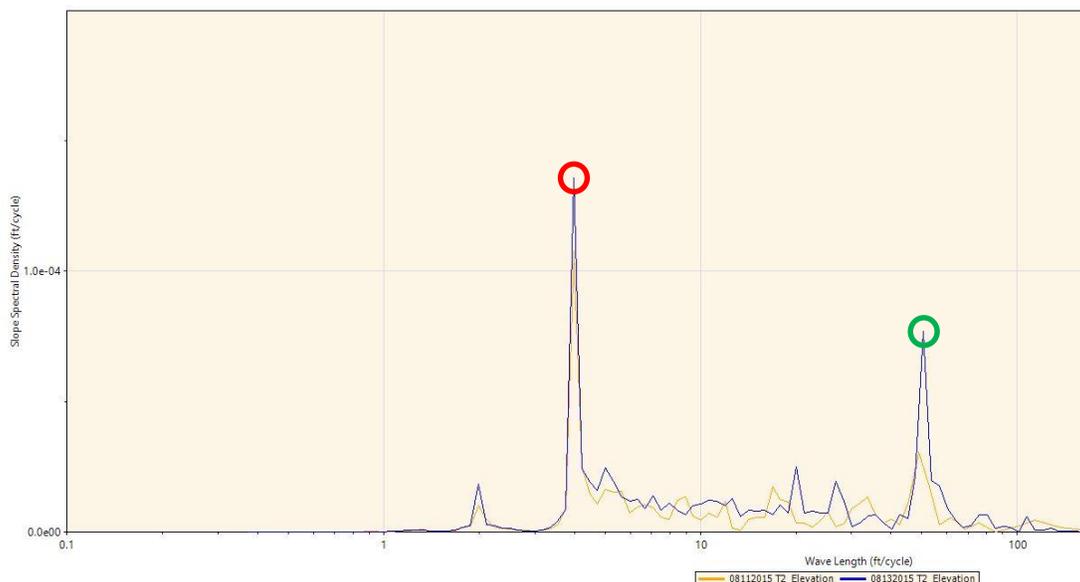
Two wavelengths show up as predominant in the power spectral density analysis (Figure 7). The peak at 4' (red circle) is related to the transverse bar supports which are spaced at 4' c/c. The cause of the peak at 50' (green circle) is not certain, but may be attributable to the 3D model used for machine control. The polylines used in the model were based on points at 50' intervals in the tangent sections of roadway.

Figure 7. Power Spectral Density Analysis from August 11 and 13, 2015 for Trace 2 (right wheel path of the driving lane)

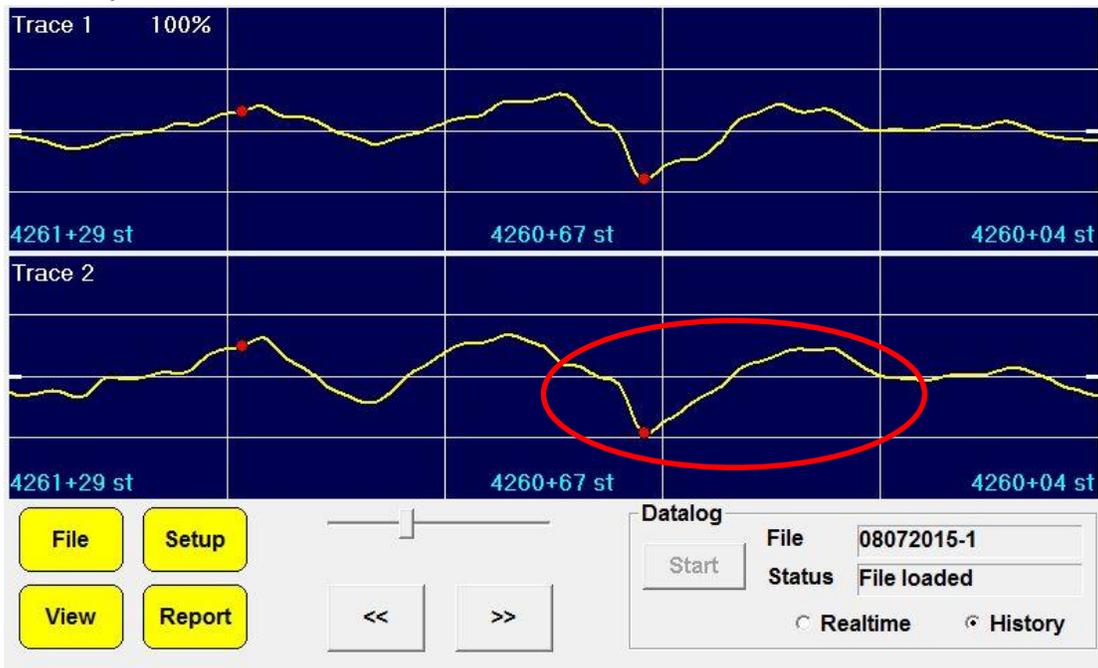
As shown from the estimated baseline IRI analysis above, the adverse effect of events that were causing localized roughness was significant. When these events occur, it is obvious even to inexperienced crews that the initial pavement smoothness is not as good as it could be. So, when these events happen, a real-time profiler isn’t necessarily needed to signal the crew that bumps and dips need to be corrected by hand finishing. However, the real-time system can be very useful in identifying the location and magnitude of the bumps and dips and perhaps more importantly gauging whether actions taken to eliminate or mitigate these events from reoccurring have been effective (Figures 8 and 9).

Figure 8. GSI Screen Showing a Dip and Bump (red oval) Where the Stringless System Malfunctioned

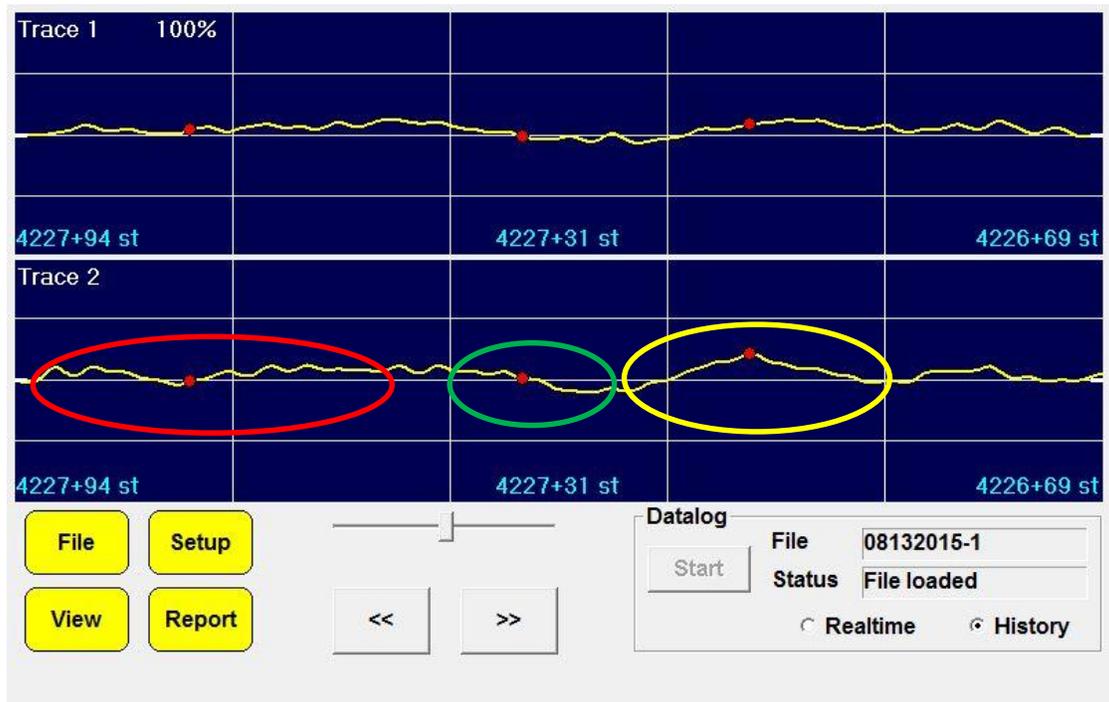
Figure 9. GSI Screen Showing Event Markers for Rough and Unstable Paver Trackline (red oval), Paver Stop (green oval) and Overloaded Paver (yellow oval).
