Assessment, Repair, and Replacement of Bridges Subjected to Fire

**Final Report
August 2022**

IOWA STATE UNIVERSITY
Institute for Transportation

Sponsored by
Iowa Department of Transportation
(InTrans Project 20-734)
Federal Highway Administration

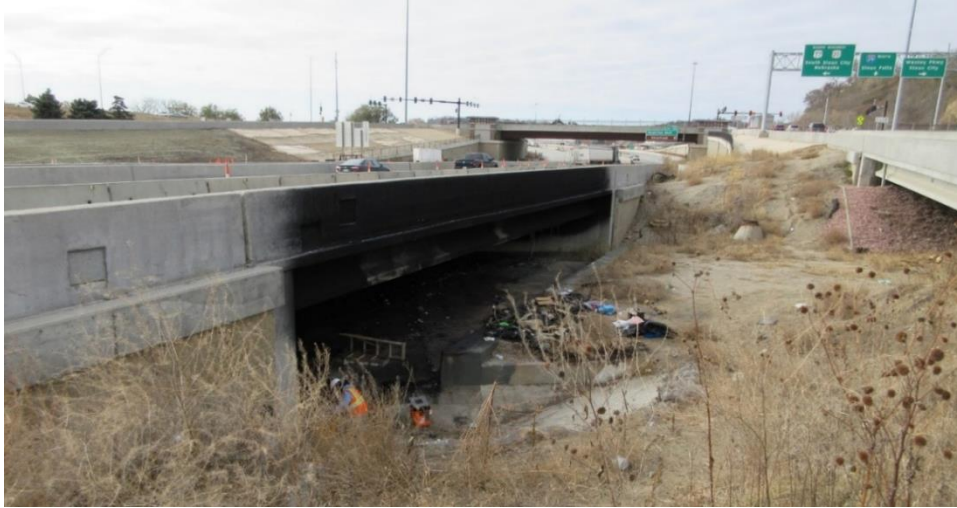
The stay-in-place polycarbonate deck forms caught on fire, which aided the spread of the fire along the deck. Spalling was extensive on the concrete prestressed girders where the fire was concentrated, resulting in the exposure of steel reinforcement strands and stirrups. Per the initial condition assessment (HDR 2019), a loss of camber was observed in Girders D, E, and F. Images of the damages incurred by the bridge are shown in Figure 1 through Figure 5.

Figure 1. I-29 Bridge fire in Sioux City, Iowa (north side of bridge looking toward west abutment)

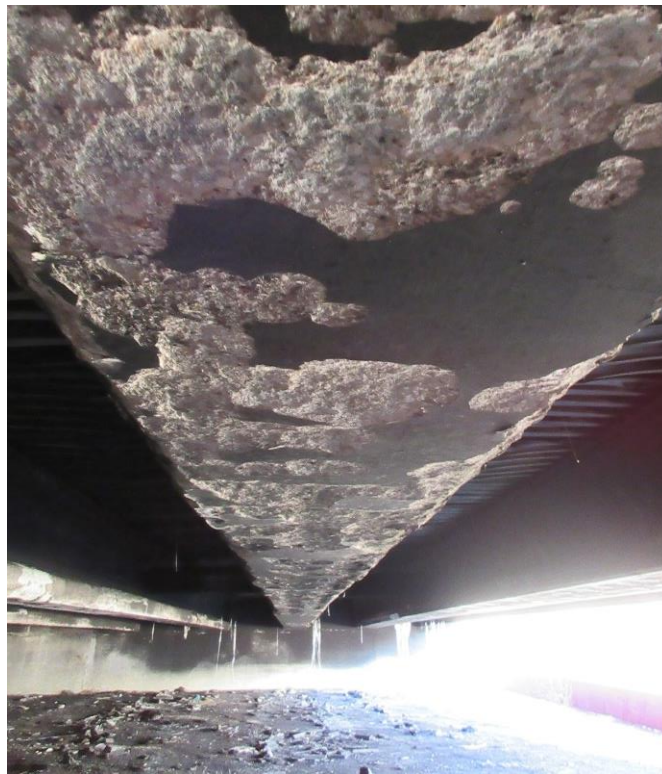
Figure 2. Concrete spalling on concrete girder

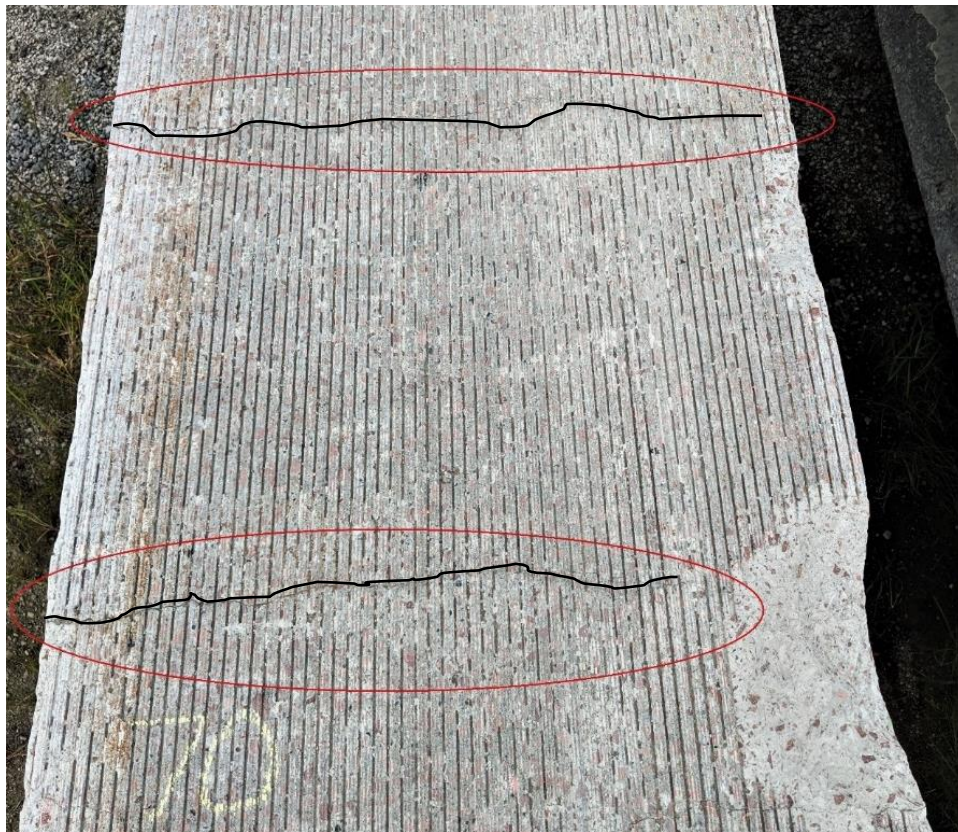
A visual assessment indicated that Girder B was least effected by the fire. Cracks observed on the deck surface were documented, but they were not considered to be a result of the fire. Rather, they appeared to be a result of concrete shrinkage typically observed on bridge decks. Figure 43 shows an example of the typical transverse cracks observed (annotated for clarity).

Figure 43. Typical deck surface cracking observed on Girder B

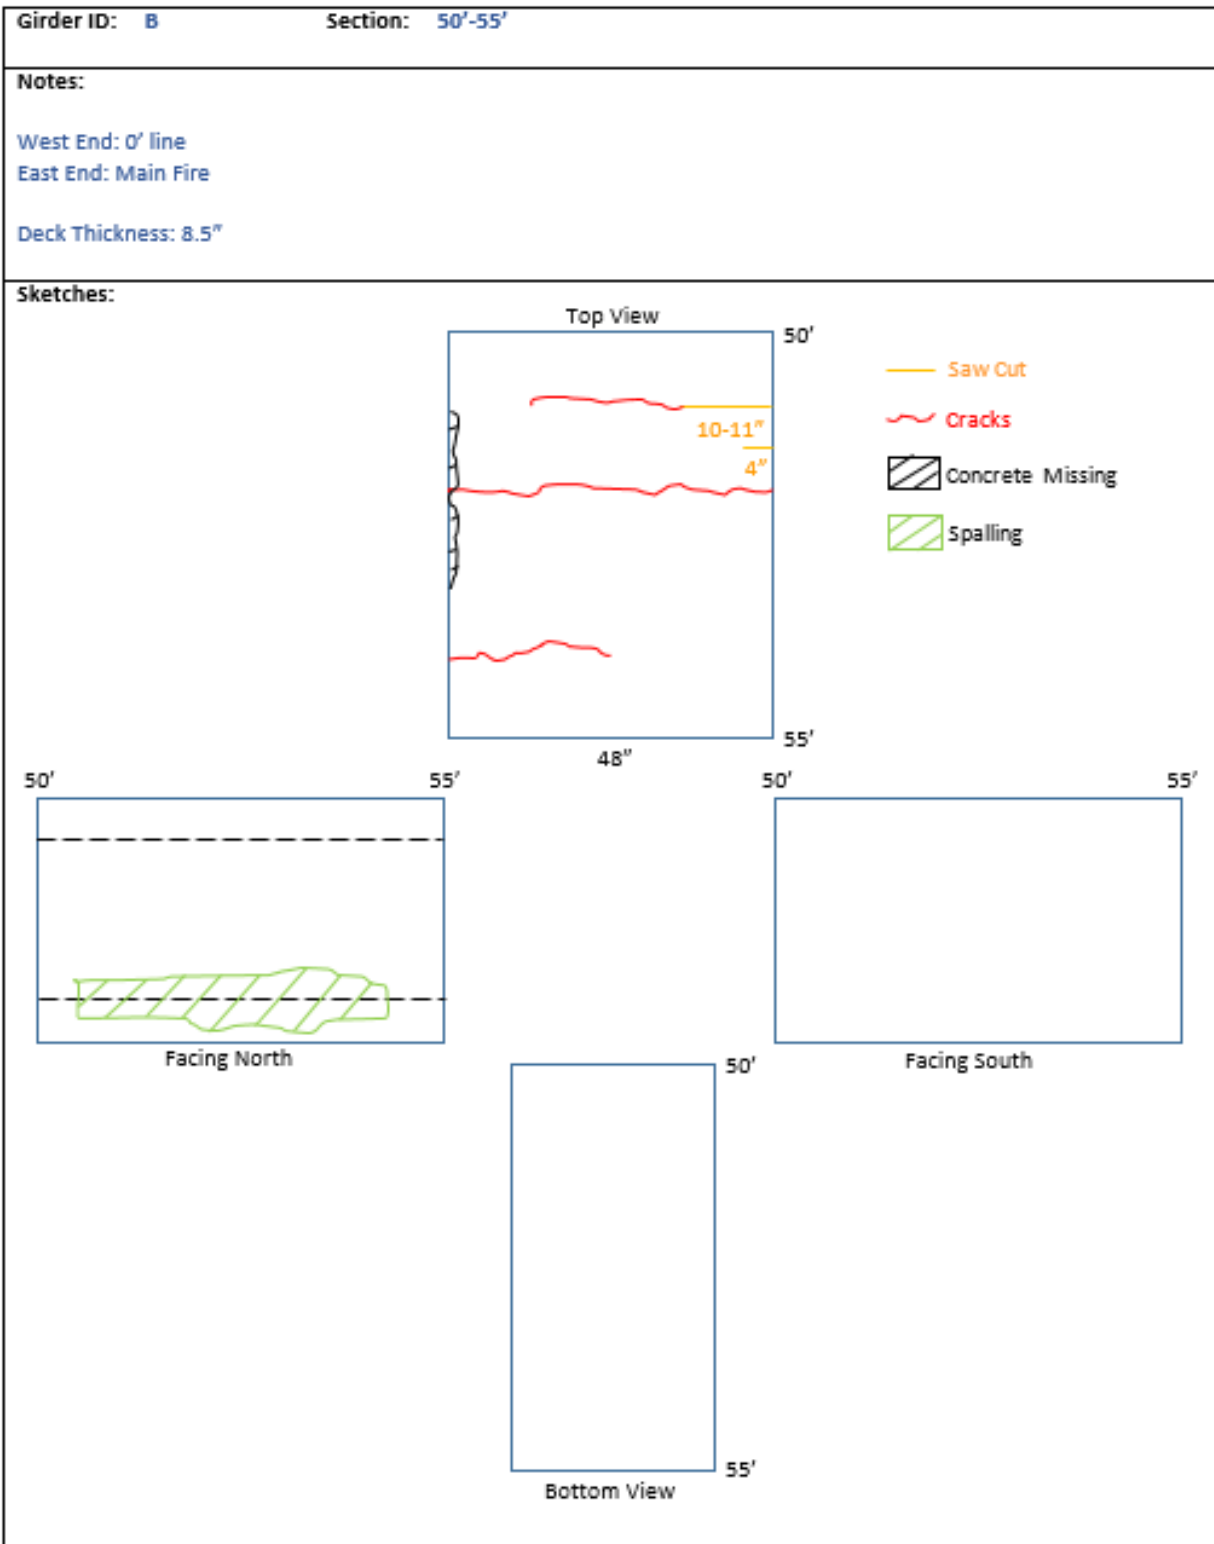
Areas of spalling were present on each side and bottom of the girder although it was in better condition than Girder E or G. An example of spalling near the midspan of Girder B at the bottom flange concrete is shown in Figure 44 and Figure 45 (annotated for clarity).

Figure 44. Example showing digitized condition assessment for Girder B

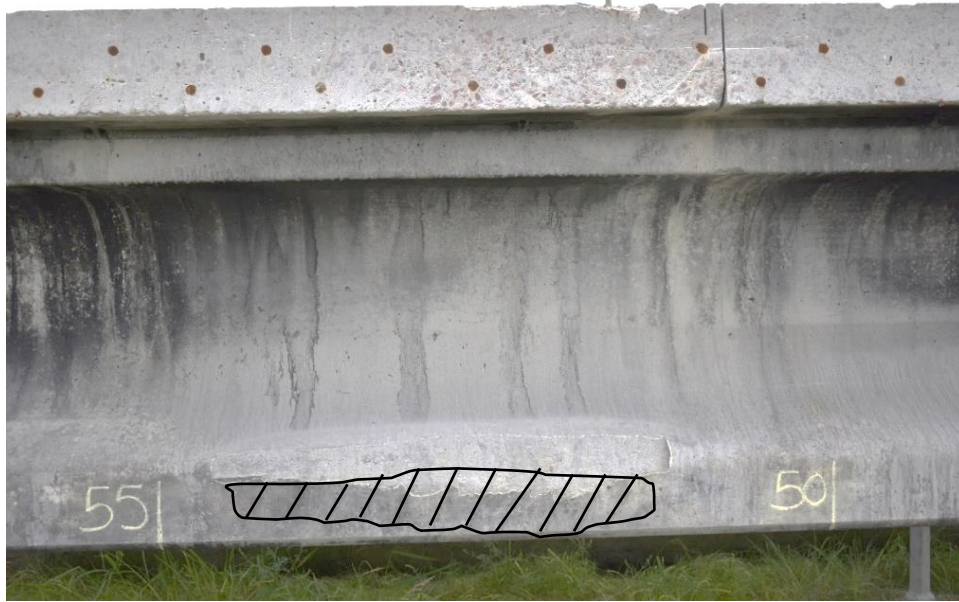
Figure 45. Spalled area on bottom flange near Girder B midspan

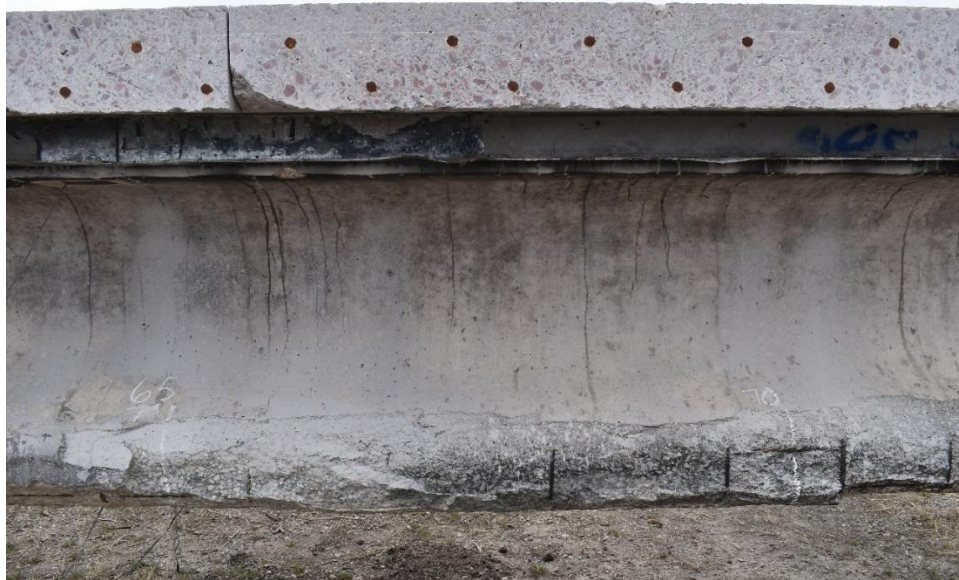
Visual observation of Girder E indicated a greater level of damage than Girder B (see Appendix). An increased area and depth of spalling was present compared to that for Girder B. The spalling occurred throughout the bottom flanges and at several areas on the web. Areas of steel reinforcement were exposed as shown in Figure 46 and Figure 47.

Figure 46. Bottom flange spalling on Girder E

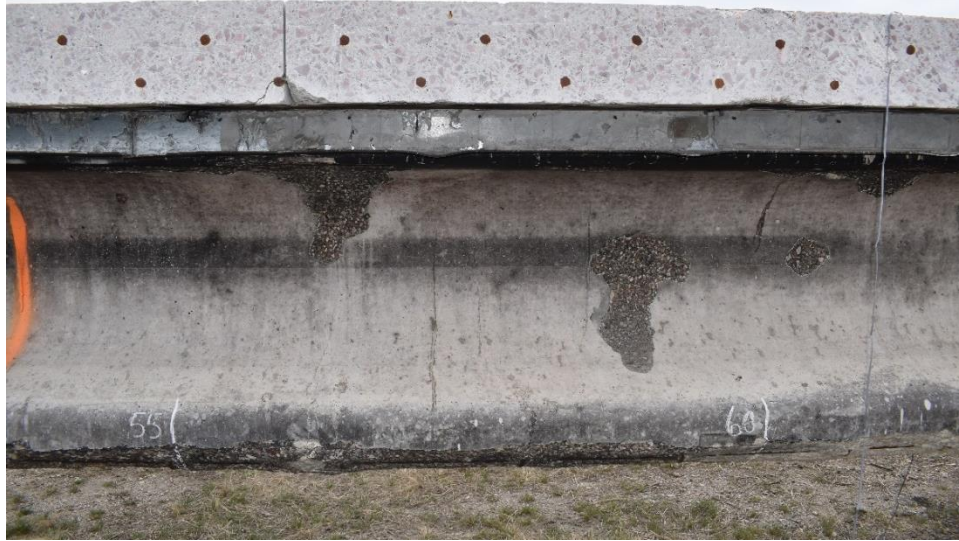
Figure 47. Web spalling on Girder E

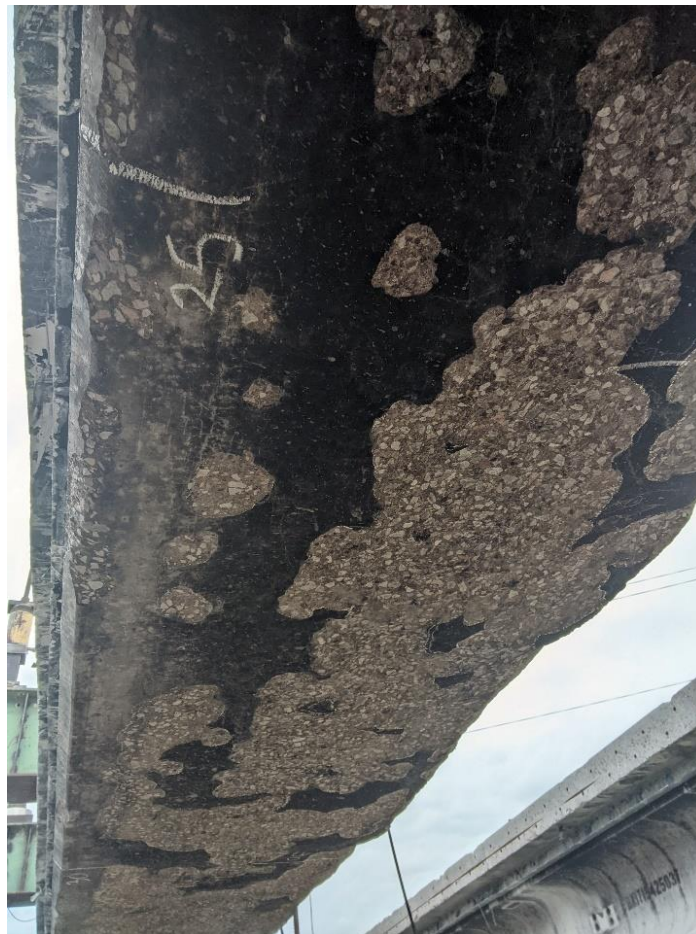
Extensive spalling on the bottom side of the girder is shown in Figure 48.

Figure 48. Bottom side spalling on Girder E

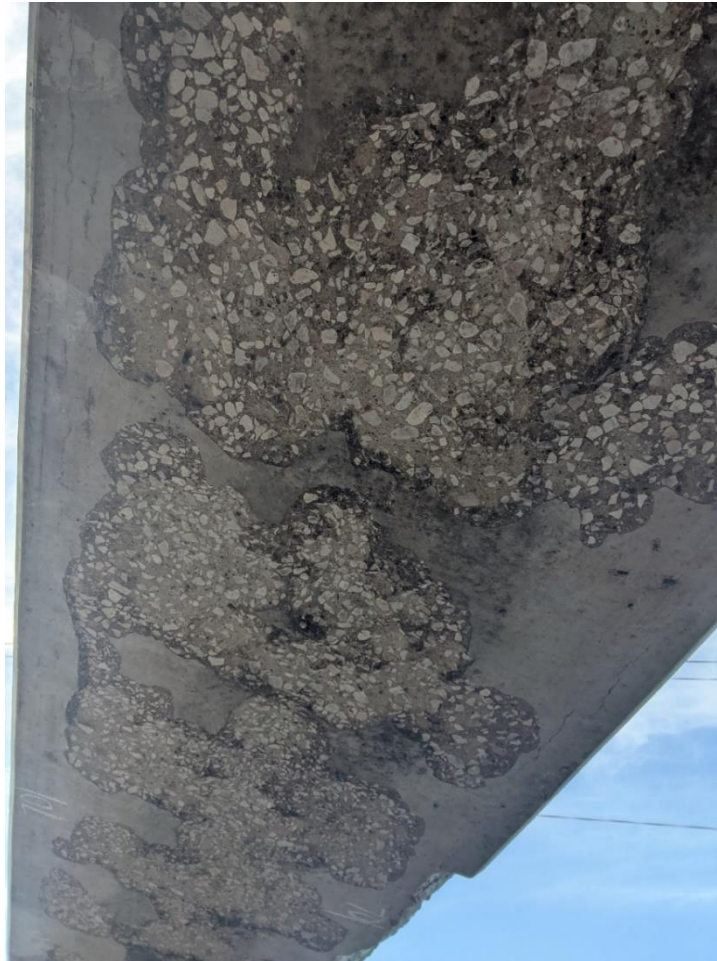
The condition of Girder G was similar to what was observed on Girder E (see Appendix), although the overall area of concrete damage was greater. The bottom flanges and bottom side of the girder had extensive spalling (see Figure 49), which resulted in the exposure of steel strands and shear reinforcement (see Figure 50).

Figure 49. Spalling of concrete on bottom side of Girder G

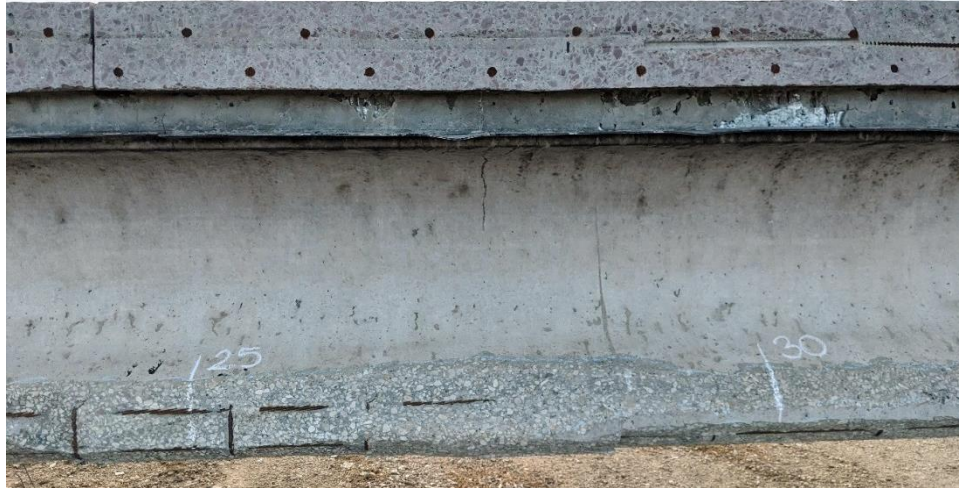
Figure 50. Exposure of steel reinforcement as a result of concrete spalling on Girder G

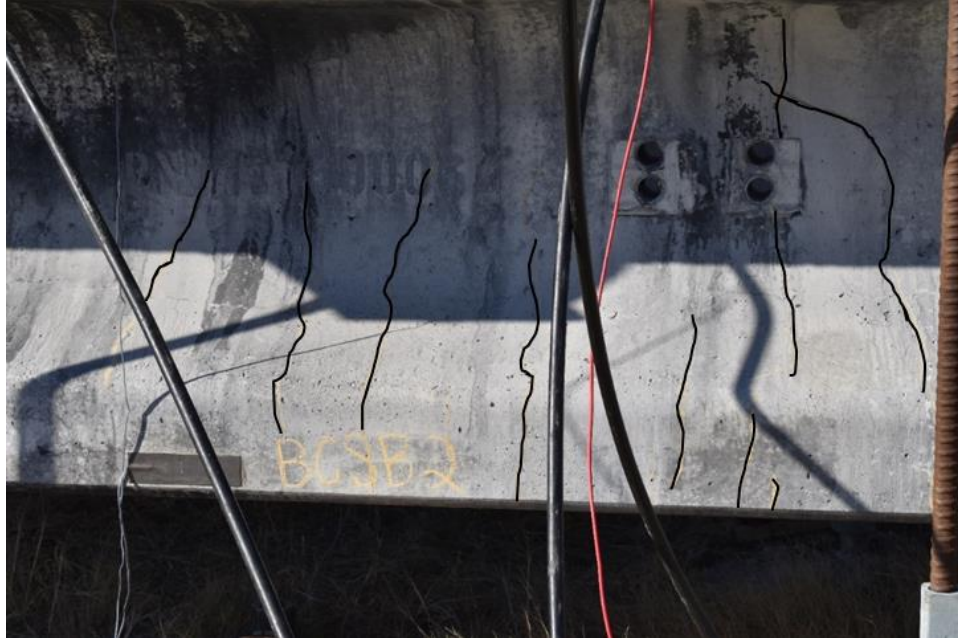
Girder B remained in an elastic state until the load reached about 70 kips at each load point location, or 140 kips total. This resulted in a midspan moment of about 2,700 kip-ft. Once this load magnitude was exceeded, yielding of the tensile reinforcement ensued at the extremities of the midspan, and flexural cracks in the concrete began to form at the bottom flange extending into the web. An example of the crack pattern is shown in Figure 52.

Figure 52. Crack patterns at midspan of Girder B

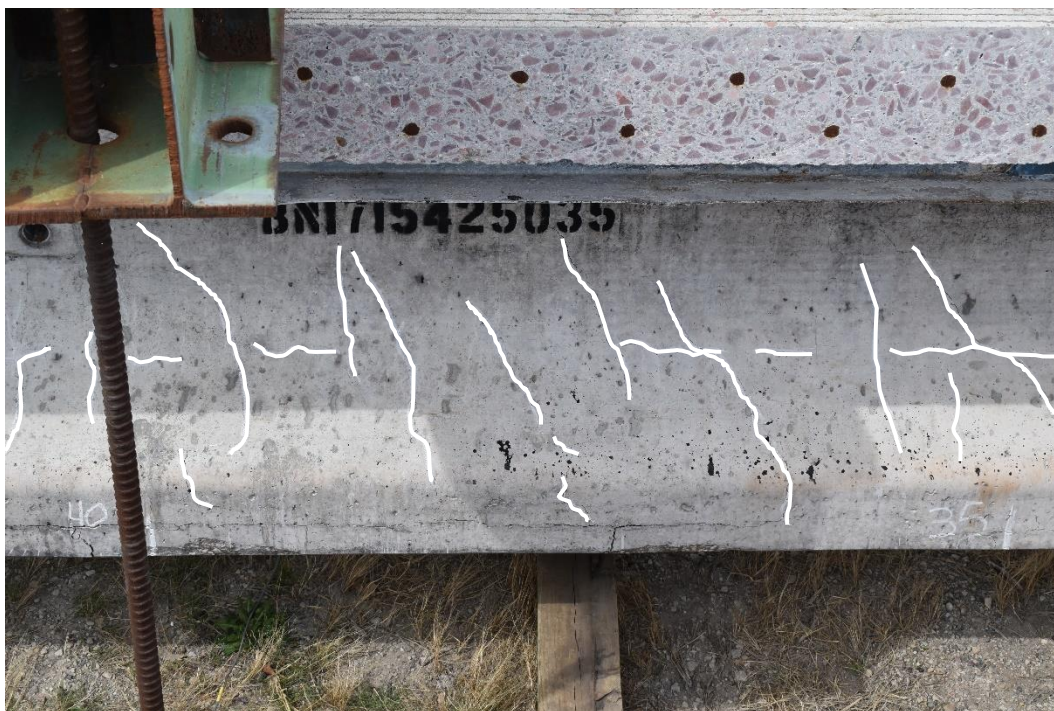
The load test of Girder E differed from that for Girder B in that the load was increased to the point of girder failure. The measured strain and deflection behavior were consistent with what was observed during the Girder B test, despite the evidence of more extensive damage (increased areas and depth of concrete spalling). Figure 57 shows the observed crack pattern near midspan prior to full failure of Girder E.

Figure 57. Cracking of Girder E bottom flange and web

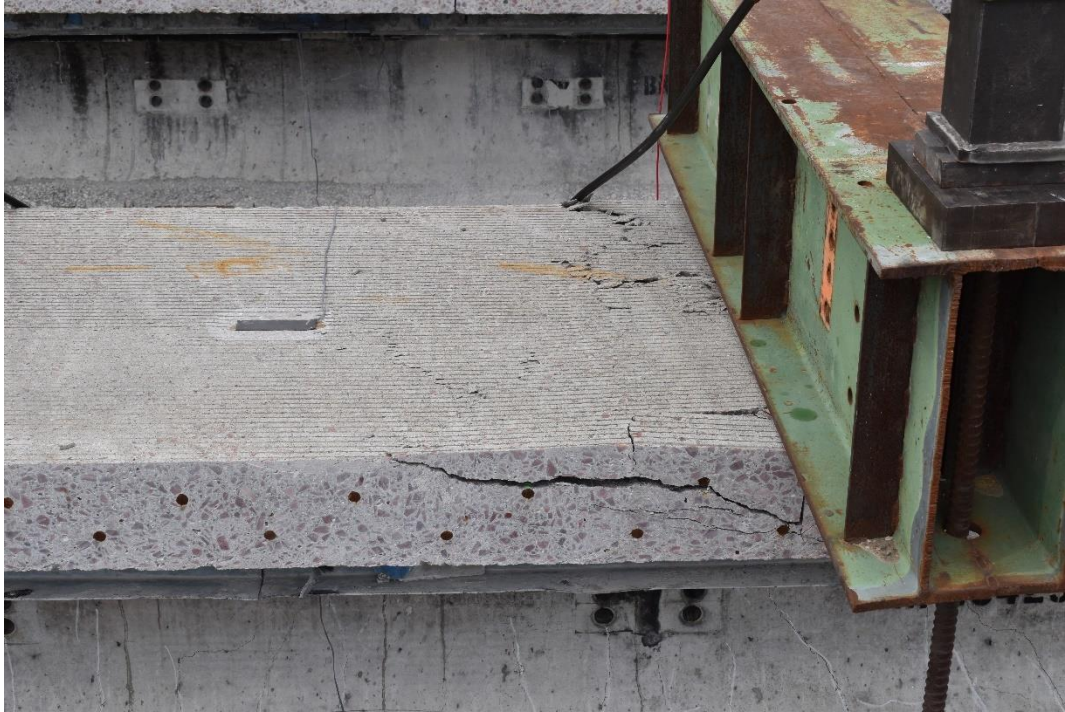
The final failure was a result of deck buckling. Capacity of the deck portion of the composite section was quickly lost upon buckling, resulting in all of the load being directed into the girder and exceeding the girder ultimate capacity. Figure 58 shows the initiation of the deck buckling near one of the points of loading, and Figure 59 shows the girder after failure occurred at a total load of 260 kips or a midspan moment of about 5,000 kip-ft

Figure 58. Initiation of deck cracking at Girder E midspan

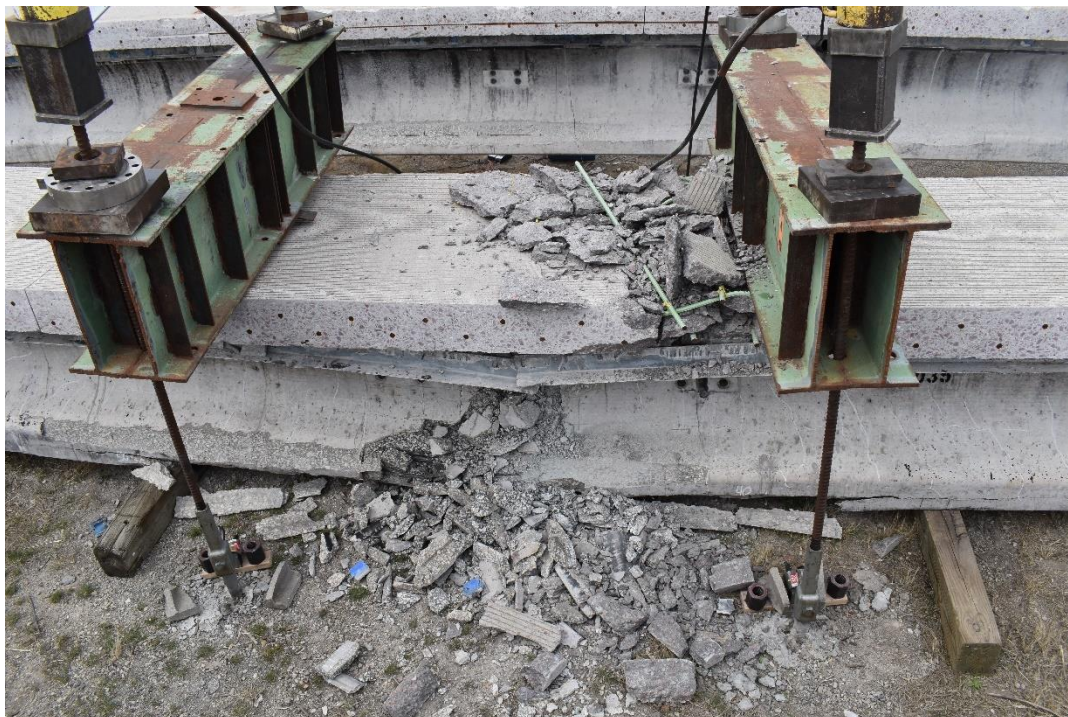
Figure 59. Girder E after failure at midspan

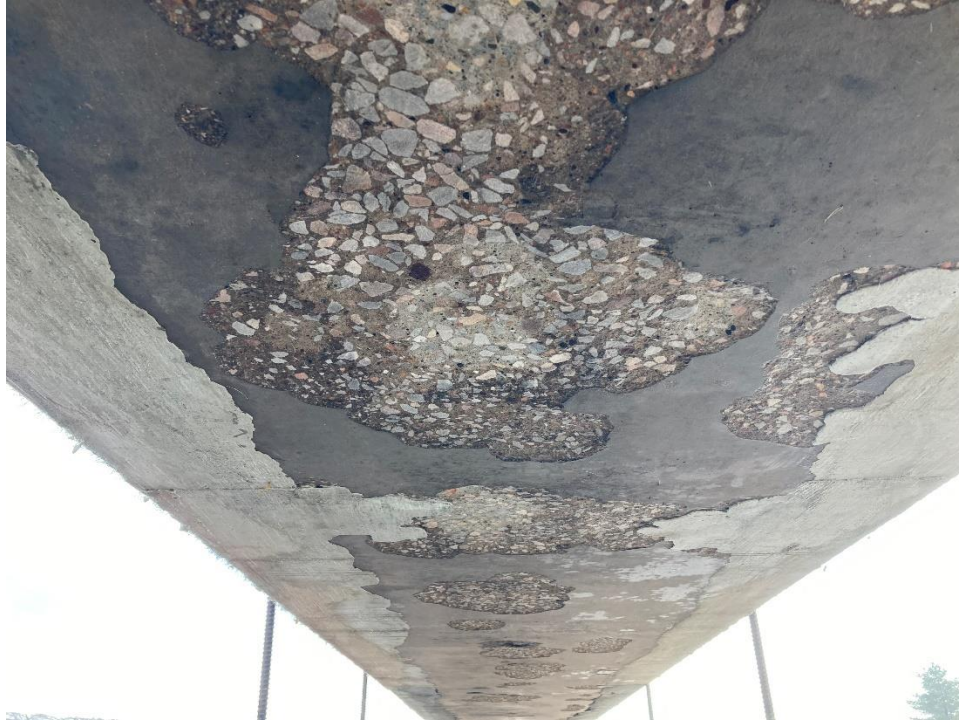
Figure 83. Bottom of girder spalls prior to repair

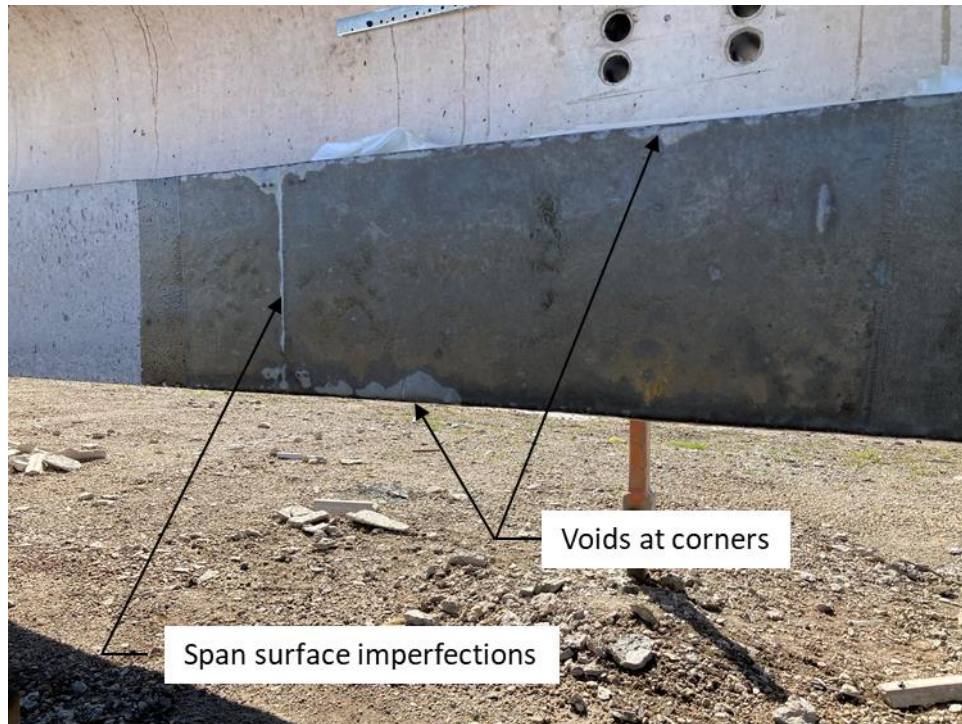
Figure 87. Problematic areas of FRP installation

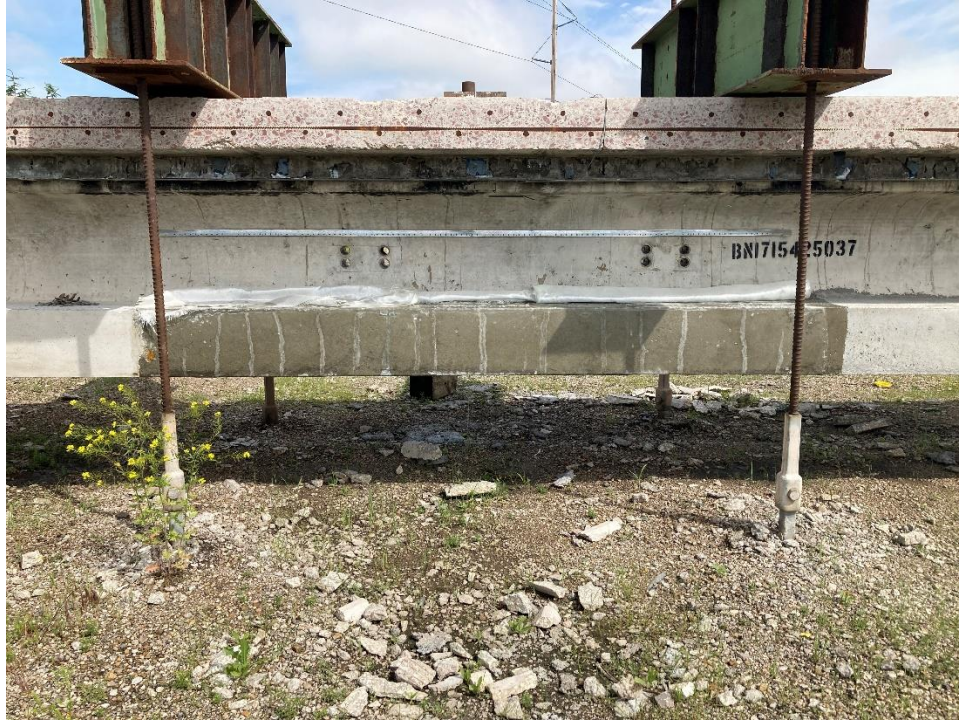
Figure 90. Vertical cracks in SCC/FRP repair section

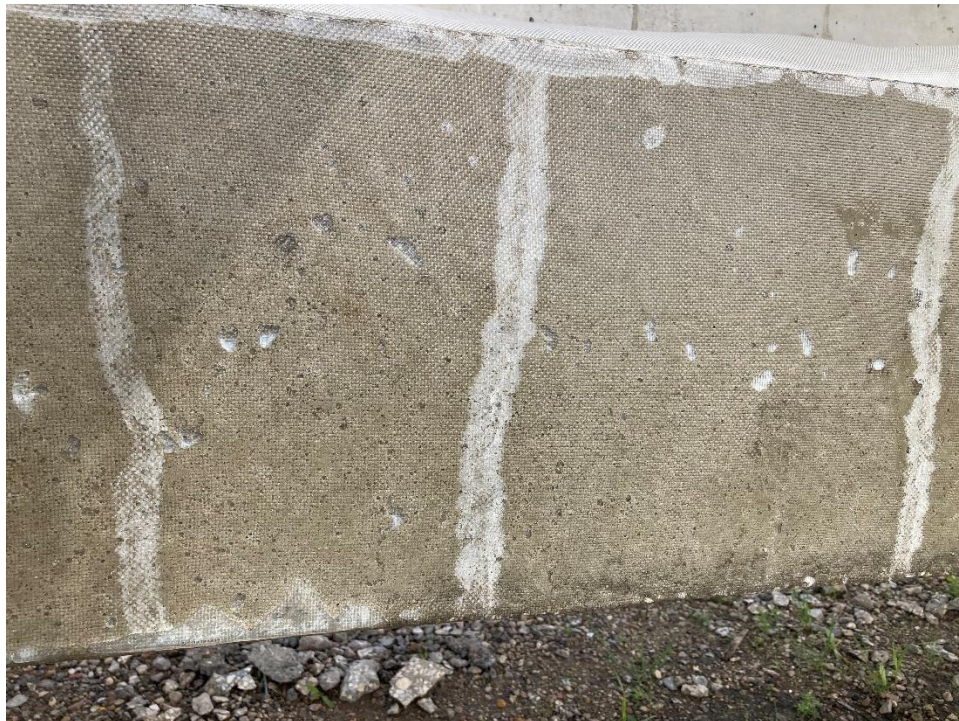
Figure 91. Closeup of vertical cracks in SCC/FRP repair section
