EL02-2015 Implementation
Assistance
Program

**Tools to Improve PCC Pavement
Smoothness During Construction
(R06E)**

FIELD REPORT: NEBRASKA EQUIPMENT LOAN

Table 1. Lincoln, Nebraska I-80 Project Information

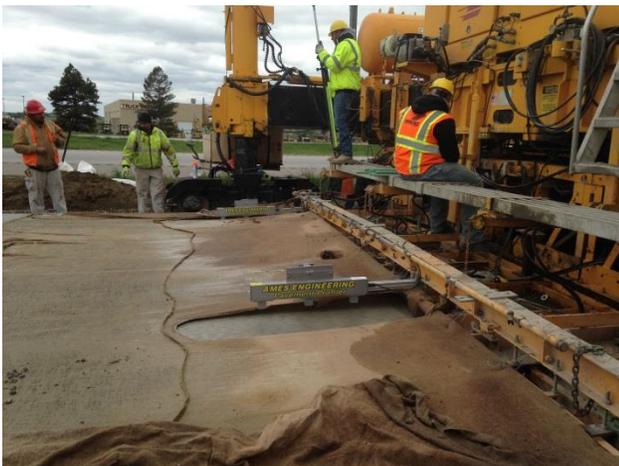
Figure 1. Ames RTP Mounted to G-Z S-850 Paver With a Float Pan

Hawkins’ paving operation was structured and skillful. The concrete mixture was batched at a central plant approximately 2 miles from the paving location and delivered in dump trucks. Figures 1 through 4 illustrate the installation of the RTP and different aspects of the paving equipment and processes used by Hawkins.

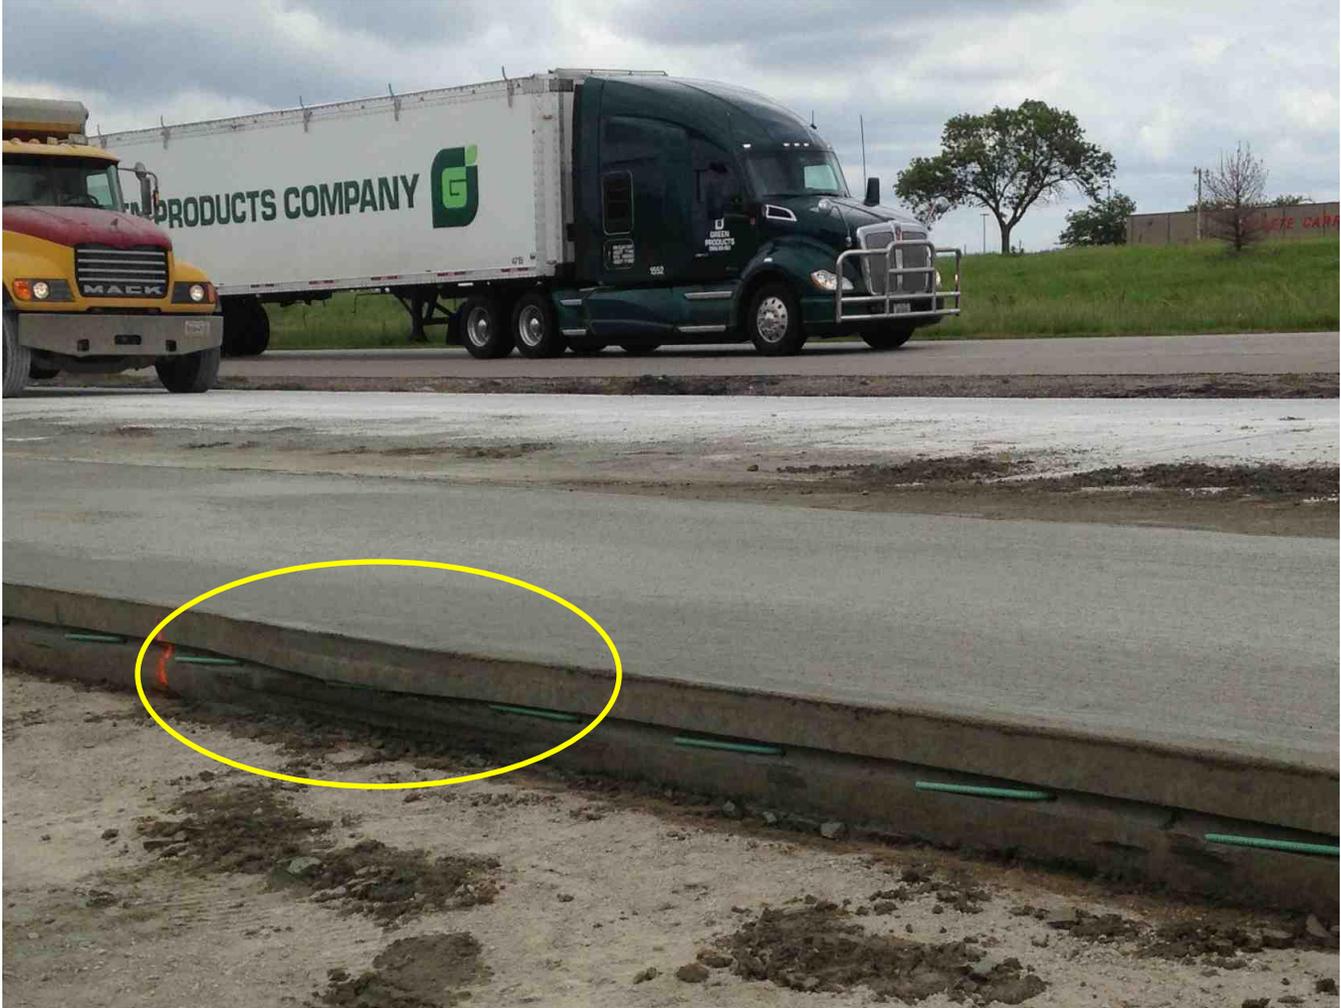
Figure 7. Isolated Area of Edge Instability (denoted by yellow oval)

The mixture produced and delivered to the project by Hawkins was observed to be uniform and workable. The mixture was very responsive to vibration; consolidation was achieved with relatively low vibrator frequencies (approximately 5,000 vpm). Isolated areas of edge instability was observed, this is likely a function of the aggregate proportions (30% coarse and 70% fine), and the resulting sensitivity to vibration (Figure 7).

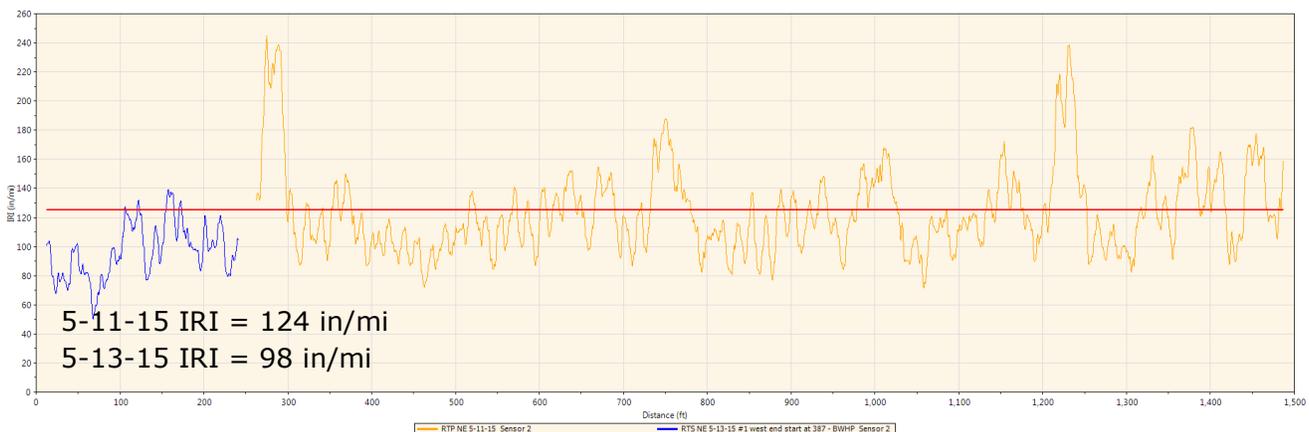
Figure 9. Comparison of Real-Time IRI Results from May 11th and May 13th

May 11th was the first day of paving on I-80 where the RTP was used. As a matter of practice, the R06 team requests that the contractor leave their operations unchanged for the first day while they familiarize themselves with operating the RTP. The next day of paving was May 13th, and the contractor made an effort to maintain a consistent and smaller head of concrete in front of the paver than was observed on May 11th. Figure 9 shows continuous IRI results (25' segment length) for both days (5-11 is yellow, 5-13 is blue and red is arbitrary action limit of 125 in/mi). The results from May 13th showed a 20% reduction in IRI despite the fact that it was only 400' long.

- Real-time smoothness (IRI) as measured by the Ames RTP was slightly higher than the QC hardened profile taken two days after paving.
- The contractor's efforts to maintain a consistent and lower concrete head on May 13th resulted in a 20% reduction in IRI as compared to the previous day's paving. The process change and resulting smoother pavement could have been achieved without real-time smoothness equipment. However, the instant feedback provided by the RTP provided positive reinforcement for the process change.
- Power spectral density plots show that transverse joints are the dominant contributor to pavement roughness.
