**EL08-2016** Implementation  
Assistance  
Program

**Tools to Improve PCC Pavement  
Smoothness During Construction  
(R06E)**

# FIELD REPORT: UTAH EQUIPMENT LOAN #8

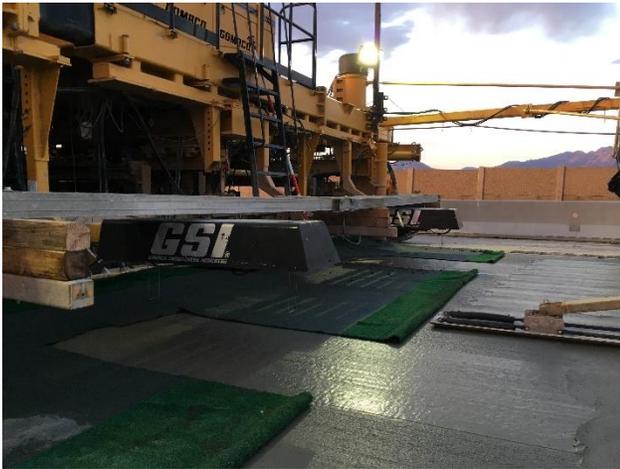
Figure 1. GSI Installed Directly at the Rear of the Paver

Figures 1 through 4 illustrate different aspects of the project and RLW's paving processes.

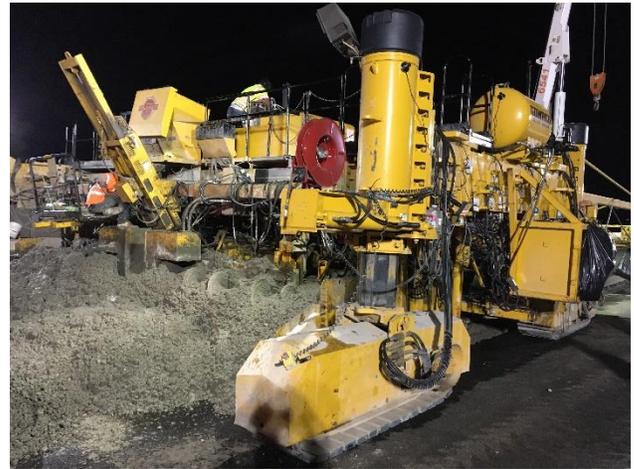
Figure 2. Concrete Dumped Directly in Front of the Paver

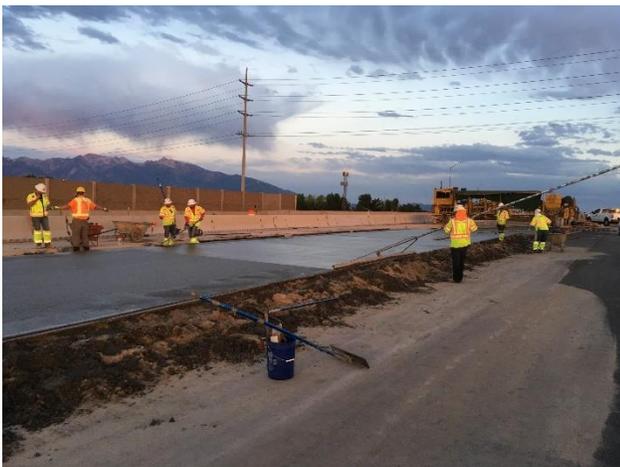
Figure 3. Typical Finishing Hand Finishing Behind the Paver
