**Tools to Improve PCC Pavement
Smoothness During Construction
(R06E)**

FIELD REPORT: UTAH EQUIPMENT LOAN #9

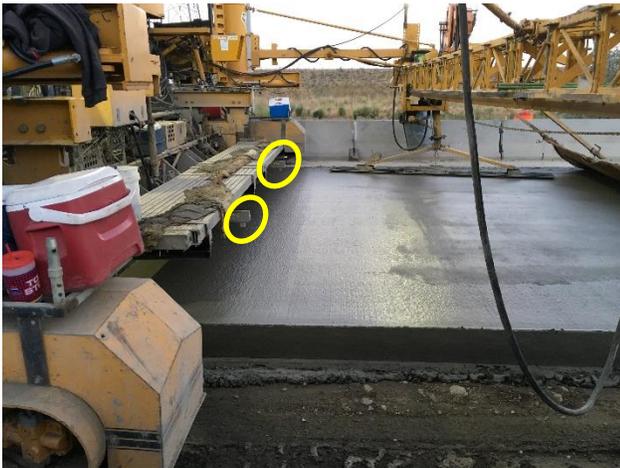
Figure 1. RTP (yellow ovals) Installed Behind the Dowel-Bar-Inserter (with OCB).

Figures 1 through 4 illustrate different aspects of the project and RLW's paving processes.

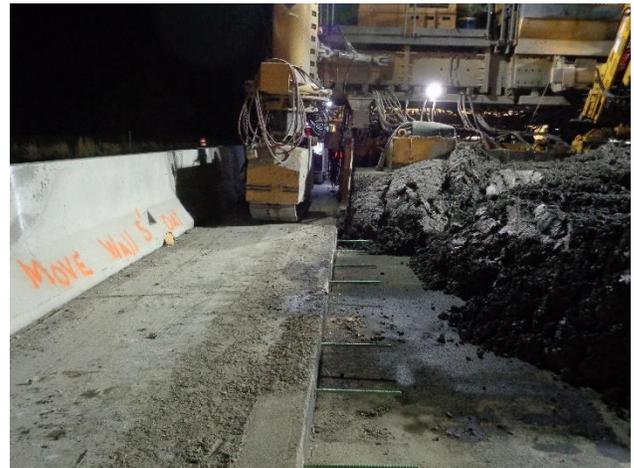
Figure 2. Concrete Dumped Directly in Front of the Paver and Right Side of Paver Matching Existing Slab.

The paving observed by the SHRP2 team was rural mainline paving. I-15 was widened to the inside median. The primary challenge to achieving smoothness for this project was the influence of matching the existing I-15 mainline pavement which can introduce roughness which wouldn't otherwise be present for pilot lane paving. Geneva's crews demonstrated quality workmanship and a clear understanding of slipform paving materials and processes. No major issues were observed during our tenure on the project.

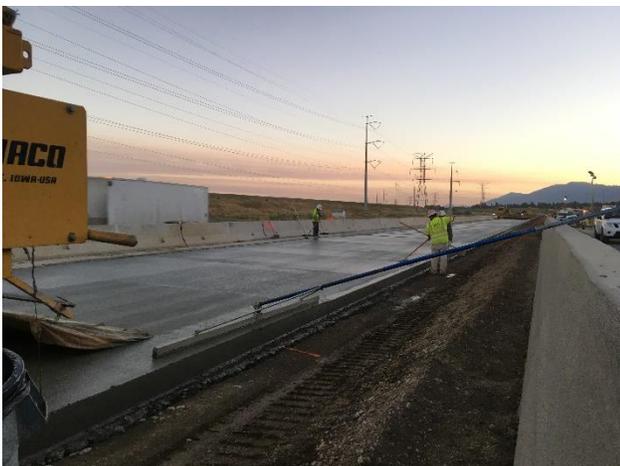
Figure 3. Typical Finishing Hand Finishing Behind the Paver

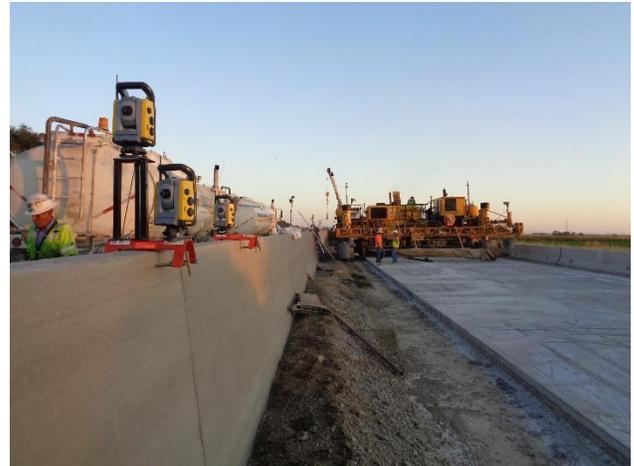
Figure 4. Trimble Stringless Robotic Lasers Setup on Median Barrier

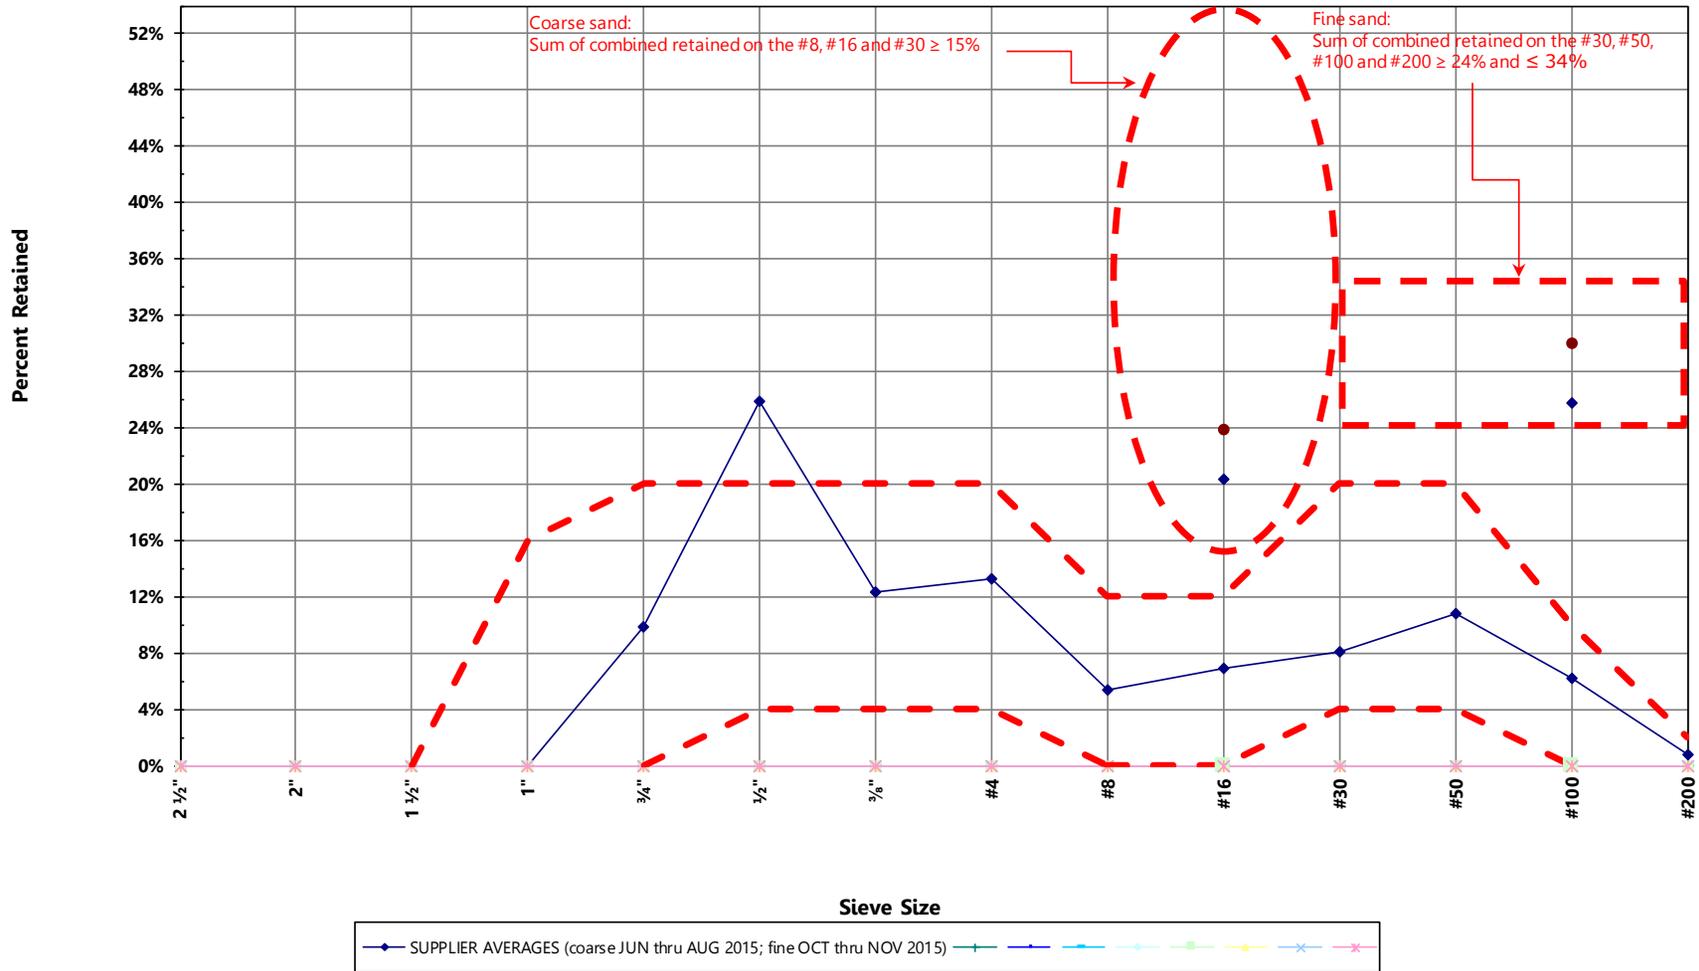
Figure 5. I-15 Combined Percent Retained (Tarantula Curve)

Combined gradation data is provided in Table 4 and Figures 5 and 6.

Sieve	Coarse	Intermediate	Fine #1	Fine #2	Combined % Retained	Combined % Retained On Each Sieve	Combined % Passing
2 ½"	100%		100%		0%	0%	100%
2"	100%		100%		0%	0%	100%
1 ½"	100%		100%		0%	0%	100%
1"	100%		100%		0%	0%	100%
¾"	84%		100%		10%	10%	90%
½"	42%		100%		36%	26%	64%
⅜"	22%		100%		48%	12%	52%
#4	1%		99%		61%	13%	39%
#8	1%		85%		67%	5%	33%
#16	1%		67%		74%	7%	26%
#30	1%		46%		82%	8%	18%
#50	0.4%		19%		92%	11%	8%
#100	0.3%		3%		99%	6%	1%
#200	0.2%		1.2%		99.4%	0.8%	0.6%

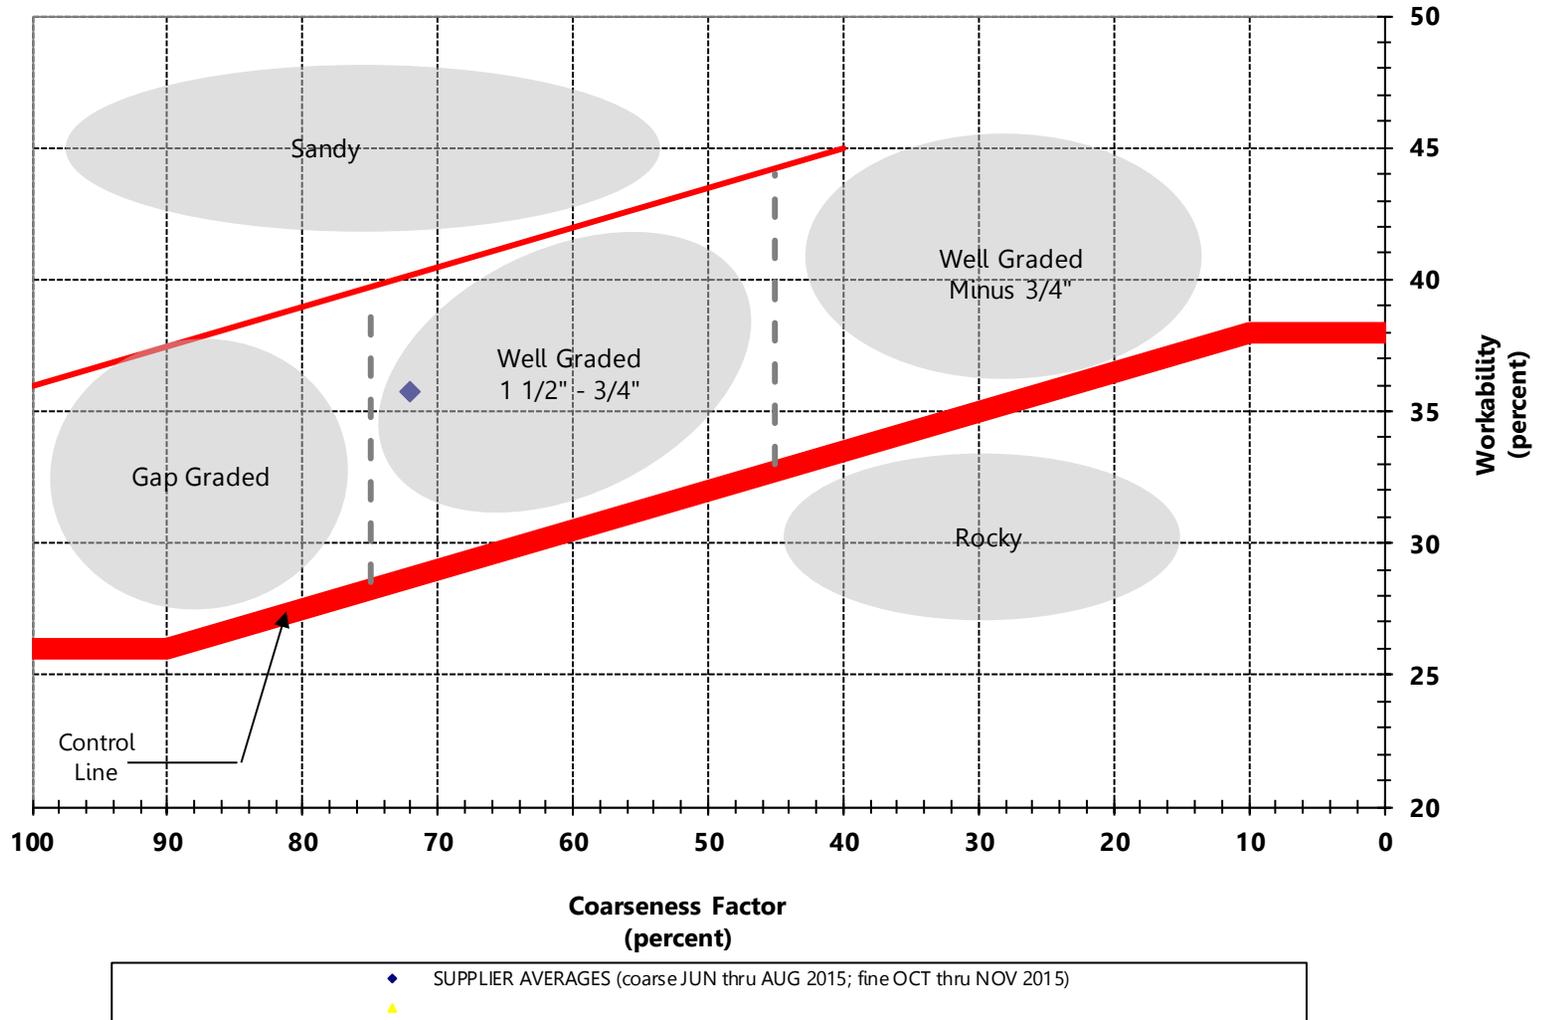
Figure 6. I-15 Combined Gradation Coarseness and Workability Factors

Workability Factor: 35.8 20% Coarse Sand
Coarseness Factor: 72.0 26% Fine Sand

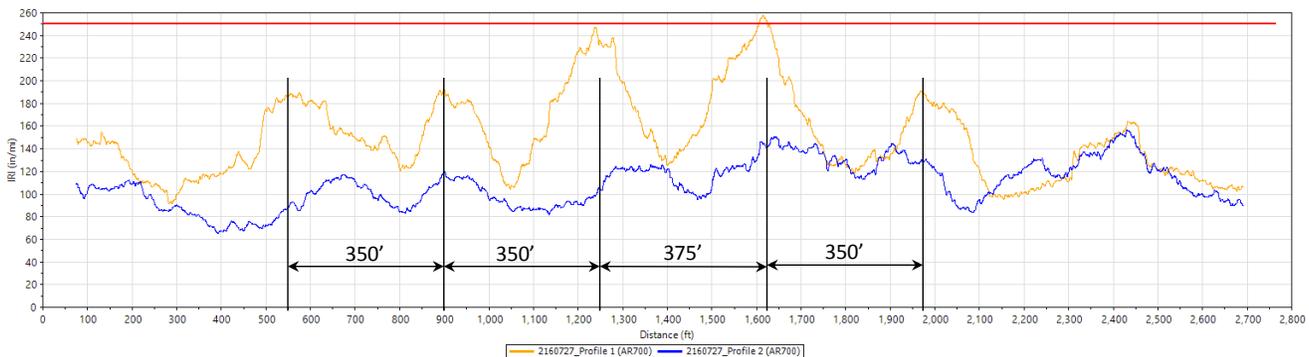
Figure 7. Real-Time Profile Data Illustrating Fluctuation of IRI Corresponding to Stringless Gun Swaps (IRI based on 150' base length matches real-time settings as viewed on the screen 27JUL2016)

During the equipment loan, it was observed that the IRI values fluctuated regularly. On the night of July 27, a pattern of increasing and then decreasing IRI was apparent at intervals of approximately 350' (Figure 7), and particularly on the right side of the paver. This matched the spacing between the stringless robotic total stations controlling the paver's elevation and steering, with the right side of the paver being further from the stringless total stations than the left side.

Once this relationship was observed, the contractor reduced the distance between robotic total stations to improve IRI results.

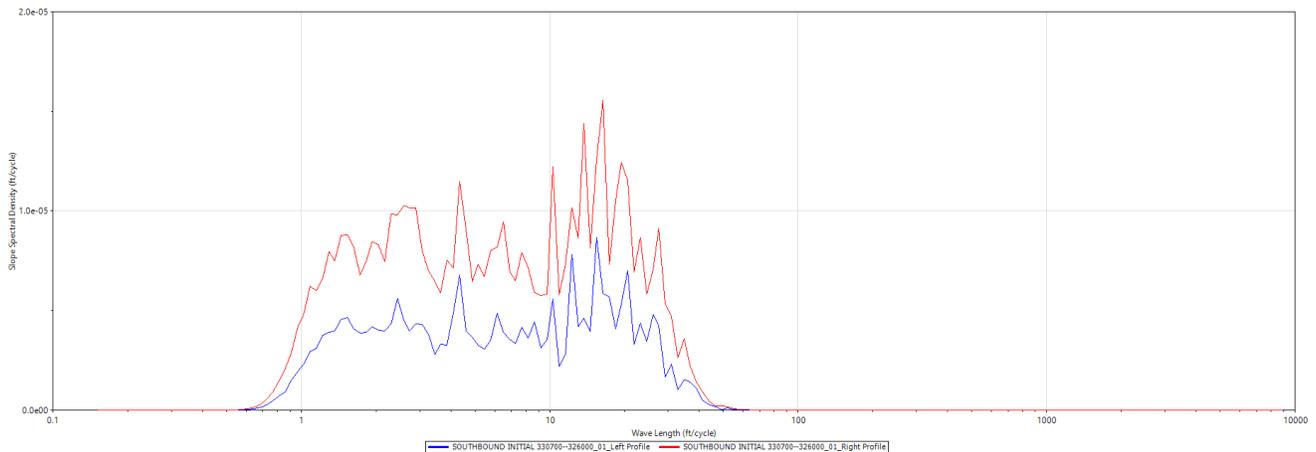
Figure 8. PSD Analysis Showing Joint Spacing at 15' and Concrete Loads at 13' with Associated Harmonic Wavelengths Contributing to Pavement Roughness

The power spectral density analysis (PSD) from ProVAL shows the 15' joint spacing and 13' from concrete load spacing as the dominant wavelengths contributing to roughness in the hardened profile (Figure 8). The PSD for hardened profile was run with a butterworth band pass at 1' to 30' to remove the influence of long wavelength roughness from the operation of the stringless system.
