# Precast Concrete Elements for Accelerated Bridge Construction

## Volume 2. Laboratory Testing, Field Testing, and Evaluation of a Precast Concrete Bridge: Madison County Bridge

**Final Report**  
**January 2009**

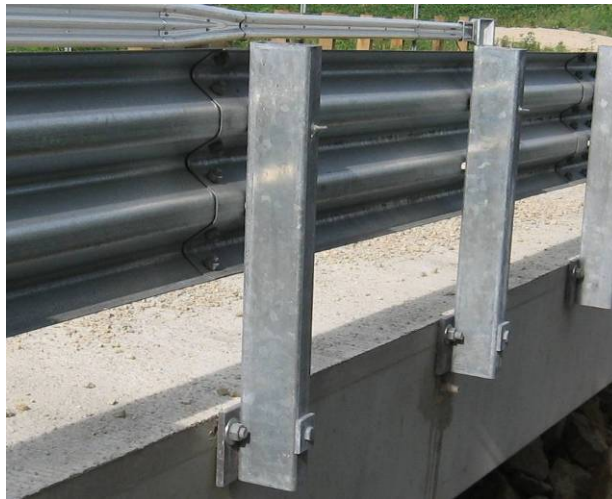
**Figure 2.4. Photograph of bridge guardrail system**

The bridge guardrail consists of the galvanized steel post and thrie beam extending the full length of the bridge shown in Figure 2.4. The guardrail posts are bolted to the exposed face of each exterior girder with two 1 in. diameter embedded bolts. No curbs are present on the bridge.

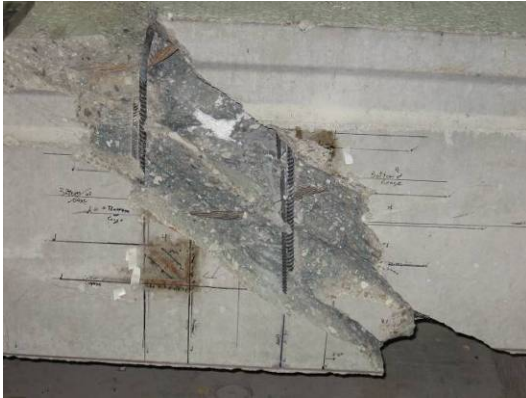
**Figure 4.13. Photographs of box girder after shear failure**

Figure 4.13a shows the shear crack after testing concluded. The angle of the shear crack was measured to be approximately 45 degrees. Inspection of the failure afterwards revealed a #3 stirrup fractured at the time of failure. This can be seen in Figure 4.13b.

**a. shear crack after failure**

**b. fractured stirrup**

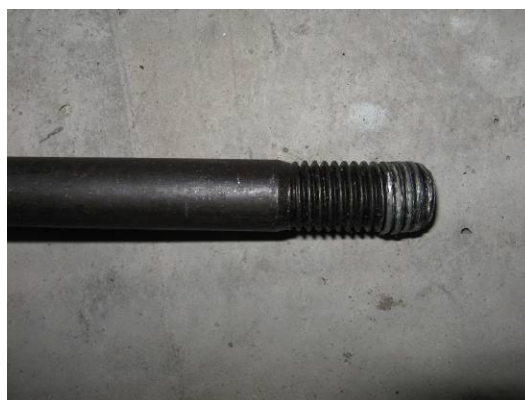
Figure 4.19. Photographs of failed guardrail connection elements

**Figure 4.19** shows the components of the guardrail connection after different post failures. The base plate for each post yielded during testing. **Figure 4.19a** shows the yielded base plate for post 1, along with a longitudinal concrete crack that developed. Post 1 was the only location where longitudinal concrete cracking occurred. During loading, the portion of the post base bearing against the base plate buckled, which is shown in **Figure 4.19b**. The width of the posts was measured to have increased as much as 1/2 in. to 3.5 in. A ruptured 3/4 in. bolt from test 2 is shown in **Figure 4.19c**, and sheared base plate threads can be seen in between the threads of a 3/4 in. bolt in **Figure 4.19d**. A summary of the results for the guardrail connection tests are presented in Table 4.7. Values presented in the table include the magnitude of the maximum applied load, at which post the failure occurred, the force carried by the post, the force applied to the 3/4 in. bolt at failure, the capacity of the connection, and the failure type.

**a. yielded base plate and concrete cracking**

**b. buckled post**

c. ruptured bolt

d. bolt with sheared base plate threads

Loading during test 1 reached 15.4 kips. At this load, the 3/4 in. bolt connecting post 1 to the base plate ruptured. Using the strain data collected during testing, a 7.29 kip force was resisted by the post at failure. Using simple statics, this is equivalent to a tensile force of 41.0 kips in the bolt. The published strength of a 3/4 in. bolt is 39.7 kips.

The applied load during test 2 reached 16.9 kips. The 3/4 in. bolt connecting post 4 to the base plate ruptured during the test. The bolt force equaled 41.9 kips.

Failure during Test 3 occurred when the threads of the post 6 base plate sheared. The theoretical force required to shear the base plate threads was 32.2 kips, and the applied bolt force was calculated to be 36.7 kips. One explanation for this discrepancy would be the shear area of the threads exceeding the area used in the calculations.

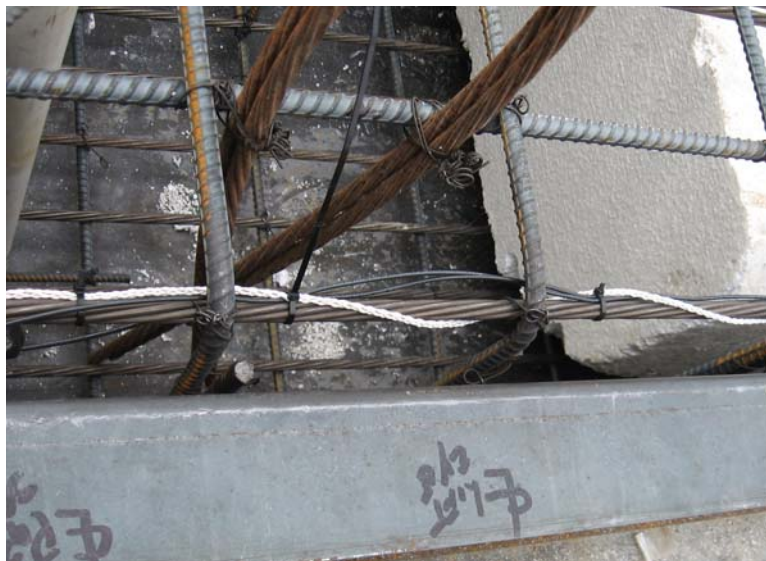
**Figure 6.17. Corrosion electrode wrapped around strand**

Corrosion monitoring of the strands was completed with the use of Vetek V2000 corrosion monitoring system. The V2000 braided silver electrode that is wrapped around the monitored strands can be seen in Figure 6.17. The V2000 monitor works by measuring the electric potential between the strand and the electrode with the pore water of the concrete acting as an electrolyte between the two. An increase in the electric indicates that corrosion activity is taking place. The electric potential is measured with a voltmeter with three different ranges of readings representing three different stages of corrosion. The three different stages are listed below in Table 6.5.
