Report # MATC-ISU: 134

Final Report

## Methods for Removing Concrete Decks from Bridge Girders

**Final Report  
August 2014**

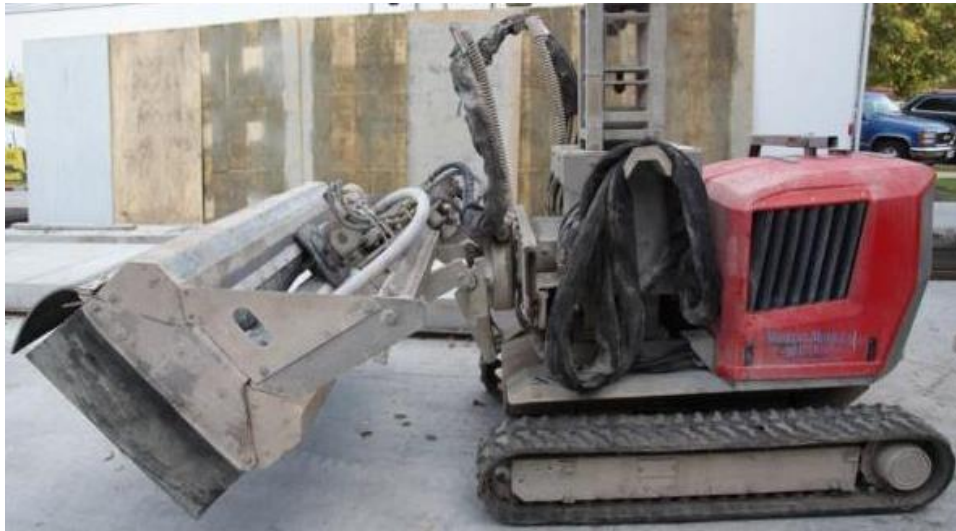
**Figure 4. Demolition unit (Dang 2013)**

The hydrodemolition equipment used in this trial has two primary units, a power unit and a demolition unit. The demolition unit, Aqua cutter 710V classic, was used to perform the demolition tasks (see Figure 4).

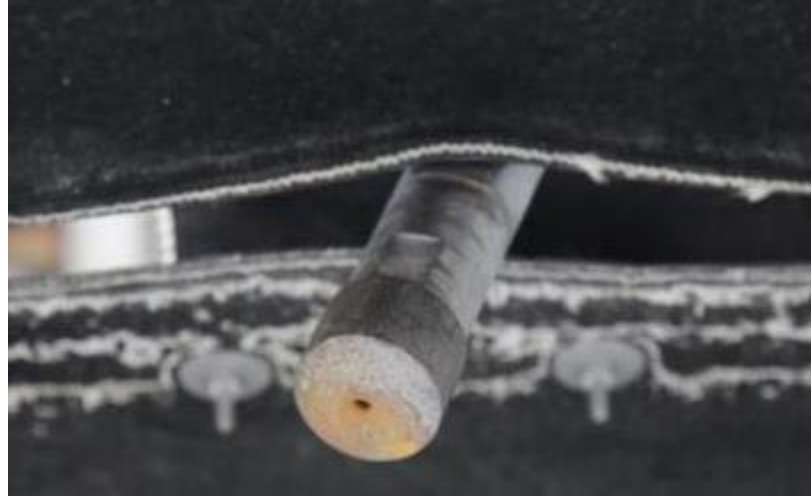
**Figure 6. Front close-up view of the nozzle (Dang 2013)**

The nozzle is designed to maintain a set distance from the nozzle tip to the concrete surface regardless of the lance attack angle. The effectiveness at breaking concrete is the reciprocal of the lance attack angle; whereas, the effectiveness at removing concrete from the reinforcing steel is proportional to the lance attack angle. For example, a zero lance attack angle is more effective at breaking concrete and a 30° inclination is more effective at cleaning the reinforcing steel. A front close-up view of the hydrodemolition nozzle is shown in Figure 6.

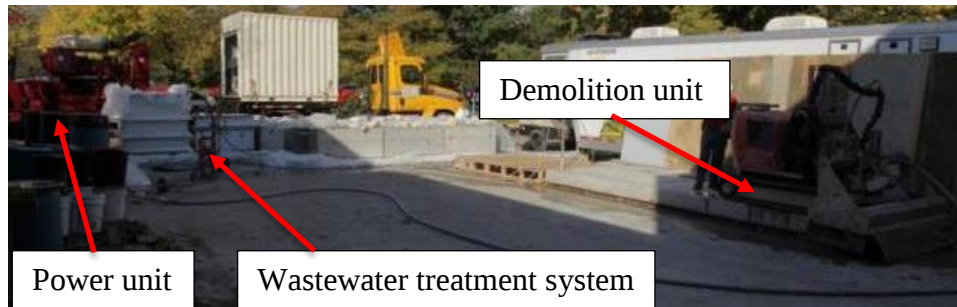
**Figure 8. Hydrodemolition site (Dang 2013)**

To conduct the hydrodemolition trial, the operator located the demolition unit on top of the small-scale specimen and then calibrated the demolition unit. A photograph of hydrodemolition site is shown in Figure 8.

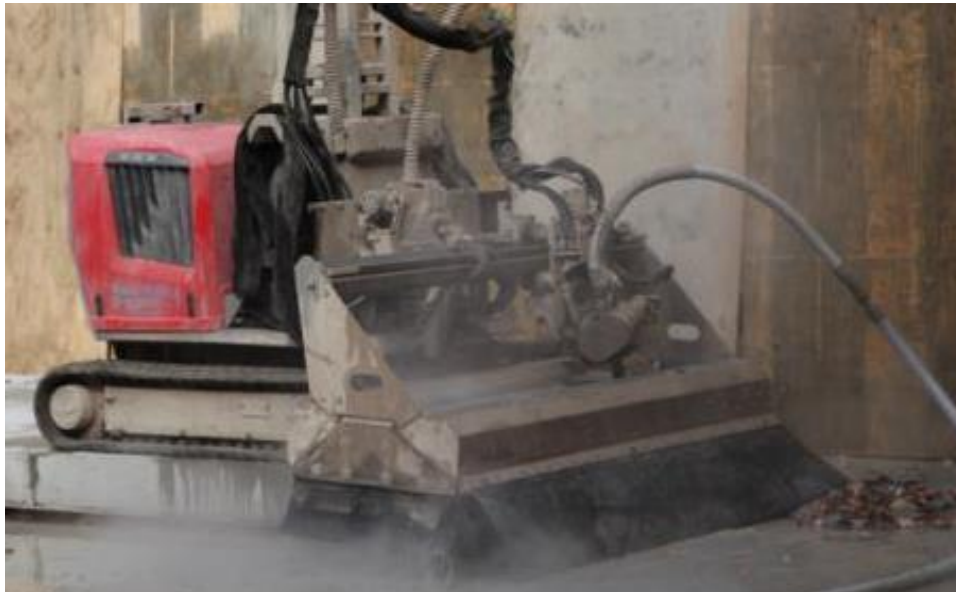
**Figure 9. Hydrodemolition trial (Dang 2013)**

The first hydrodemolition test demonstrated the removal of just the top layer concrete. The demolition unit was preprogrammed to perform a 24 in. wide, 4 in. deep, and approximately 18 in. long concrete removal. A photograph taken during the first hydrodemolition test is shown in Figure 9.

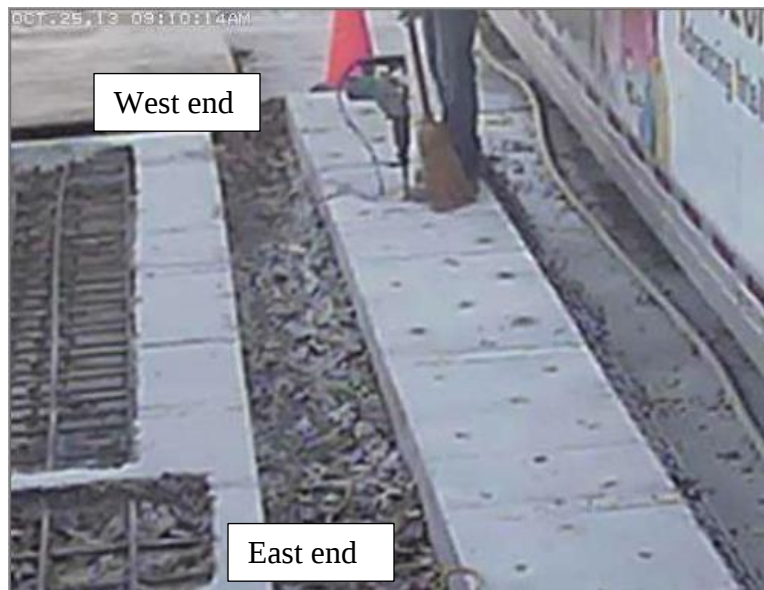
**Figure 15. Drilling and cleaning holes taken by the networked camera**

To prepare the chemical splitting agent, three liters of cool, clean water were poured into a clean bucket, and 22 lb of chemical splitting agent was mixed with the water for three minutes. Then the holes were filled within five minutes of mixing. All holes filled with the expansive grout were then capped. A photograph during the hole drilling process is shown in Figure 15.

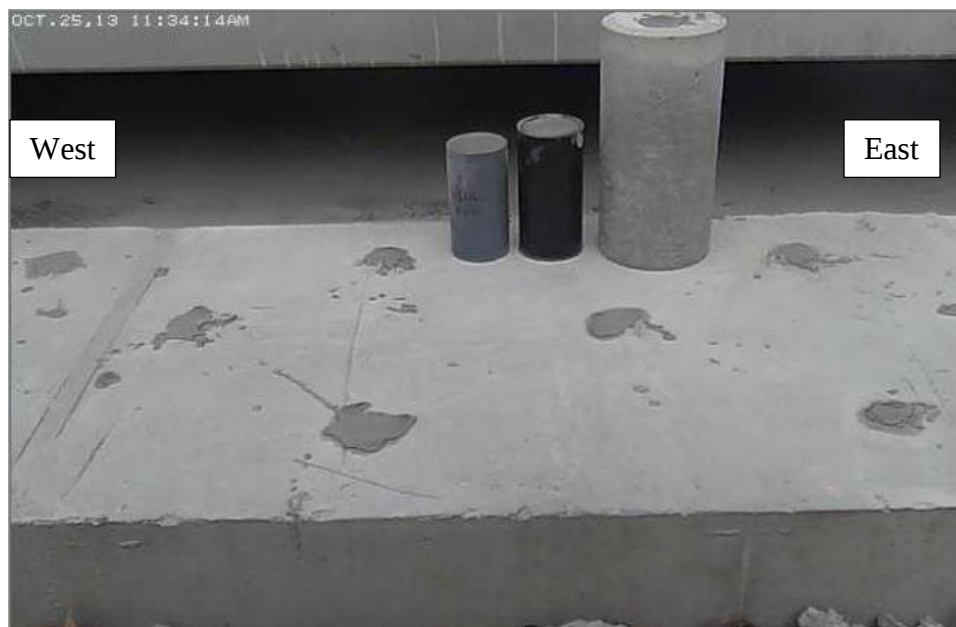
**Figure 17. Chemical splitting specimen and the grout**

Photographs were taken every 12 minutes after grout placement. A photograph of the chemical splitting specimen after placement of the expansive grout is shown in Figure 17.

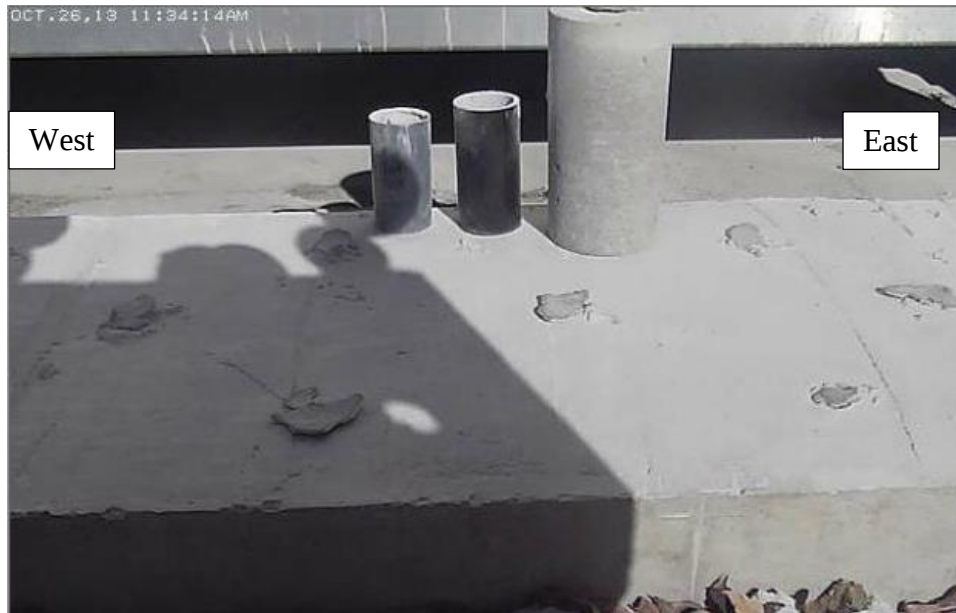
**Figure 18. Chemical splitting on day one (after 24 hours)**

One day after placing the chemical splitting agent, the chemical splitting specimen was observed to be sound (see Figure 18). Although it is possible that micro cracks might have developed, the research team observed no signs of cracks.

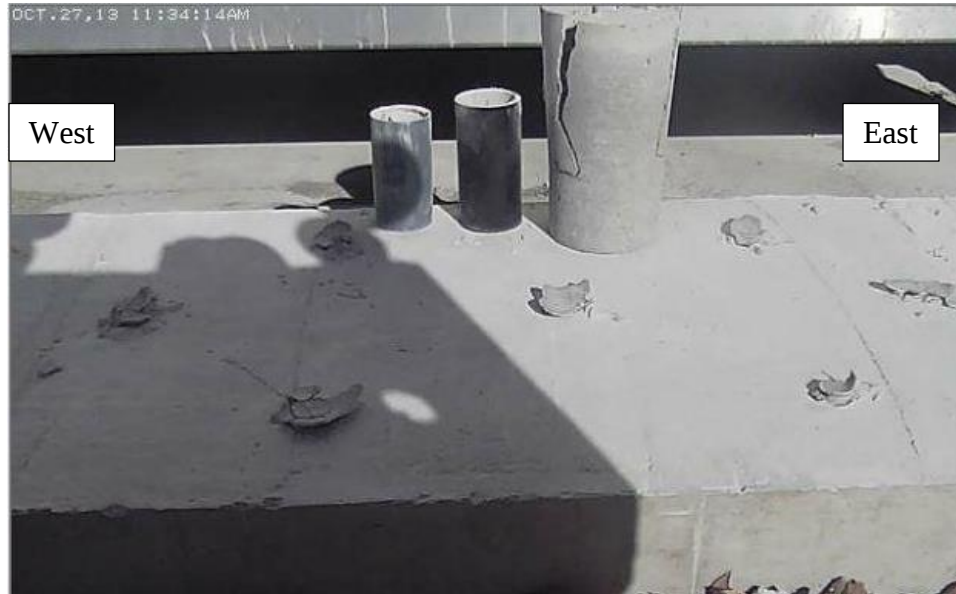
**Figure 19. Chemical splitting on day two (after 48 hours)**

On day two, three major cracks developed on the top of the concrete cylinder (Figure 19). Small cracks initiated on the surface of the concrete slab, and two major cracks formed at the ends of the specimen.

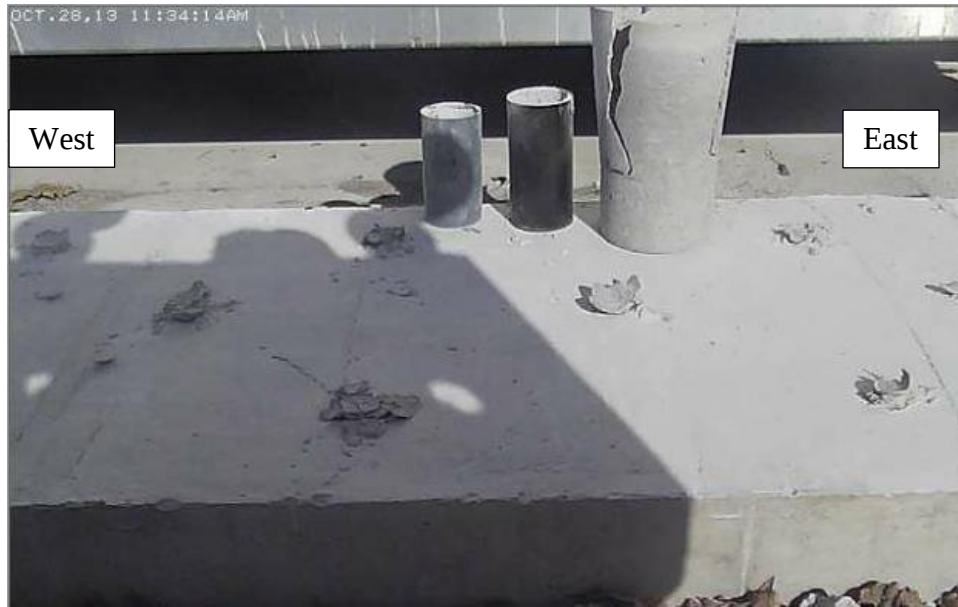
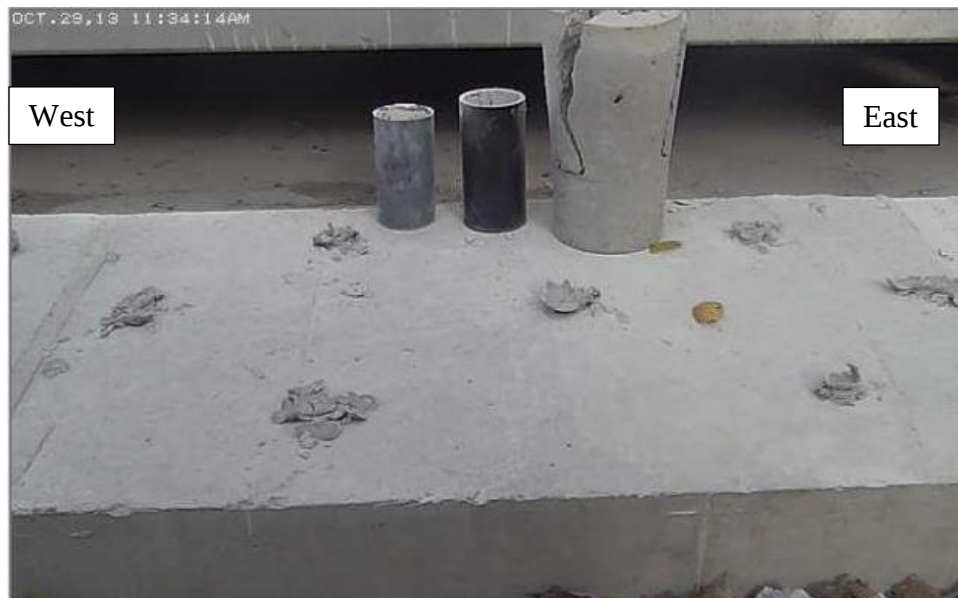
On days three and four, the cracks initially observed on day two grew and propagated (see Figure 20 and Figure 21). In addition, new cracks developed on the surface of chemical splitting specimen.

**Figure 20. Chemical splitting on day three (after 72 hours)**

**Figure 21. Chemical splitting on day four (after 96 hours)**

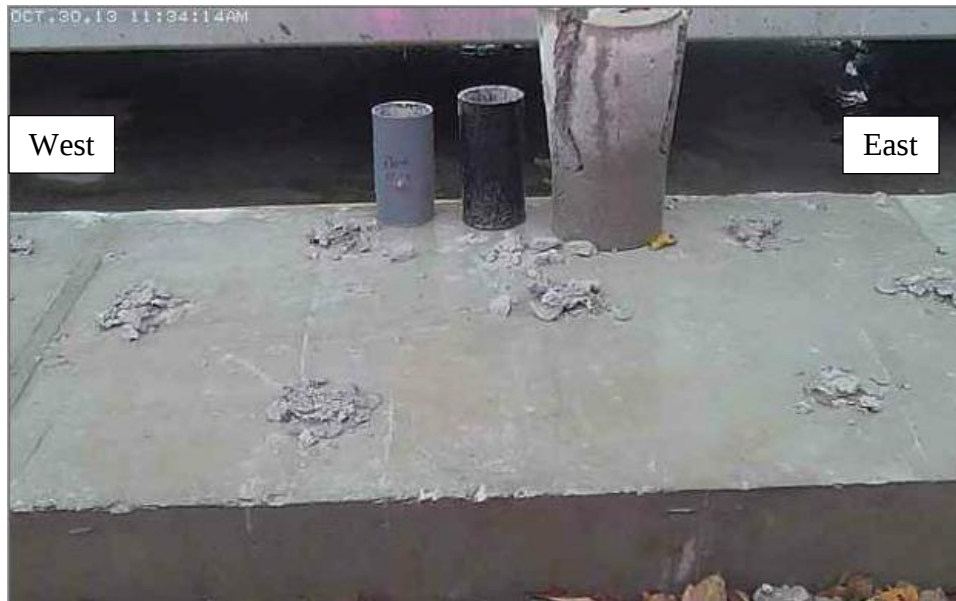
**Figure 22. Chemical splitting on day five (after 120 hours)**

On day five, a 25-minute rainfall occurred at 1:00 a.m. and another three-hour rainfall started at 9:00 a.m. (see Figure 22). As a result, it is possible that the expansive grout absorbed additional water and may have been rehydrated.

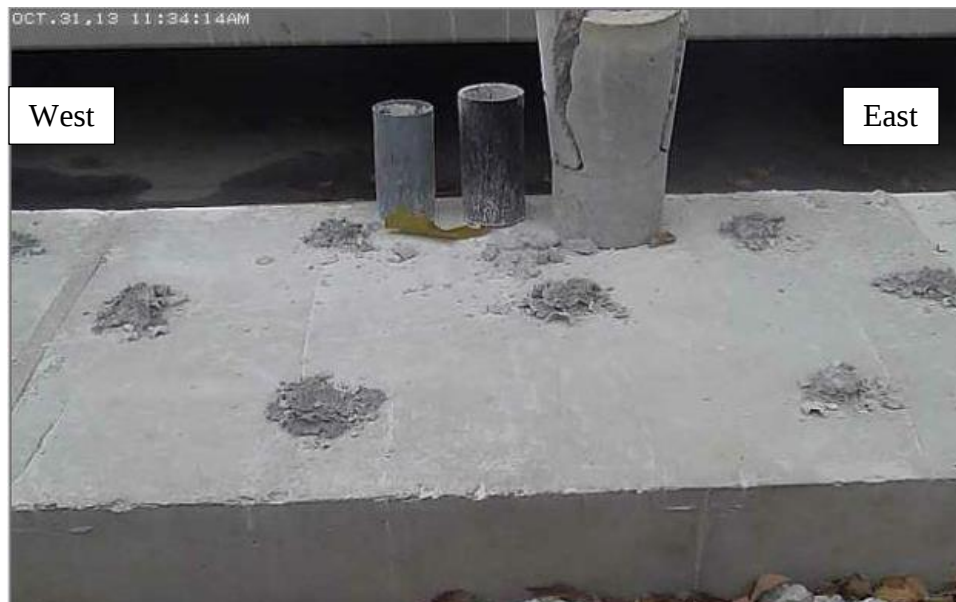
**Figure 23. Chemical splitting on day six (after 144 hours)**

On day six, the concrete slab remained as one piece (see Figure 23). Large cracks were observed at both ends of the specimen and small cracks were present in the middle of the specimen.

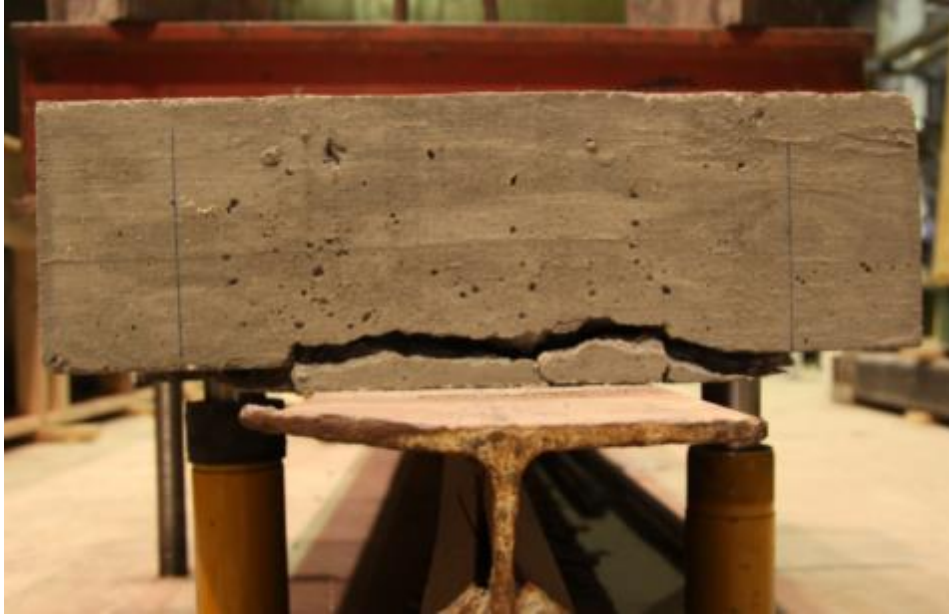
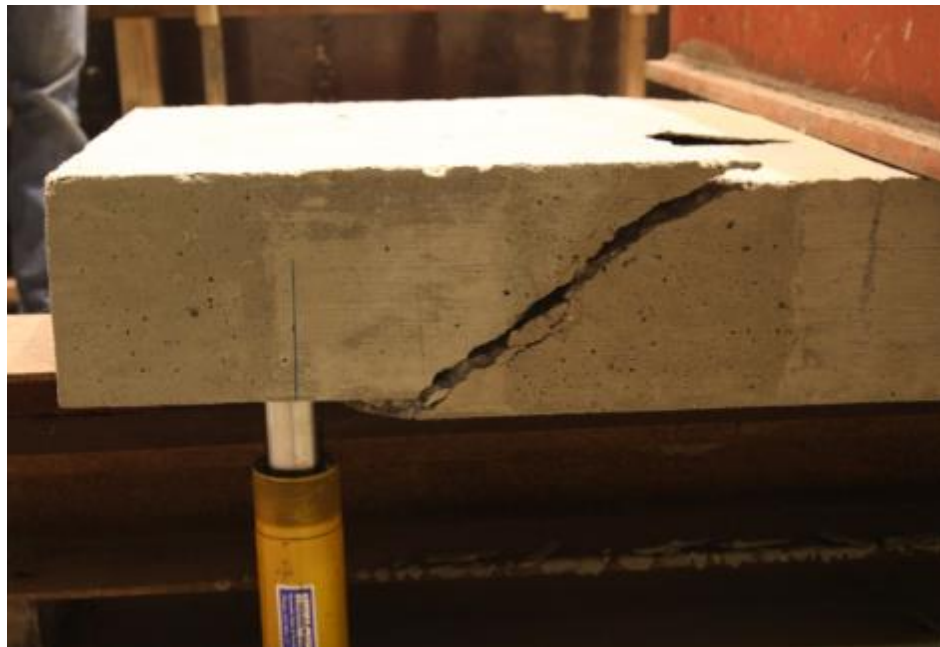
The first peeling test result is illustrated in Figure 27 and Figure 28. The failure appeared to be relatively symmetric about the longitudinal centerline of the steel girder. The peak load for this test was 21.1 kips.

**Figure 27. Front view of the first peeling test (3 shear studs) (Dang 2013)**

**Figure 28. Side view of the first peeling test (3 shear studs) (Dang 2013)**

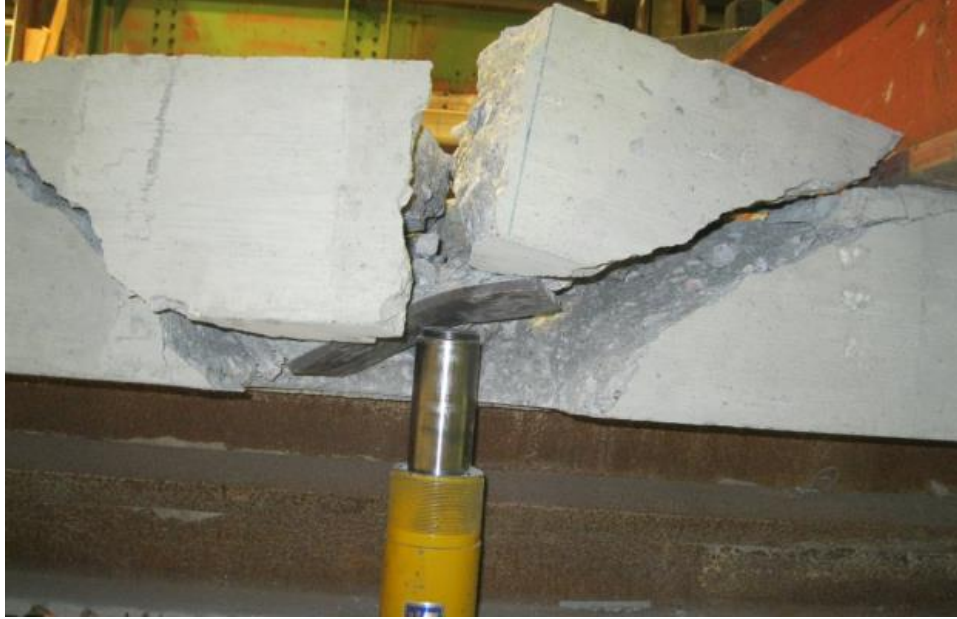
**Figure 29. Second peeling test (3 shear studs) (Dang 2013)**

The second test apparatus was modified by adding a steel plate to distribute the hydraulic jack load over a larger area. An image of the second peeling test is shown in Figure 29. Only one side of the concrete slab failed and broke into two large pieces. The peak load for this test was 41.8 kips.

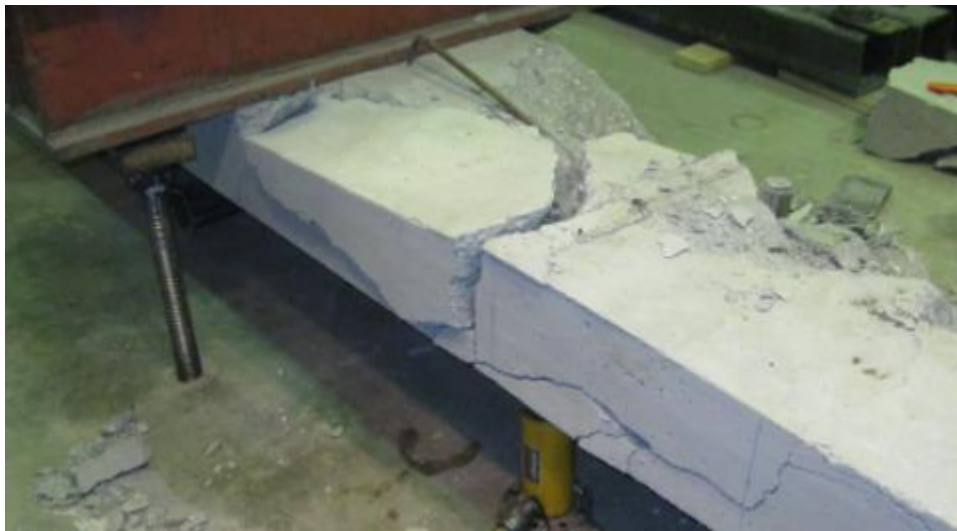
**Figure 30. Third peeling test (3 shear studs) (Dang 2013)**

The third peeling test resulted in only one side failing since the concrete on the opposite side had been damaged during the second test. The peak load for this test was 36.1 kips. A photograph of the third peeling test result is shown in Figure 30.

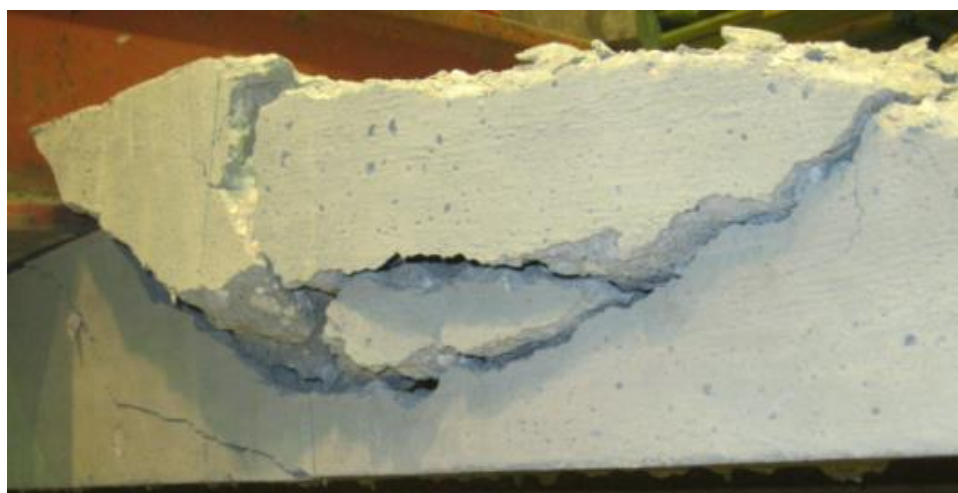
**Figure 32. Fifth peeling test (3 shear studs) (Dang 2013)**

The fifth peeling test resulted in two pieces of concrete being broken off the concrete slab with the failure pattern similar to previous failures. The peak load for this test was 26.7 kips. A photograph of the fifth peeling test is shown in Figure 32.

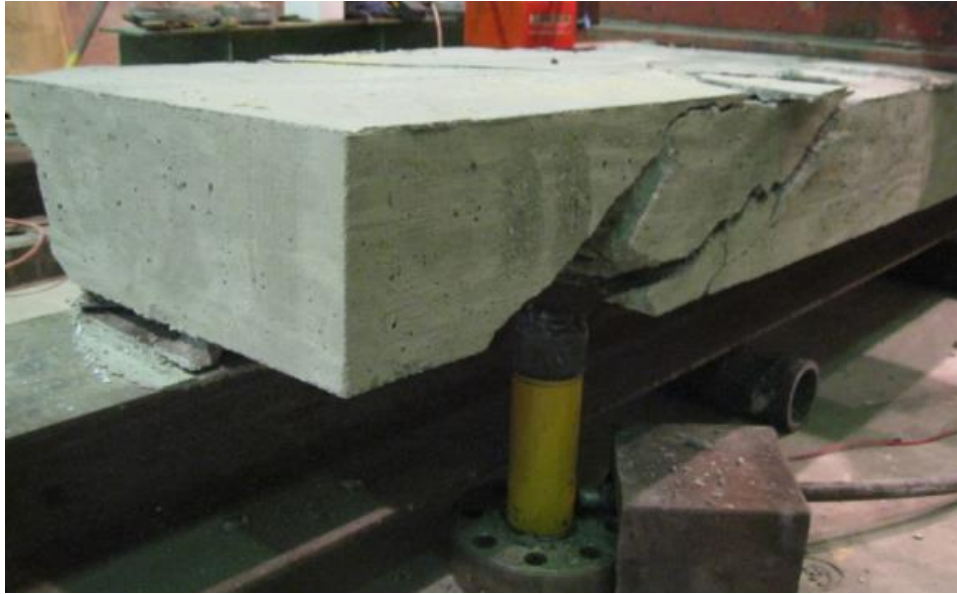
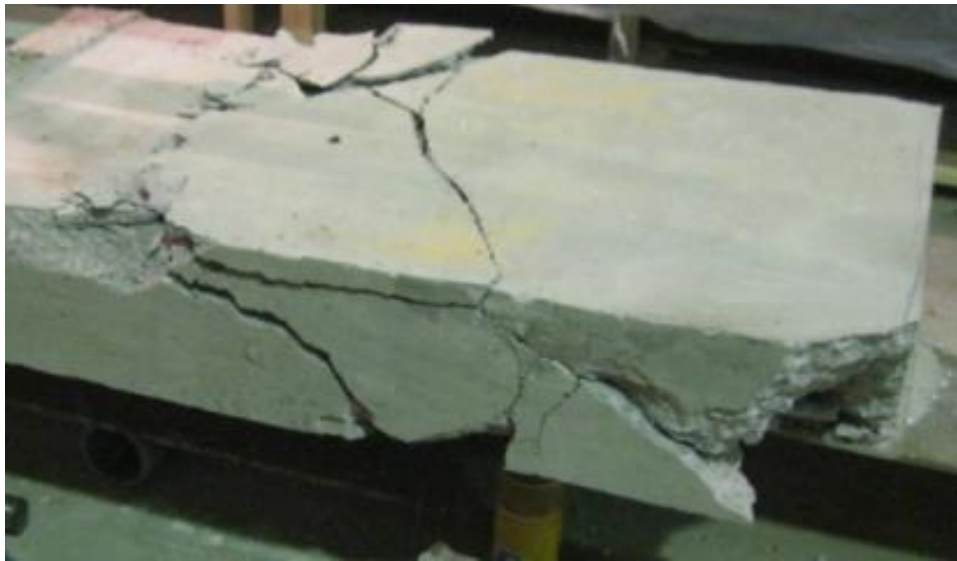
The peeling trial for section B (2 shear studs) had similar failures. Compared to the loads applied to section A, the loads were applied more consistently from the end of the specimen to the middle of the specimen. The testing ensured every peeling test was loaded from a free end. The first test failed in shear as shown in Figure 33 and Figure 34. The peak load for this test was 15.8 kips.

**Figure 33. Side view of the first peeling test (2 shear studs) (Dahlberg 2014)**

**Figure 34. Top view of the first peeling test (2 shear studs) (Dahlberg 2014)**

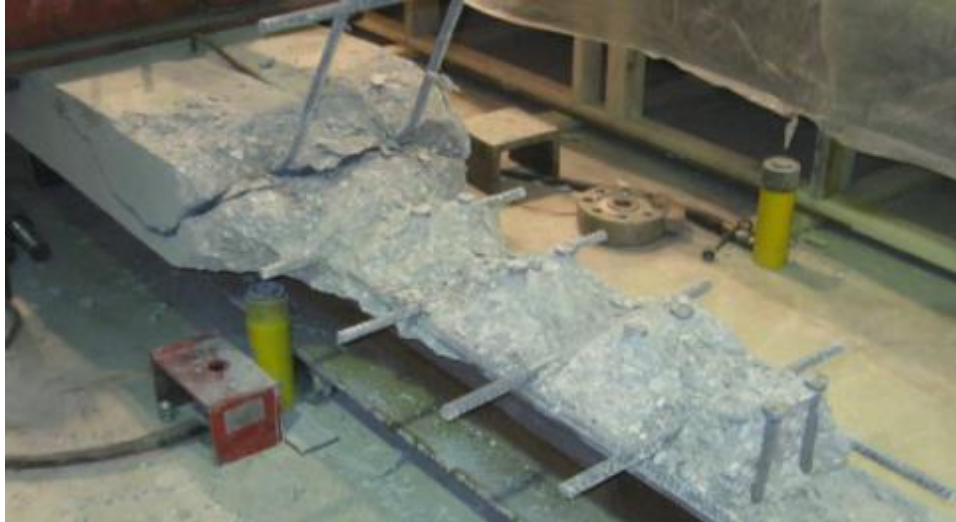
**Figure 35. Second peeling test (2 shear studs) (Dahlberg 2014)**

The section B peeling trial removed most of the concrete by multiple peeling tests conducted one after the other. A photograph of the section B peeling trial is shown in Figure 35. The peak loads were summarized in following result section.

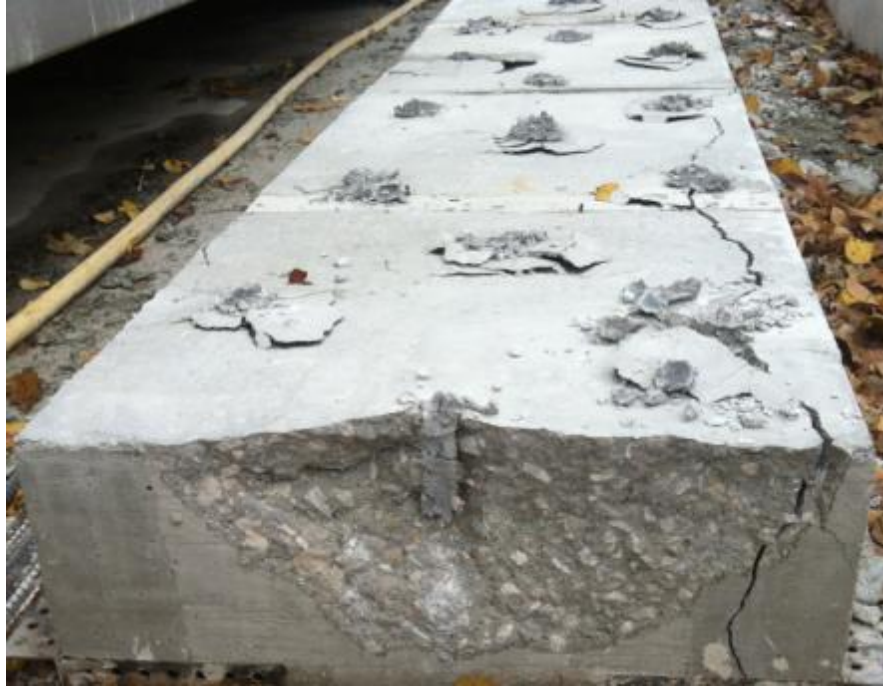
**Figure 36. Chemical splitting on day six (Dang 2013)**

Chemical splitting produces no noise, dust, or vibration, but even in the best cases requires a long time to break the concrete deck and needs a method to catch falling materials. In this study, this method was not an effective deck removal method. The result of chemical splitting after six days (144 hours) is illustrated in Figure 36. The cracks caused by chemical splitting were not sufficient to remove the concrete deck from the steel girders.

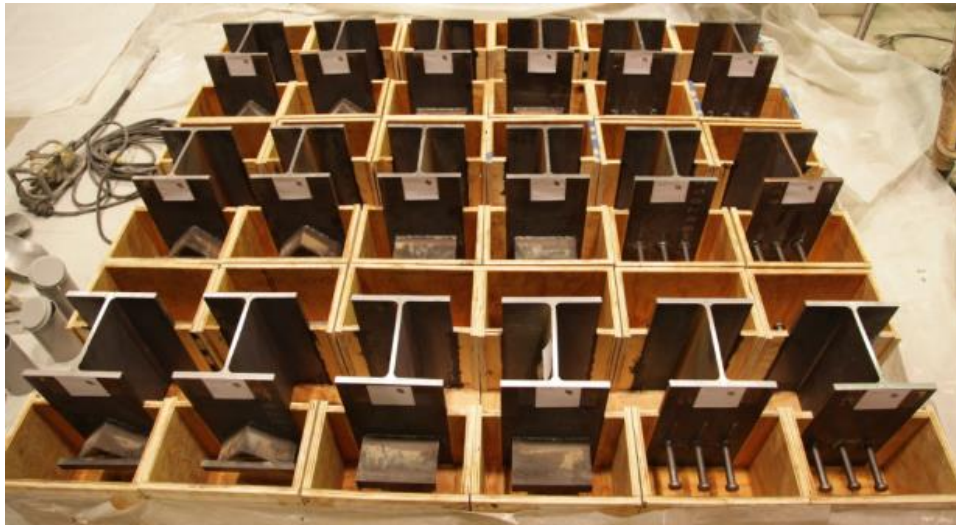
**Figure 38. Constructed steel specimens and concrete formwork (Dang 2013)**

After all shear connectors were welded to the steel girders, concrete formwork was constructed for the initial concrete placement (Figure 38). The formwork was designed to allow for a concrete cover of 6 in. on both sides of the shear connector, simulating a concrete deck with a thickness of 8.75 in.

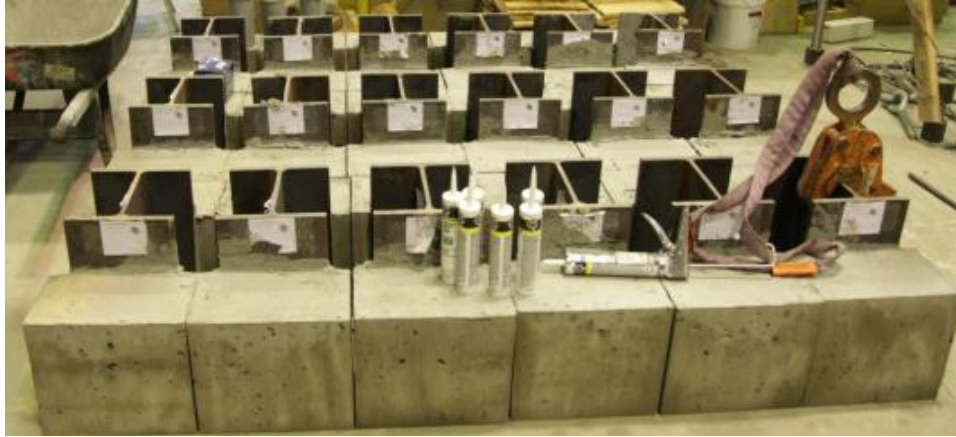
**Figure 39. Eighteen specimens after initial concrete placement (Dang 2013)**

Initially, 18 specimens were fabricated using Iowa DOT standard C-4WR concrete mix and then cured for 28 days (Figure 39).

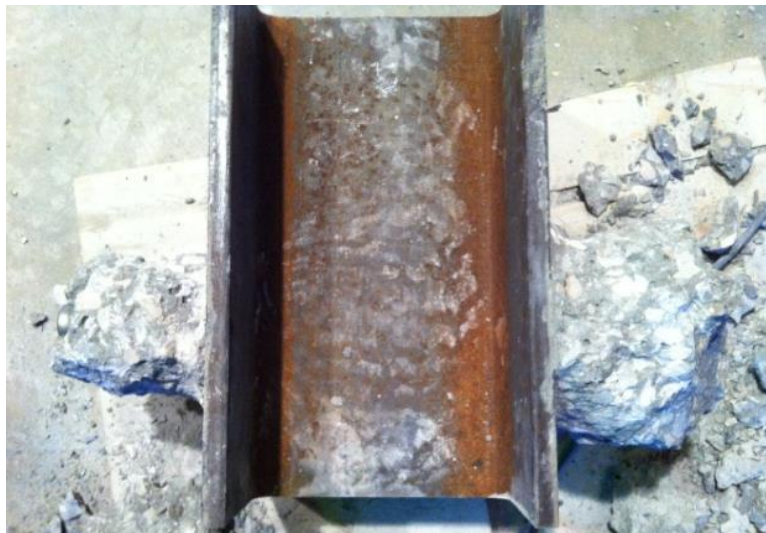
**Figure 40. Partially removed concrete specimen (Dang 2013)**

After curing the concrete for 28 days, a rotary hammer was used to remove the concrete to the desired level. The level of concrete removal was controlled by weighing the removed concrete. Figure 40 shows a photograph when the left side has reached 75% removal and the right side has reached 50% removal. Note that the right side will have additional material removed until it closely matches the 75% removal shown on the left side.

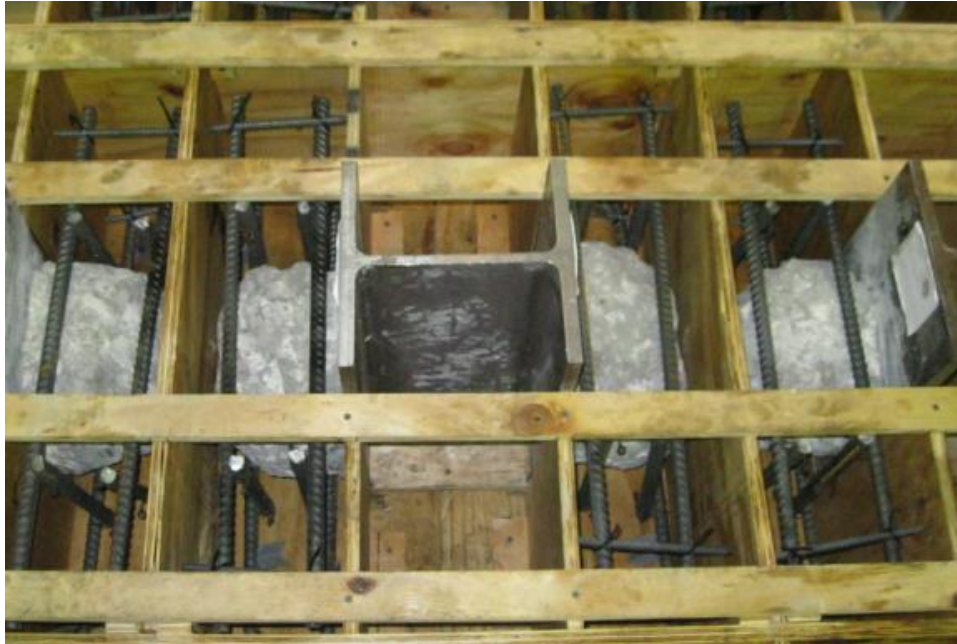
Figure 41, Figure 42, and Figure 43 show the specimens in the formwork. All specimens were then cured for 28 days before testing.

**Figure 41. Schematic dimensions of specimens**

**Figure 42. Partially removed concrete specimens and formwork (Dang 2013)**

**Figure 43. Specimens, reinforcing steel, and formwork (Dang 2013)**

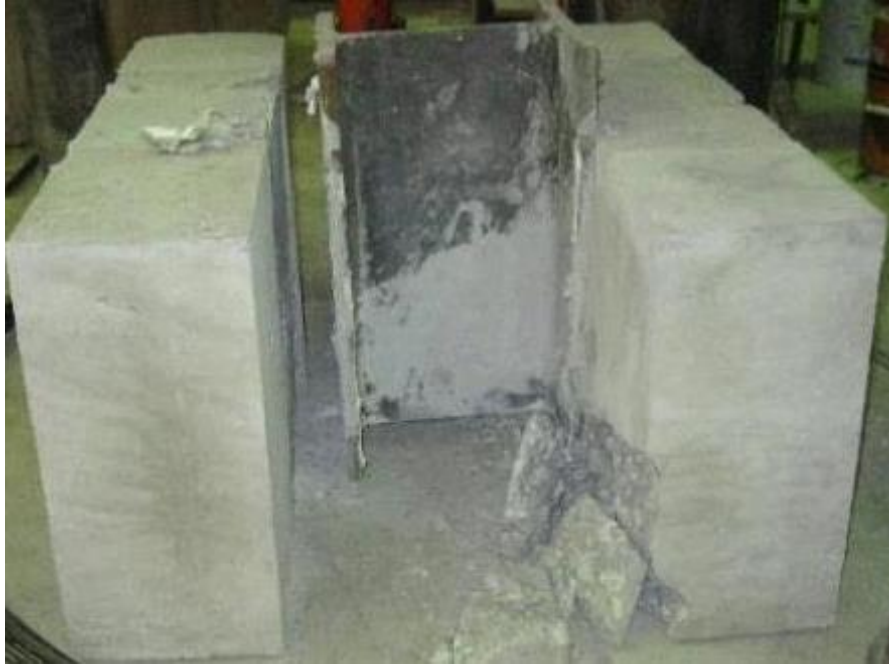
**Figure 45. Typical shear connector failure (Dang 2013)**

Two types of failures, including shear connector failure and concrete failure, were observed during testing. An example of a specimen with a shear connector failure is shown in Figure 45.
