Report # MATC-ISU: 236

Final Report

Digital Documentation of Element Condition for Bridge Evaluation

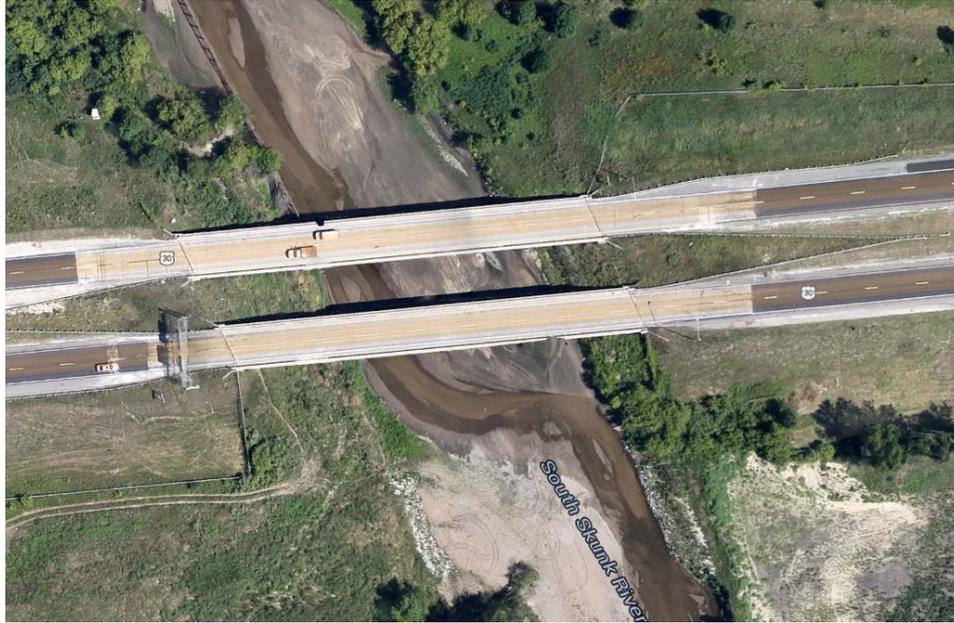
Figure 1. Bridges 8550.2.R.030 and 8550.2.L.030

The research team, made of two full time faculty members and a graduate student, worked with Iowa DOT to collect plans and previous inspection data for two existing bridges; bridges 8550.2.R.030 and 8550.2.L.030, steel bridges (Figure 1), and bridges 8548.4.R.030 and 8548.4.L.030, pre-stressed concrete bridges (Figure 2), all located on highway US-30, in the state of Iowa.

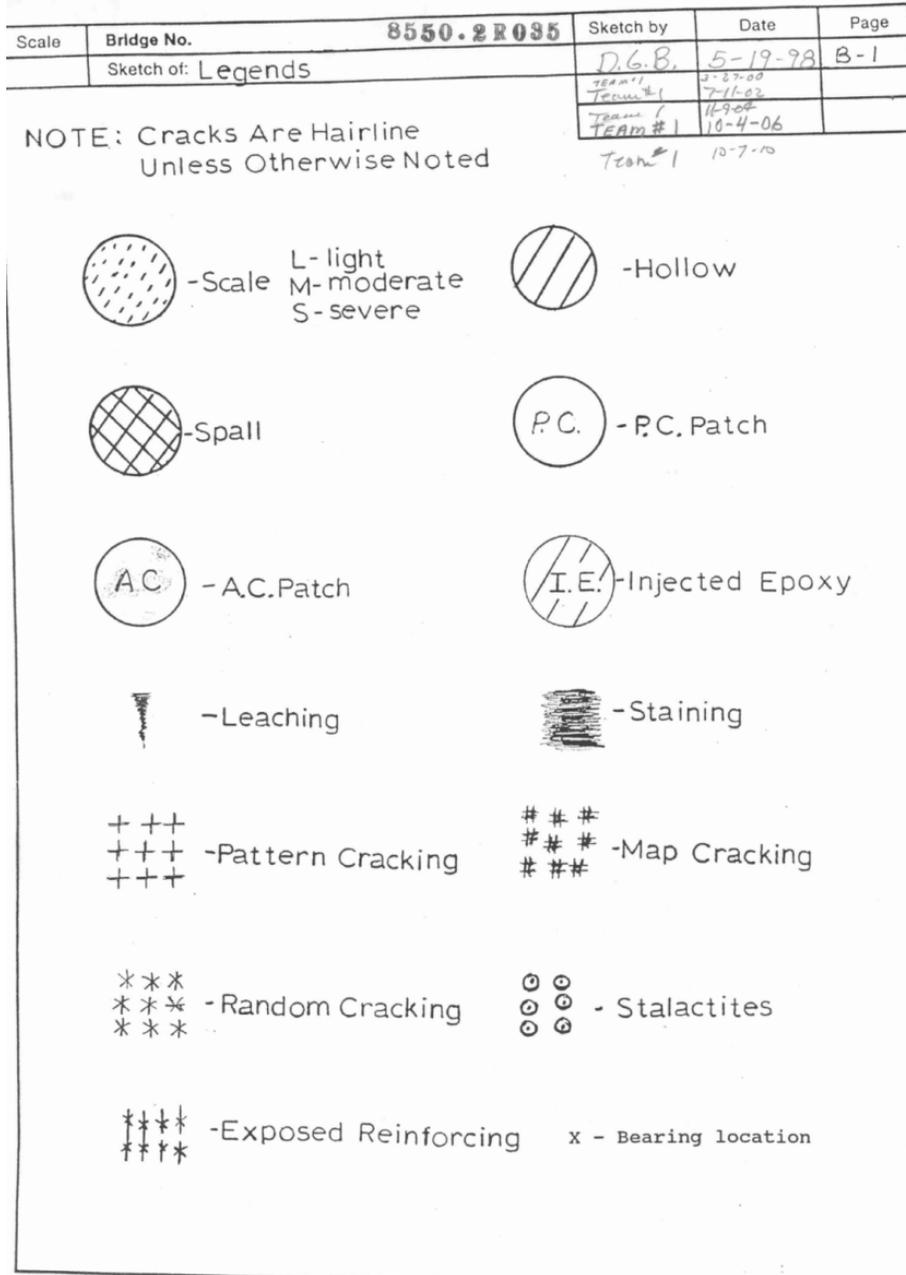
Figure 3 Inspection sketch legend sample

Then, the inspection team draws manual sketches to document the type of damage, its size, severity, depth and location using true dimensions. Sketches are drawn on pre-drawn basic sketches that are not bridge specific which requires more effort to deliver its intended message. Inspectors use a predefined legend (Figure 3) to represent the different treatments or problems of bridges. Finally, the report and the sketches are taken to the office where a comparison with the last inspection is carried out, and an action is taken to fix problems, if any existed.

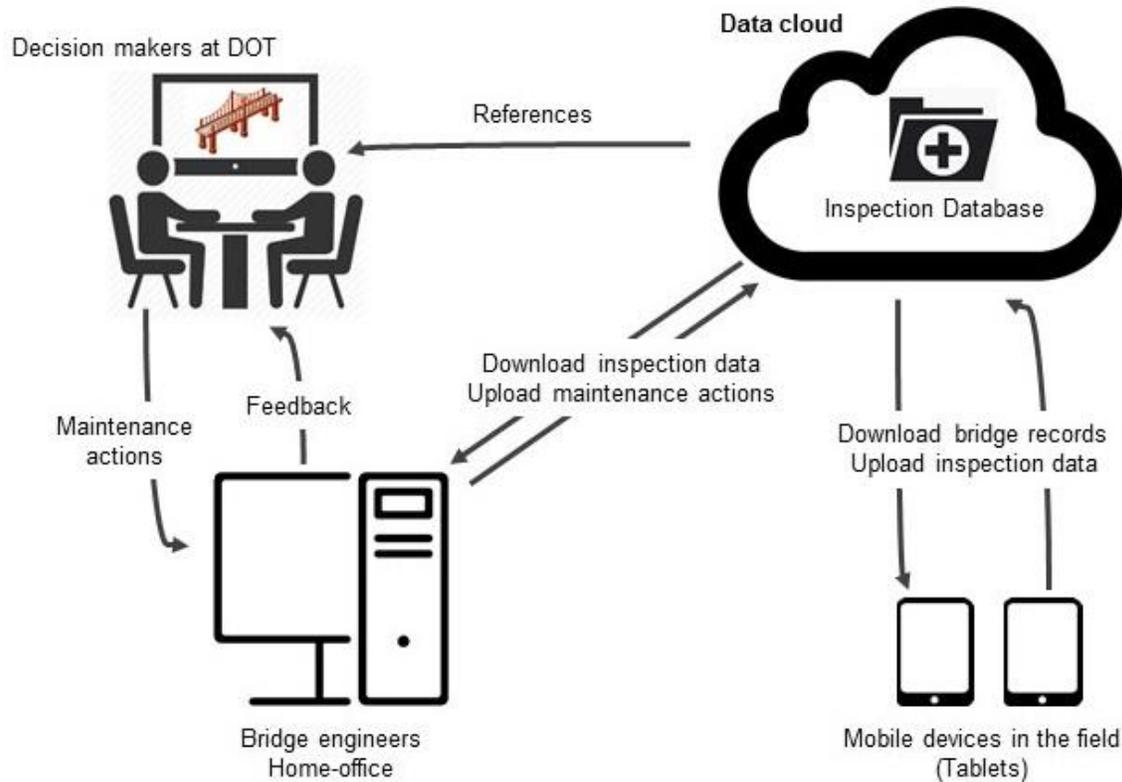
Figure 9. BrIM-based inspection framework

The research team developed a framework for bridge inspections using BrIM (Figure 9). The BrIM-enabled inspection framework consists of three major elements; data cloud, mobile devices and home office computer interface. The data cloud receives information from both home office and site inspectors and shares it with all stakeholders at DOT. This procedure could increase the speed of communication and eliminate any re-entry of the inspection data. It can also prevent any data losses.

This framework was tested with Iowa DOT engineers and bridge inspectors. Once an inspector logs in to his/her account, he/she has direct access to the data cloud that acts as a data center for inspection documents and information. All inspection actions are documented under the inspector's name with the date and time of the action and uploaded directly to the data cloud. Every element that is inspected has its unique ID number, which would eliminate any ambiguity in determining the position of damaged elements. The software application also enables isolating selected elements and provides the right angle to define the damage.

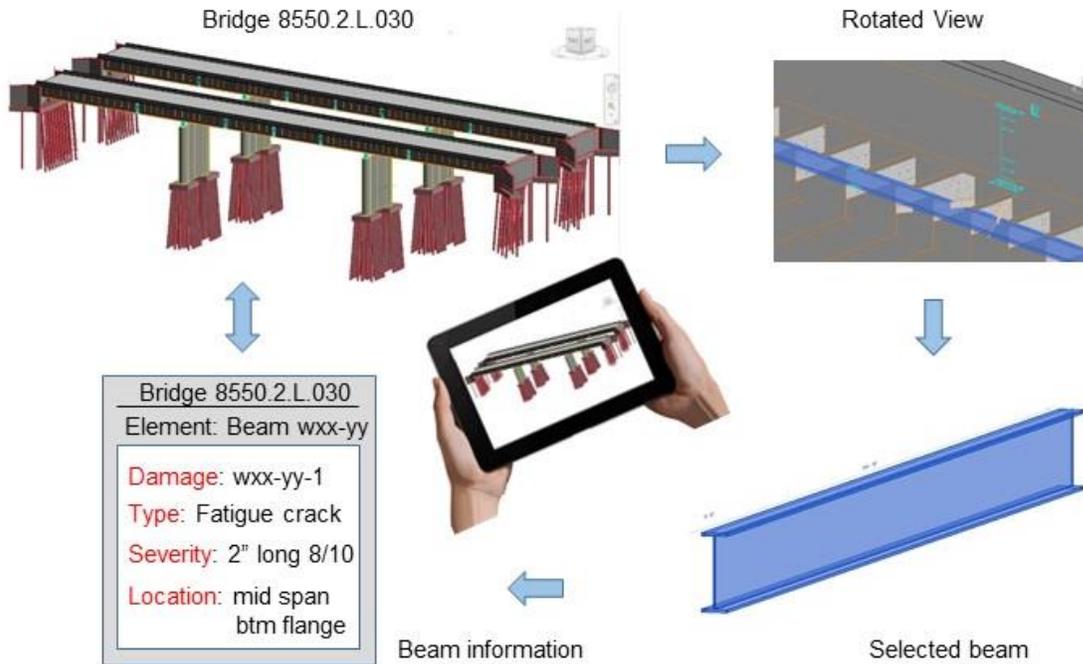
Figure 10. BrIM-based inspection process

Inspectors can choose the element that has a deficiency where they can document the problem e.g., corrosion, spalling, cracks, etc. At the same time, it is possible to pull out the previous inspection data and sketches to compare the damages and their severity. Furthermore, it is also possible to freeze the model on the angle that best shows the damage to create a still image (take

a snapshot), which would enable inspectors to draw sketches about the damage on that specific element with precise dimensions (Figure 10). Then, the inspection information can be uploaded back to the data cloud where can be accessed from different locations, such as main office. Furthermore, bridge engineers at the main office can access and analyze the data real-time or immediately. Also, BrIM model provides a better representation of the field conditions, which would enable other stakeholders to have a better idea of the problem, thus they can make better informed decisions.

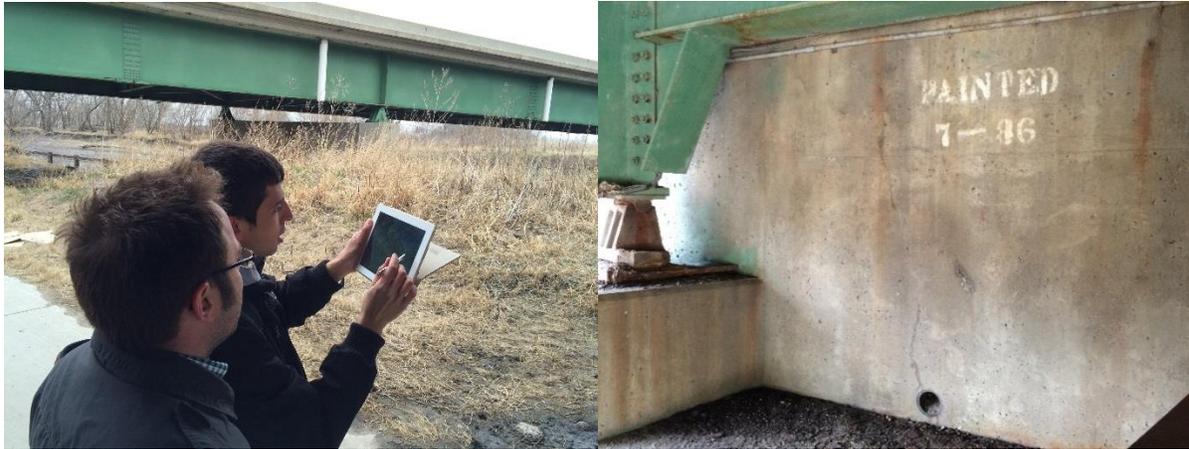
Figure 11. BrIM on-site demonstration

The research team demonstrated the BrIM-based inspection methodology (Figure 11) with the help of Iowa DOT personnel in order to get the experts' feedback on it. Many elements of the bridge were inspected, including the hinges, concrete cracks, girders and piers.

Iowa DOT bridge engineers and inspectors confirmed that BrIM can be used to automatically query, sort, evaluate and send information to decision makers. They also provided some good feedback and recommendations that will be discussed later in this report. Moreover, a web-based survey, using the Qualtrics survey tool, was conducted in order to evaluate applicability of BrIM for inspection purposes in other states outside Iowa. The survey was sent out to eight DOTs in the Midwest in addition to New York and Pennsylvania DOTs to obtain their feedback on implementing BrIM technology for bridge inspection and maintenance. DOT personnel ranging from bridge engineer to a director of bureau of structures from eight different DOTs participated in the survey.

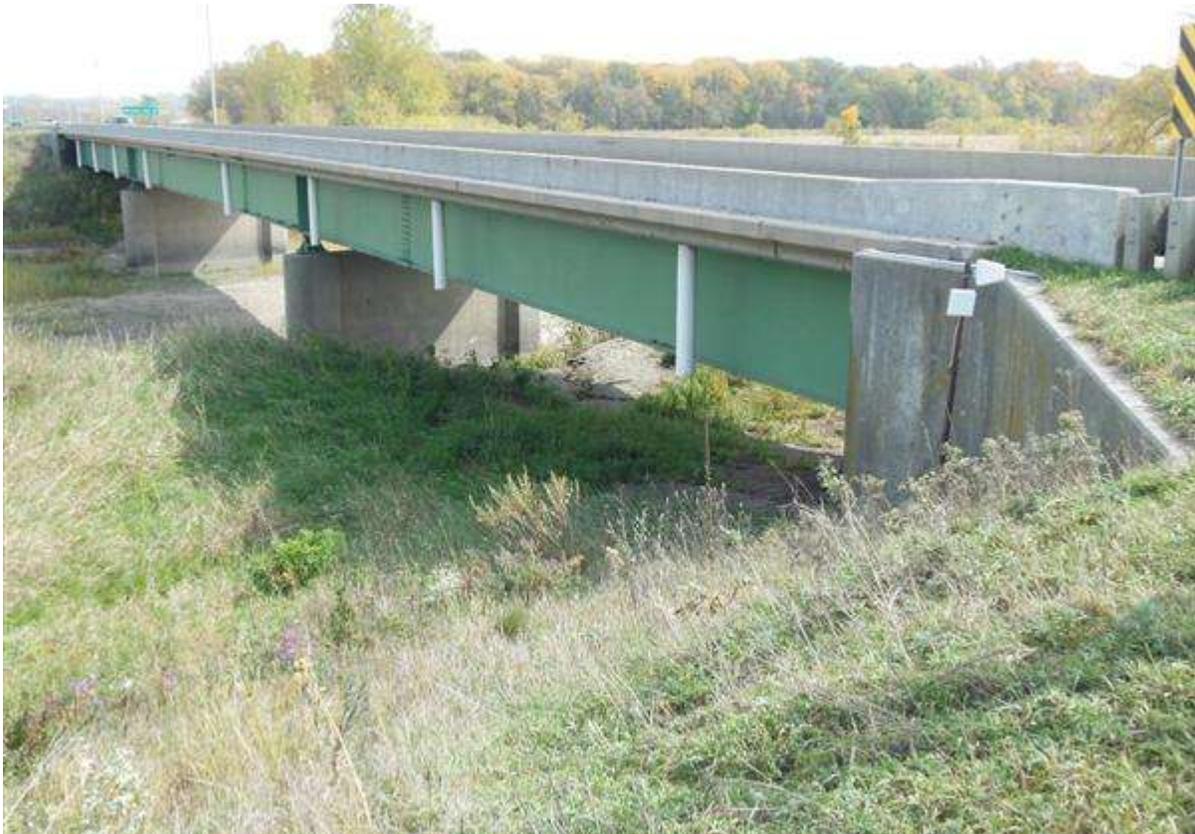
Bridge Condition Report

Bridge ID: 8550.2R030 NBI Number: 48730
District: 1 Inspection Group: Team 1
Inspection Type: In-Depth and Fracture Critical
Inspection Date: In-Depth: 10/01/2012 Frac Crit: 10/01/2012
Carrying: EB US 30 over SOUTH SKUNK RIVER
Location: 1.2 MI. W OF JCT. I-35
Approved By: Olson, Paul

Item	Description	Condition	Comments
Substructure Overall:	NBI Item 60	5 - Fair Condition (minor section loss)	There are spalled and hollow areas.

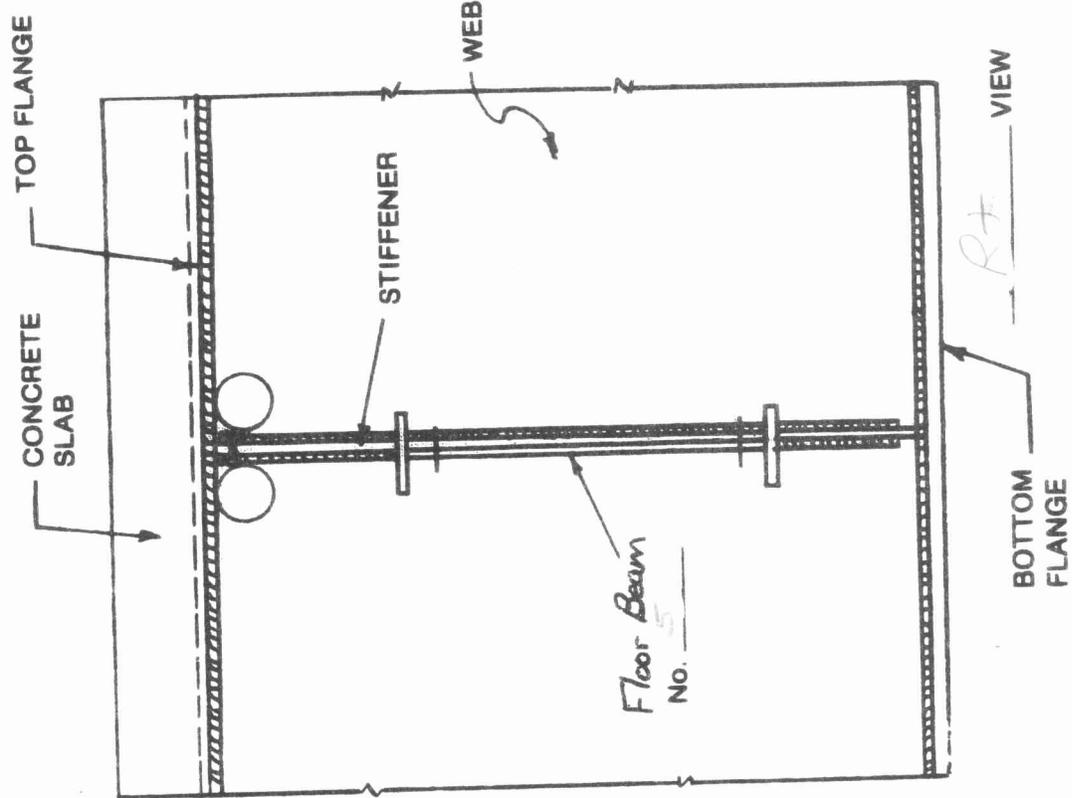
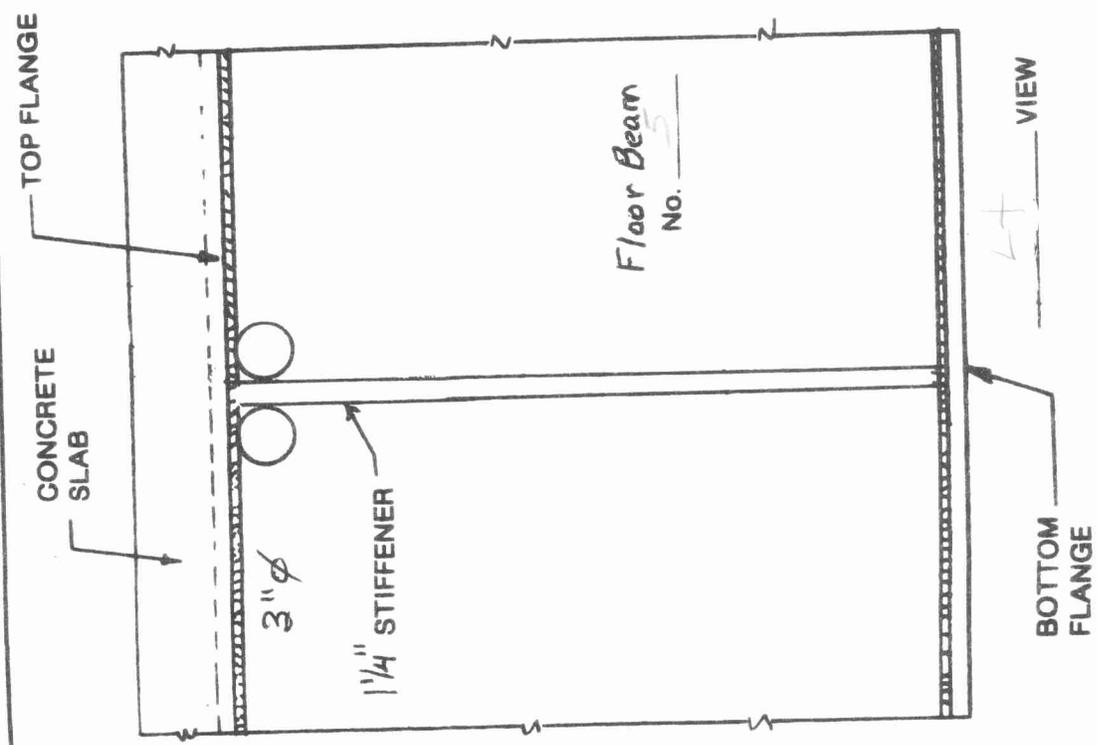
Scale	Bridge No. 8550.2 R 030	Sketch by	Date	Page
Sketch of:	Lt Girder	BVN	10-1-12	B-12A
Span No. #1	F.B. #5 @ Pier #1			
Location "B" over Pier #1

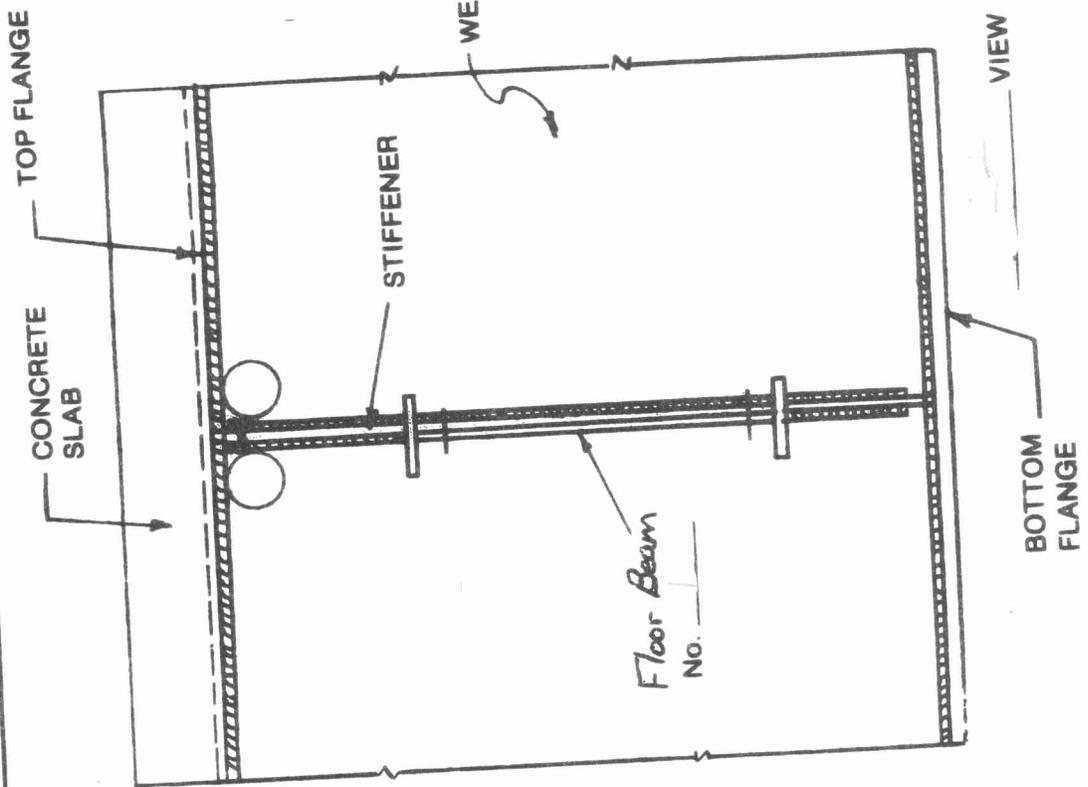
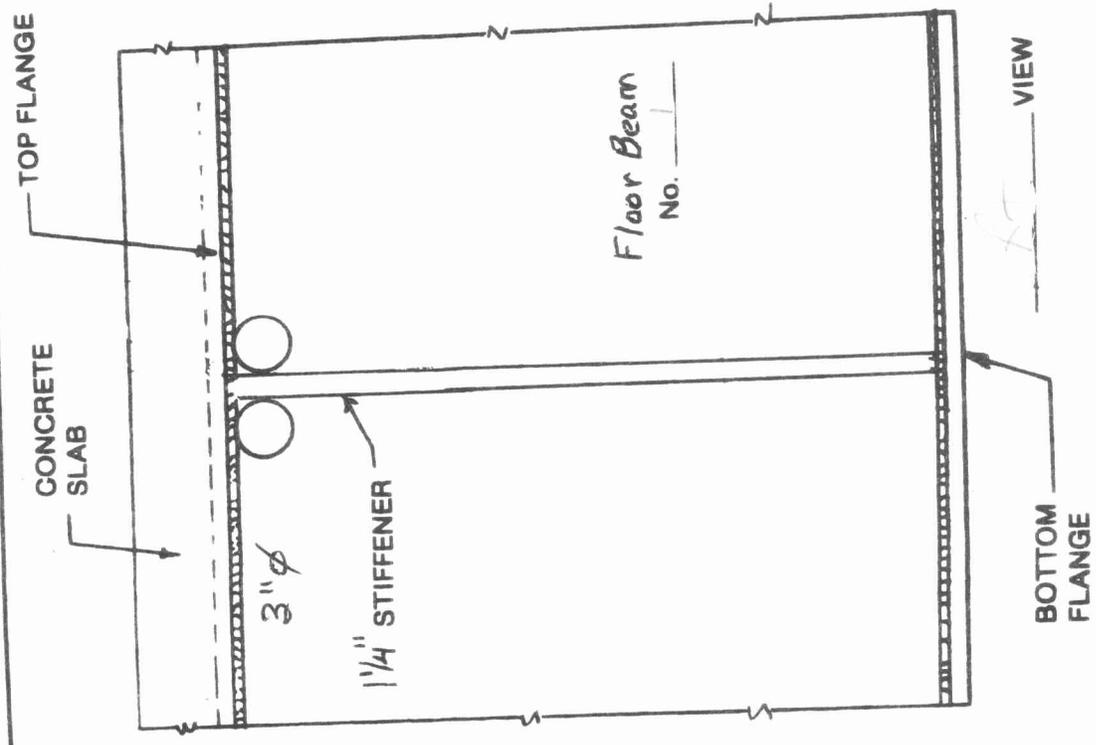
Scale	Bridge No. 8550.2 R 030	Sketch by	Date	Page
	Sketch of: R+ Girder		10-1-12	B-125
	Span No. #2 F.B. @ Pier			
	Location "C" 5101 Pier #1

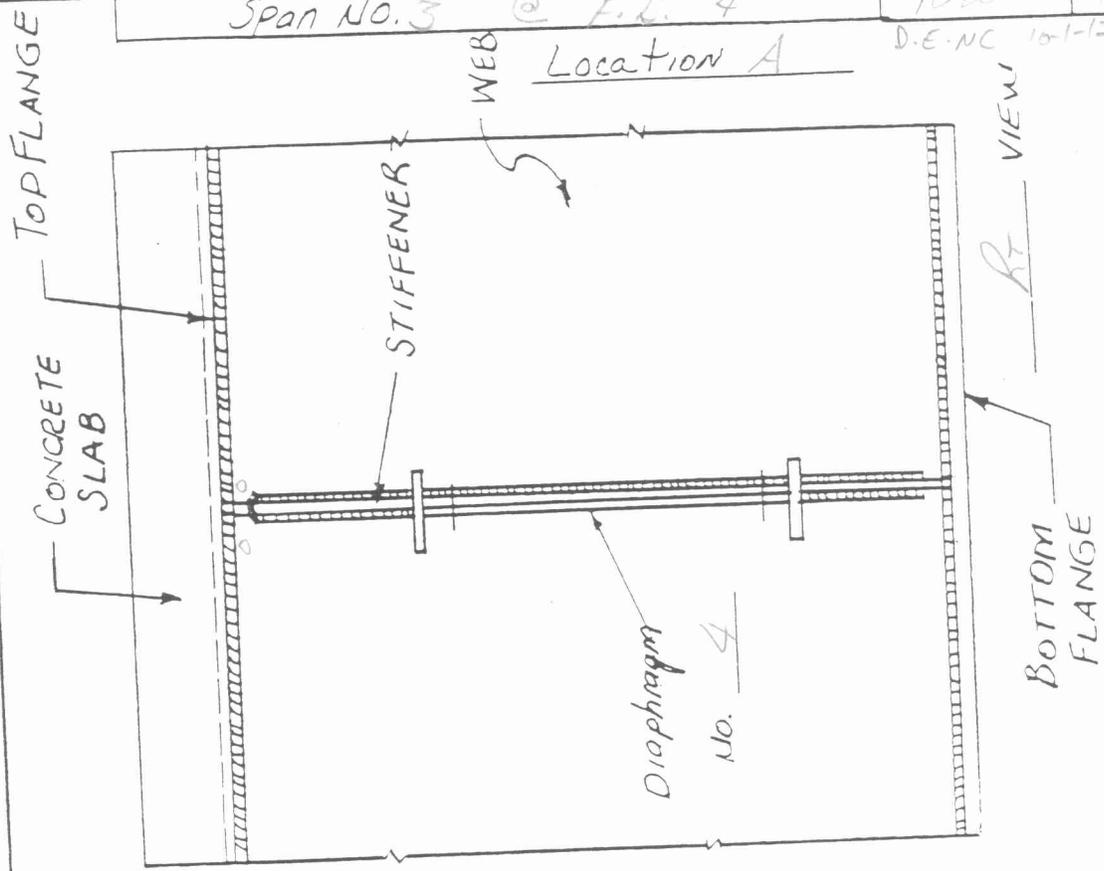
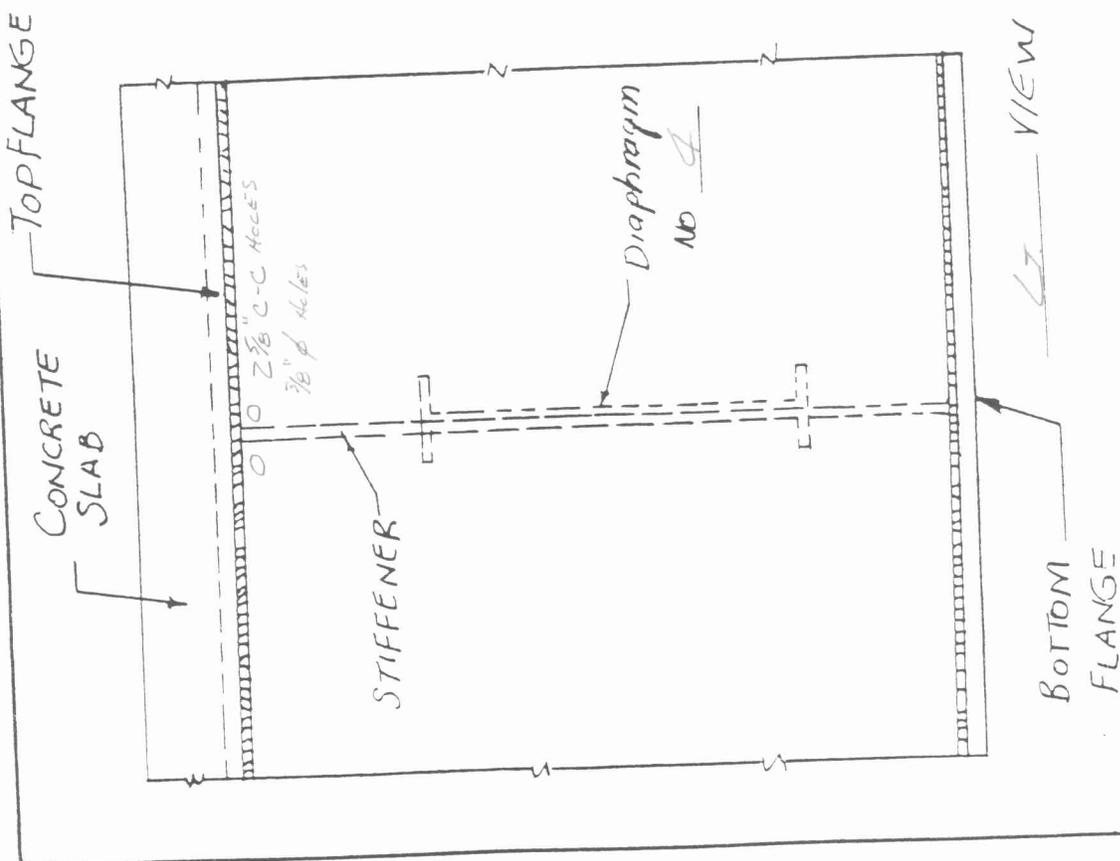
Scale	Bridge No. 8550.2 ^R C30	Sketch by Team #1	Date 7-10-02	Page B-13
Sketch of: Crack in Lt Girder		RHS	10-7-10 NC	
Span No. 3 @ F.L. # 4		D.E. NC 10-1-12

Crack Found	Crack U.T.	Holes Drilled	Holes Drilled
By	Date	By	Date
DGB	8-29-84	W.C.	11-20-84
ALC	7-11-02	DST/Reddy	11-20-84
9-04 MC			
10-06-06 NC			
10-30-08 NC			
RHS

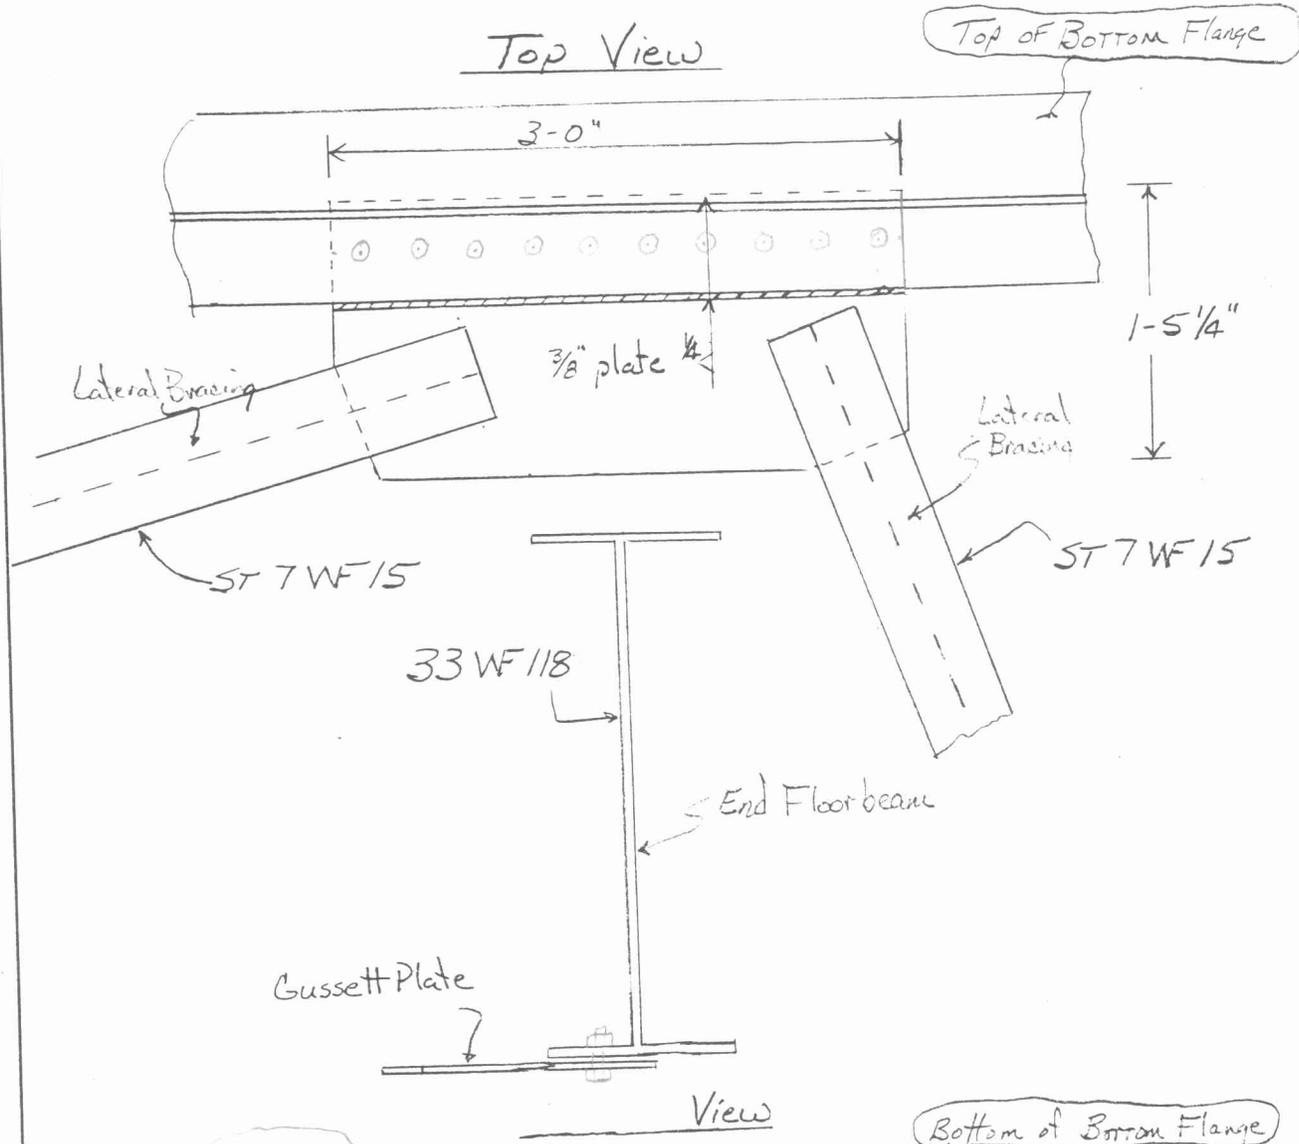
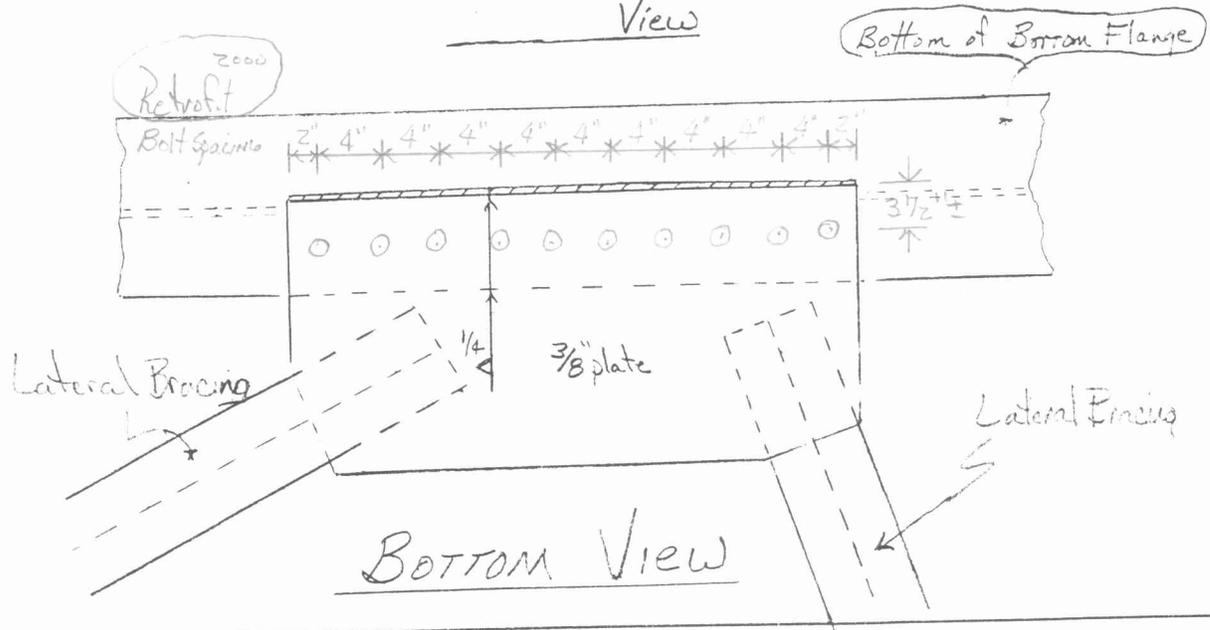
Scale	Bridge No.	Sketch by	Date	Page
10	8550.2 ^B 030	Team #1	4-17-00	B-14
	Sketch of: END Floorbeam & Gusset Plate	Holm	7-11-02 NC	
	END Floorbeam # 0	Holm	11-9-09 NC	
	Span # 1 over NEAR Abutment	PKA	10-4-06 NC	
		PKA	10-20-08 NC	
		BVN	10-7-10 NC	
		BVN	10-1-12 NC

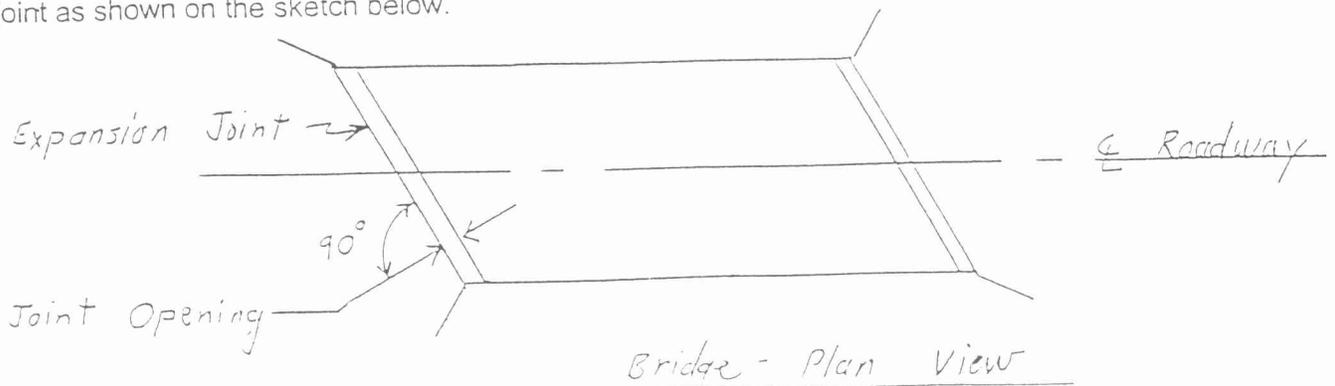
The deck expansion joint opening for skewed bridges is measured perpendicular to the expansion joint as shown on the sketch below.

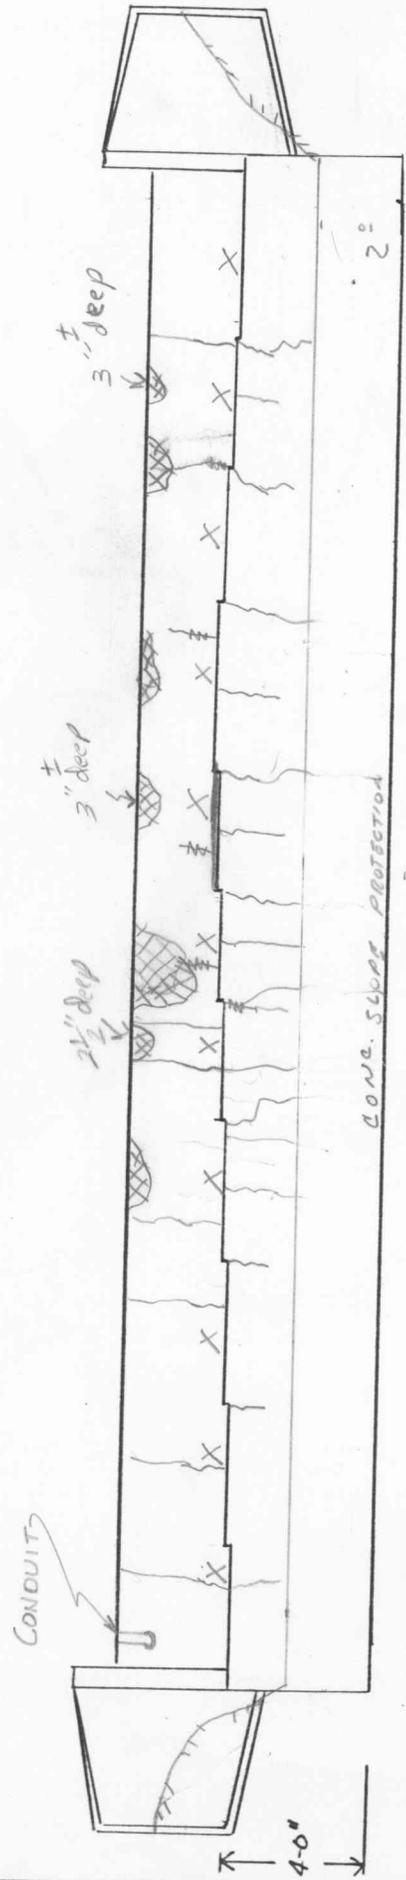
Scale	Bridge No. 8548, 4 R 030	Sketch by	Date	Page
	Sketch of: NEAR ABUTMENT	K.L.H.	HAIRLINE CRACKS 6-21-89	B-2
		A.A.R.	NO CHANGE 10-13-86	B-3

- Boro 8-13-90 N.C.
- D.G.B. 8-17-94 SPALL
- Holm 6-4-96 No Change
- Bun 10-21-02 M.W
- Bun 1-13-05 spalls
- Rks 3-10-10 NC
- Rks 3-1-12 NC
- A 03/05/14 NC

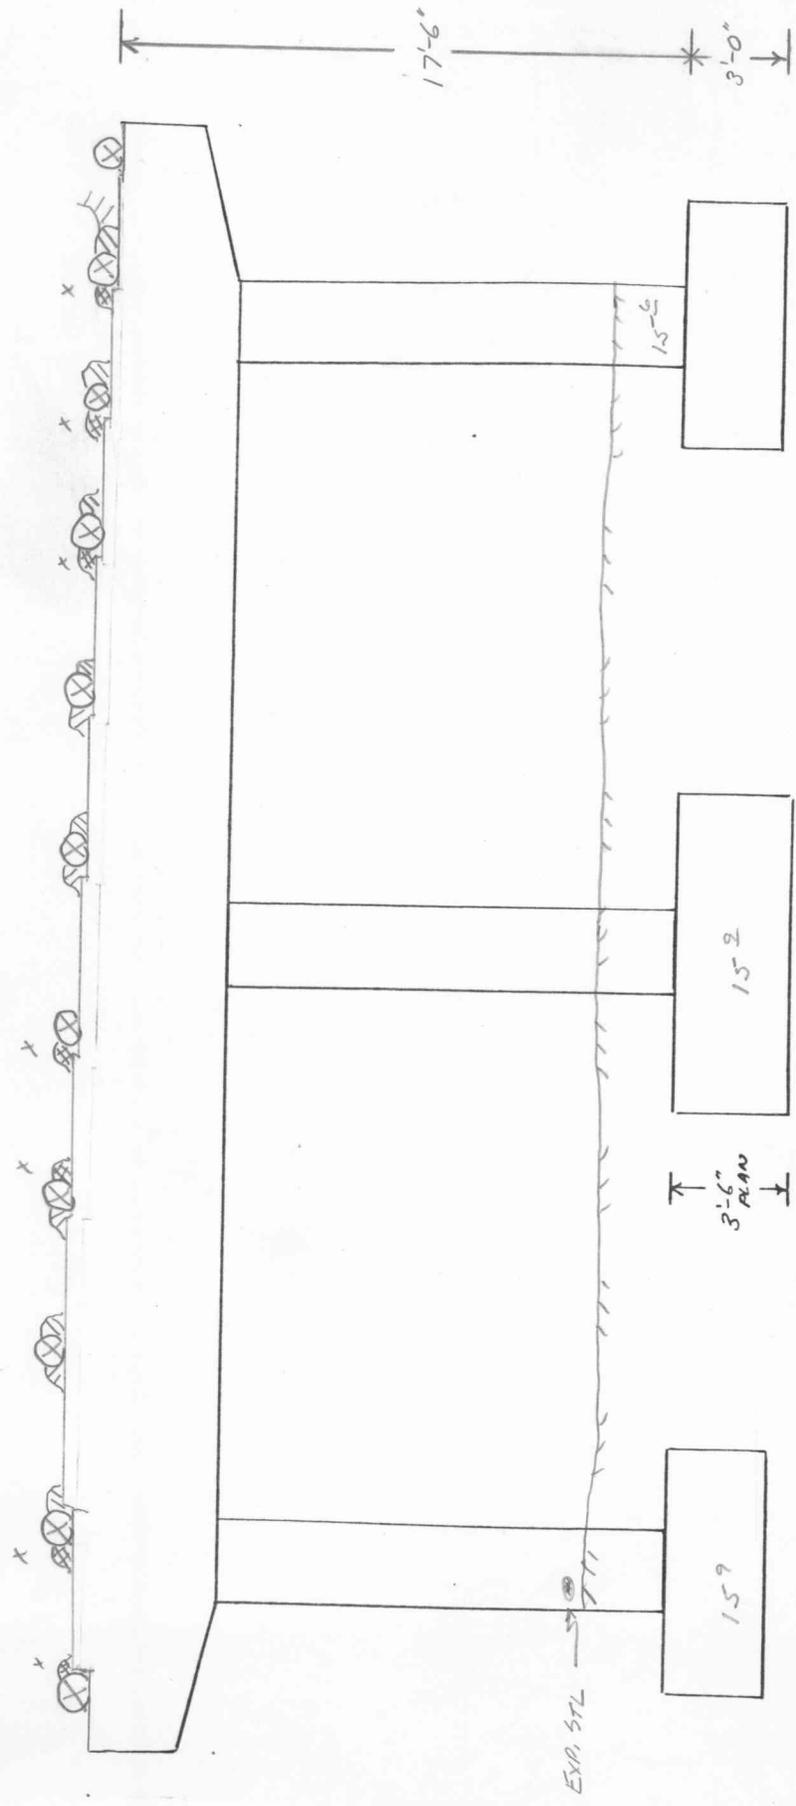
Scale	Bridge No. 8548.4 ^R 030	Sketch by	Date	Page
60	Sketch of: PIER # 1 - NEAR FACE	K.L.H.	6-21-89	B-3
		A.A.R.	MAINDR 10-13-86	B-4
		Boyo	N.C. 8-13-90

- D.G.B 8-17-94 N.C.
- Holm 6-2-96 NC
- Bun 10-21-02
- Bun 1-13-05 N.C
- PKS 3-10-10 NC
- PKS 3-1-12 MN
- FA 03/05/14 NC

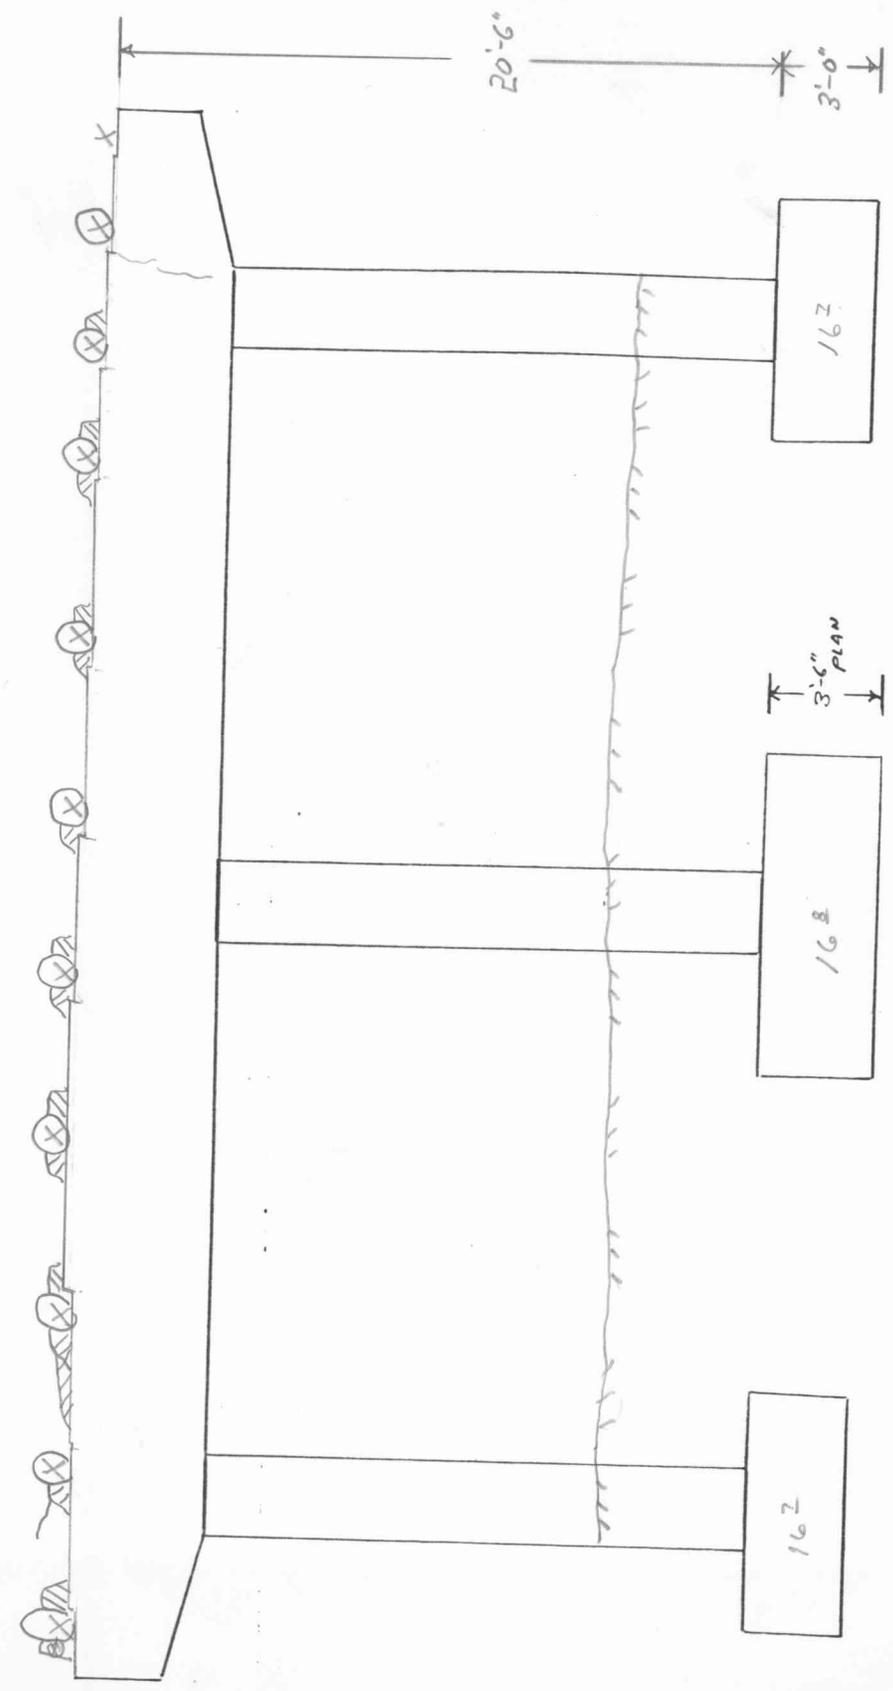
Scale	Bridge No. 8548.4 ^R 030	Sketch by	Date	Page
60	Sketch of: PIER # 2 - NEAR FACE	K.L.H.	6-21-89	B-6
		A.A.R.	NO CHANGE 10-13-86	B-7
		8070	N.C. 8-13-90	
		D.G.B.	8-17-94 minor	
		Holm	6-4-96 MW	
		Bun	10-21-02 N.C.	
		Bun	1-13-05 N.C.	
		Rka	3-10-10 NC	
		Rka	3-1-12 NC	
		A	03/05/14 NC

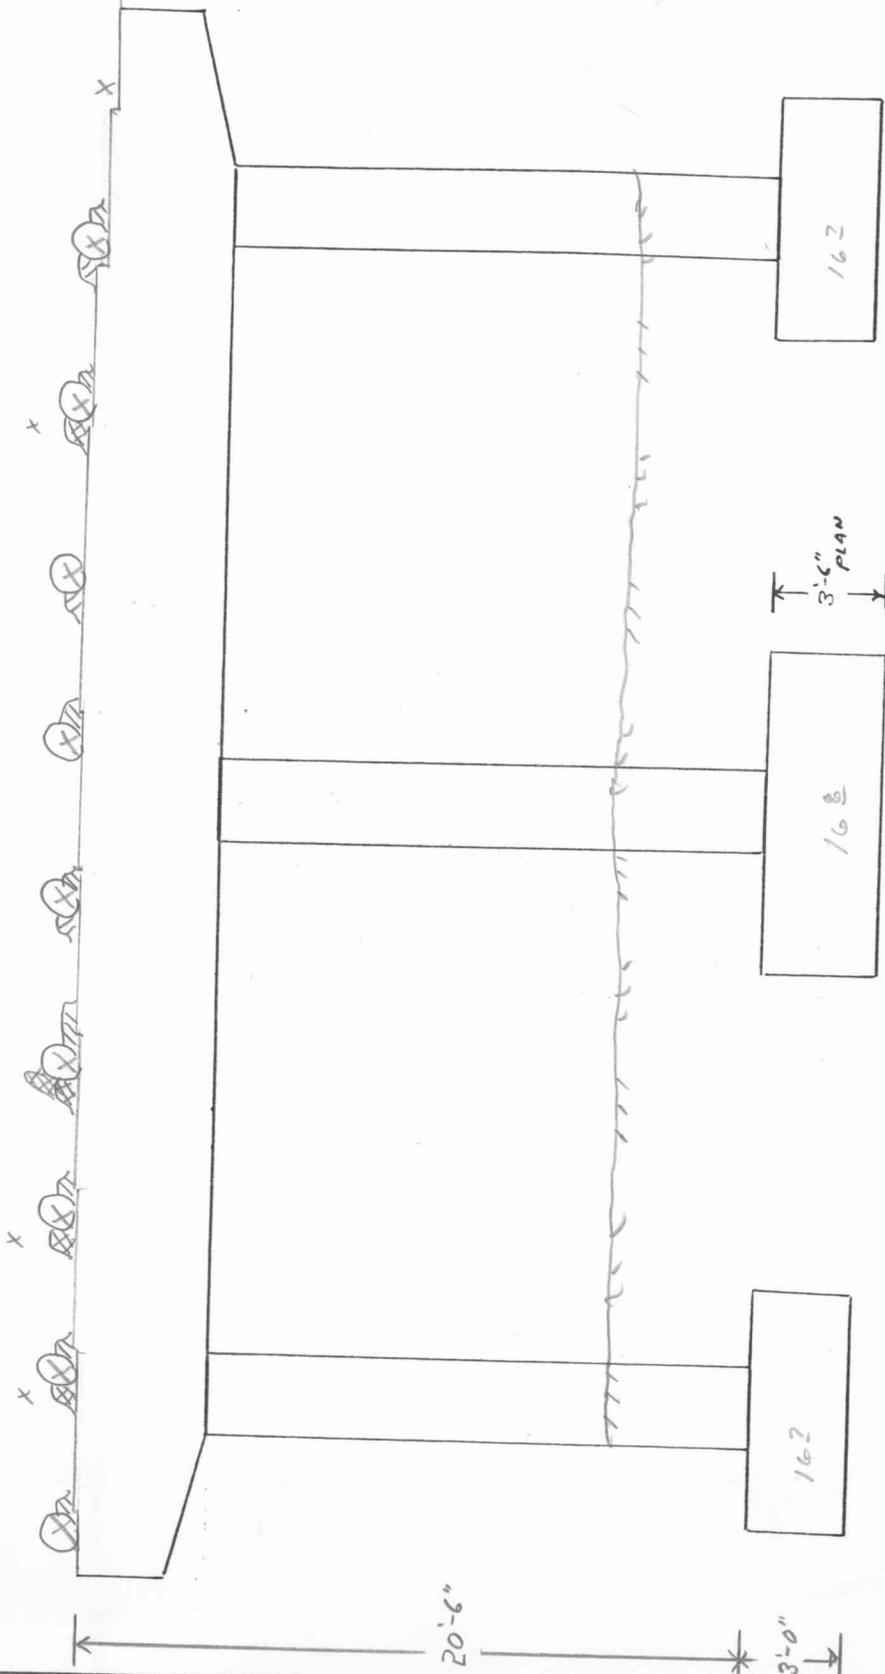
Scale	Bridge No. 8548.4 ^R 030	Sketch by	Date	Page
60	Sketch of: PIER # 2 - FAR FACE	K.L.H.	6-21-84	B-7
		A.A.R.	NO CHANGE 10-13-86	B-8
		Boro	N.C. 8-13-90

D.G.B. 8-17-94 minor
 Holm 6-4-96 NC
 Bun 10-21-02 N.C.
 Bun 1-13-05 N.C.
 RRS 3-10-10 NC
 RRS 3-1-12 MN
 03/05/14 NC
