# Investigation of Negative Moment Reinforcing in Bridge Decks

**Final Report**  
**September 2015**

**Sponsored by**  
Iowa Highway Research Board  
(IHRB Project TR-660)  
Iowa Department of Transportation  
(InTrans Project 13-469)

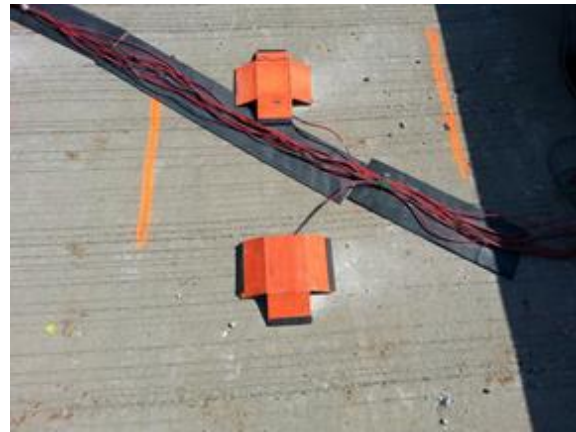
**Figure 5. Cover plates prevent damage**

During testing, strain gauges were installed at two general locations: on the top surface of the bridge deck in the negative bending region and on the girders. To study the effects of the b2 reinforcement and to generally aid in understanding bridge deck behavior, a set of deck strain gauges was placed 1 ft beyond the end of the b2 reinforcement and another set was placed 1 ft within the b2 reinforcement towards the pier. Another set of deck strain gauges was located over the pier (Figure 3, Figure 4, and Figure 5).

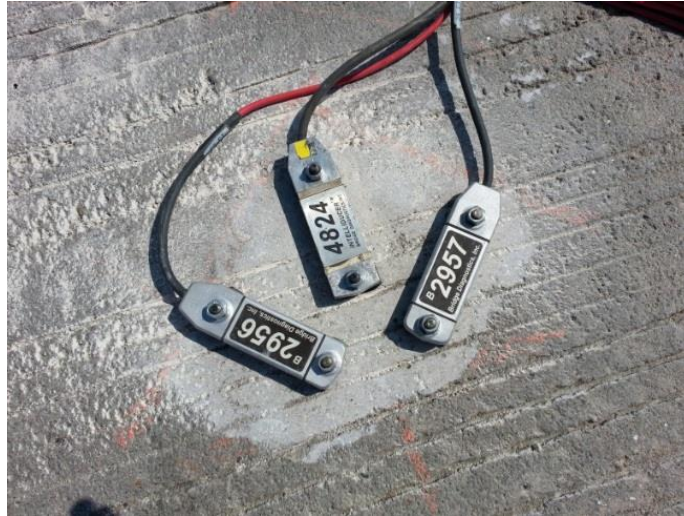
**Figure 6. Rosette near b2 reinforcement**

To investigate the behavior of the principal strains, several rosettes (Figure 6) were also installed at the end of the b2 reinforcement; as with the single gauge placements, the rosettes were similarly placed 1 ft towards the pier and 1 ft away from the pier at the termination of the b2 bar.
