**PERFORMANCE ASSESSMENT OF
NONWOVEN GEOTEXTILE MATERIALS
USED AS THE SEPARATION LAYER FOR
UNBONDED CONCRETE OVERLAYS OF EXISTING
CONCRETE PAVEMENTS IN THE US**

Cackler, T., T. Burnham, and D. Harrington. 2018. *Performance Assessment of Nonwoven Geotextile Materials Used as the Separation Layer for Unbonded Concrete Overlays of Existing Concrete Pavements in the US*. National Concrete Pavement Technology Center, Iowa State University, Ames, IA.

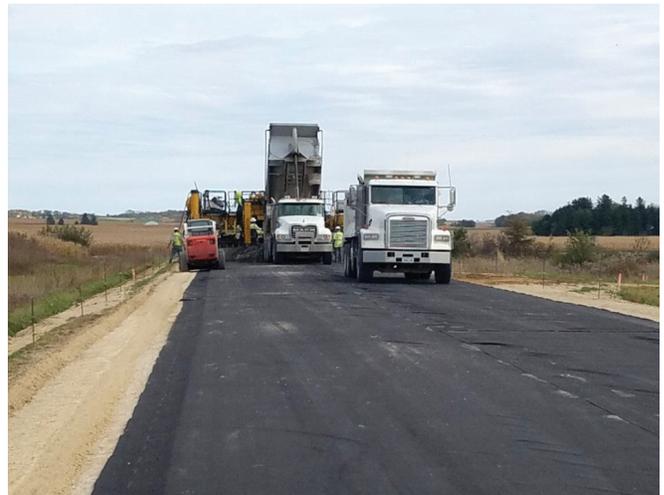
Figure 1. Placement of nonwoven geotextile separation layer

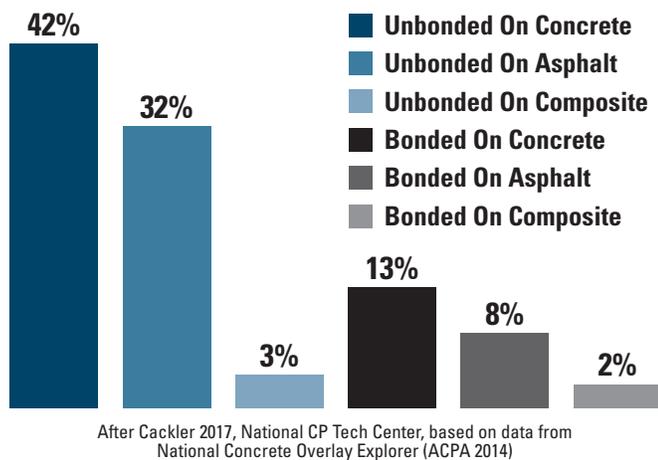
Figure 3. Percentage of bonded and unbonded concrete overlays by pavement type constructed from 1900–2010

Furthermore, as shown in Figure 3, unbonded concrete overlays on concrete (UBCOCs) have historically been the most common application of unbonded overlays. Therefore, any potential for performance improvements from using nonwoven geotextiles as a separation material could be very significant.

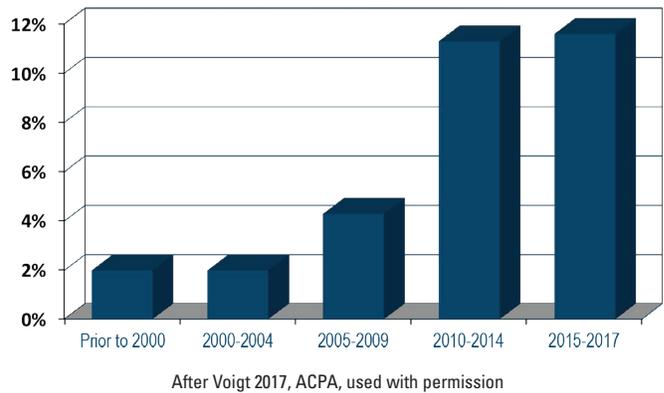
Figure 4. National concrete overlay growth as of November 2017

Also, in addition to UBCOCs being the most common overlay type, the number of concrete overlay projects has grown steadily over the last few years as shown in Figure 4.

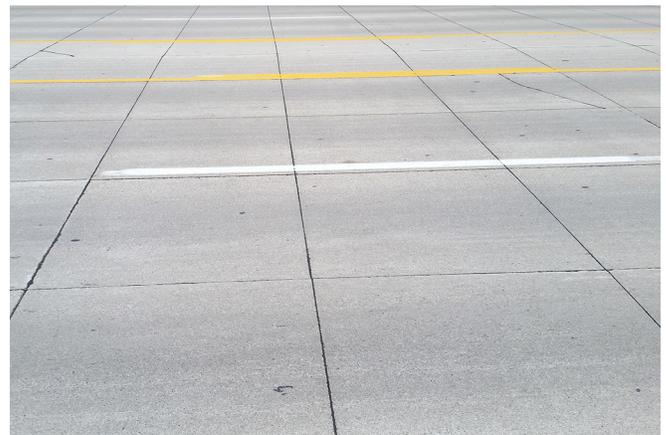
Figure 5. Lack of panel movement shown on 4 in. UBCOC overlay with geotextile separation layer after 6 years of urban traffic

An additional observed benefit of nonwoven geotextile fabrics is the reduced risk of differential panel movement. Because the overlay bonds to the fabric, the panels are held in position (see Figure 5). The ability of the fabric to maintain panel alignment results in reduced internal pressures within the overlay and reduced likelihood of pavement blowups.

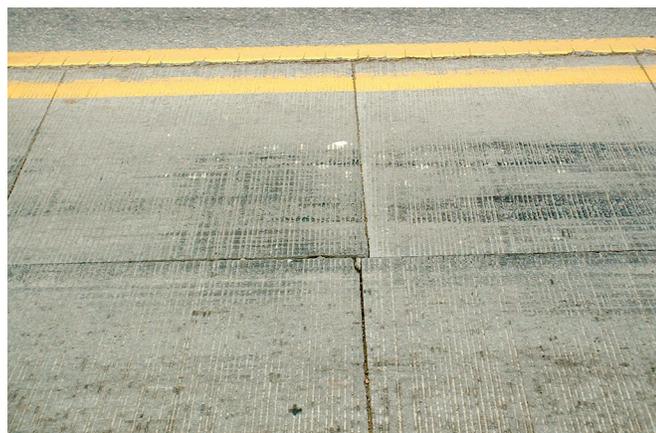
Figure 6. Panel movement on UBCOC overlay with HMA separation layer

Conversely, panel movement has occurred on some UBCOC overlays with HMA separation layers (see Figure 6).

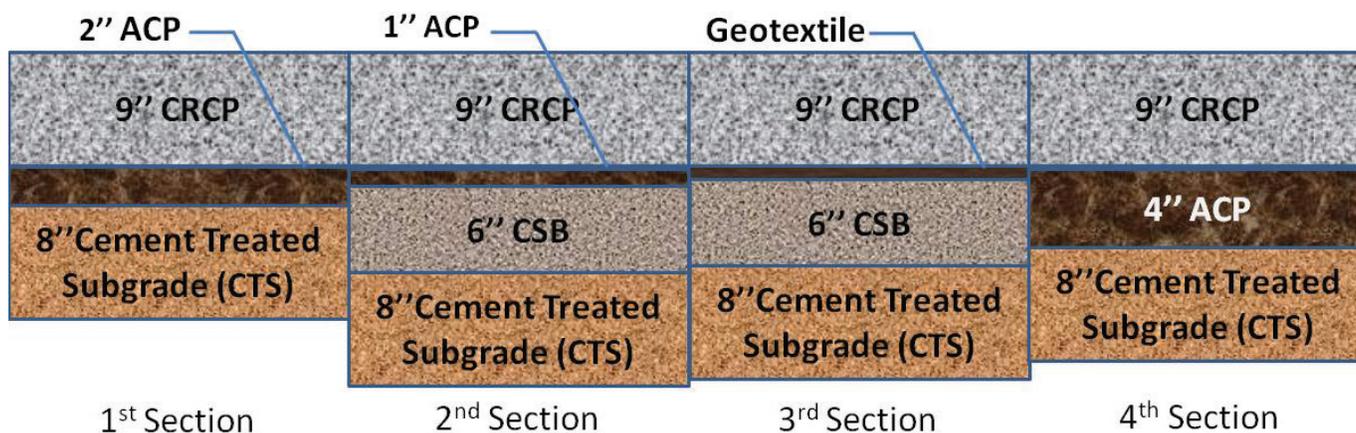
Figure 8. TTI test section layout showing four different test sections with different subbase types

It is worth noting that geotextile separation layers are not recommended when placing a continuously reinforced concrete overlay over a CRCP (Zollinger et al. 2014). The Texas DOT (TxDOT) has evaluated the use of a geotextile between CRCP and subbase layers through work conducted by the Texas A&M Transportation Institute (TTI) (see Figure 8).

Although this work was conducted on a new full-depth CRCP section and not a CRCP overlay, the research concluded that this is a questionable application of geotextiles and may not result in the desired pavement performance (Zollinger et al. 2014). This is likely due to the reduced interlayer friction from the geotextile, which resulted in longer, undesirable crack spacing.

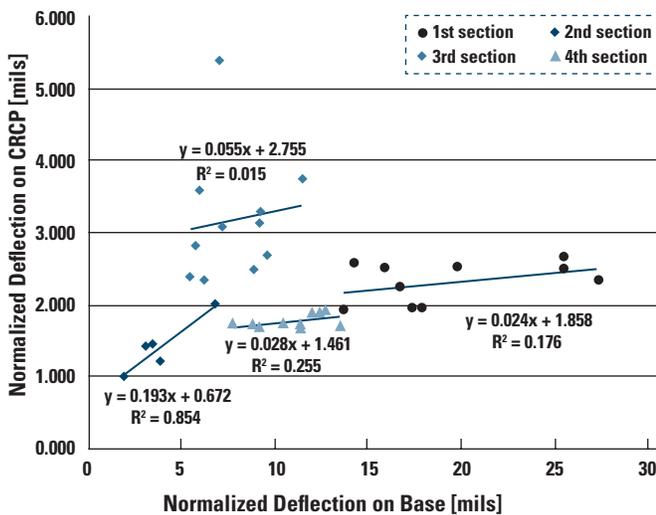
Figure 9. FWD deflections on base and CRCP

It was also noted on the sections being evaluated that the magnitude and variability of the deflections, measured using a falling weight deflectometer (FWD) on the test section with a geotextile interlayer, was considerably higher than the other sections (see Figure 9).

Larger deflections in a CRCP are not desirable. The recommended separation layer for CRCP is a dense-graded or permeable HMA (Zollinger et al. 2014).

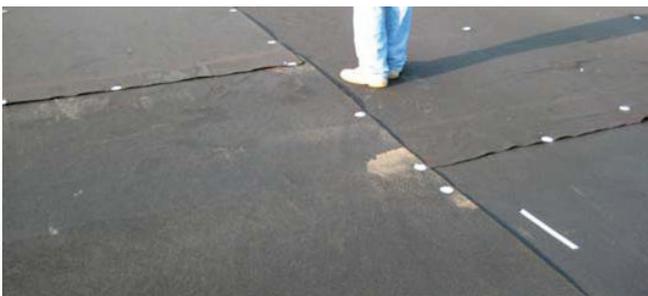
Figure 10. Overlap of nonwoven geotextile material section

- Overlap sections of the nonwoven geotextile material a minimum of 6 in. and a maximum of 10 in. and ensure that no more than 3 layers overlap at any point (see Figure 10).

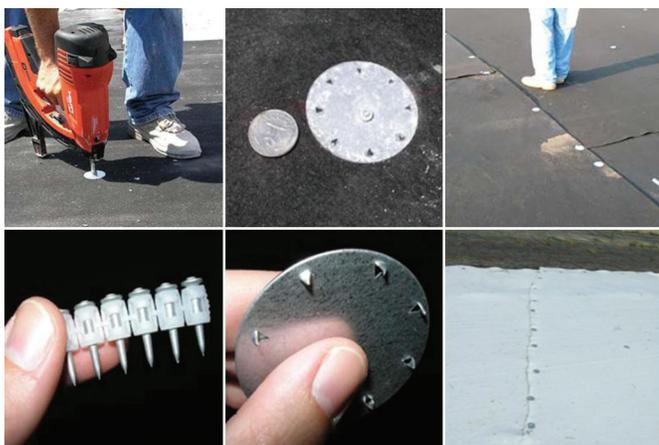
Figure 11. Securing geotextile (pins/nails) with washer

- There are several options for anchoring the geotextile, such as using nails and washers at 6 ft center-to-center (c/c) in each direction or applying an approved adhesive (see Figures 11 and 12). Several states have also been experimenting with using liquid hot-pour asphalt (tack).

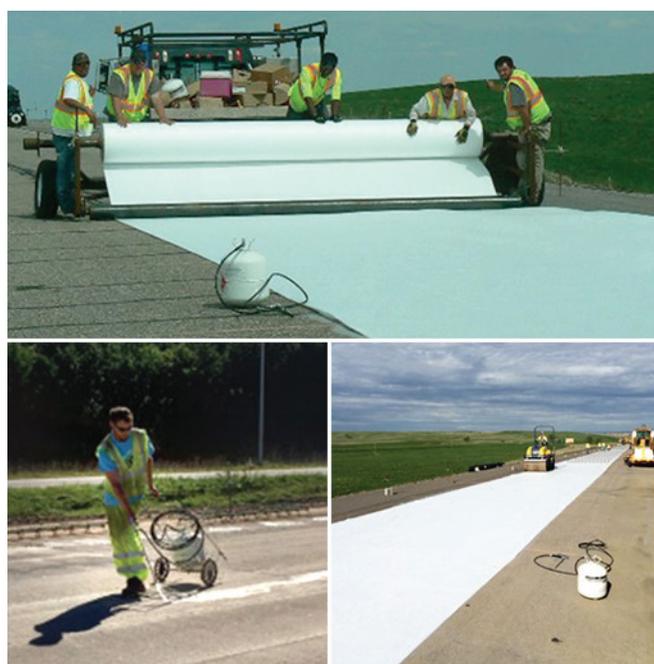
Figure 12. Securing geotextile with spray adhesive

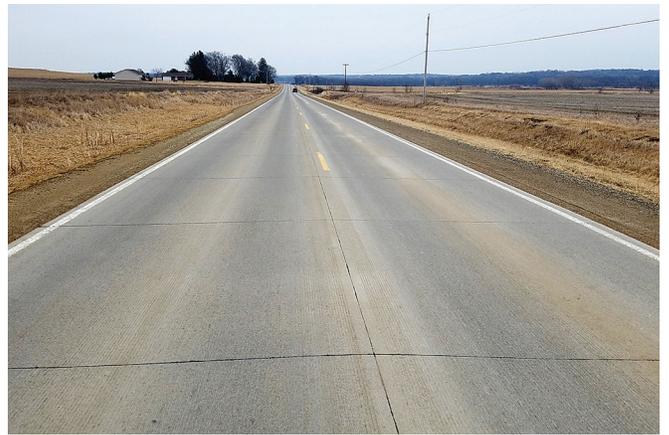
Figure 16. Iowa – Current condition

Current condition: Excellent condition with no signs of reflective cracking from the underlying pavement
Performance metrics (2015):
PCI = 89, IRI = 78 in/mi, 7 transverse cracks (0.2%)

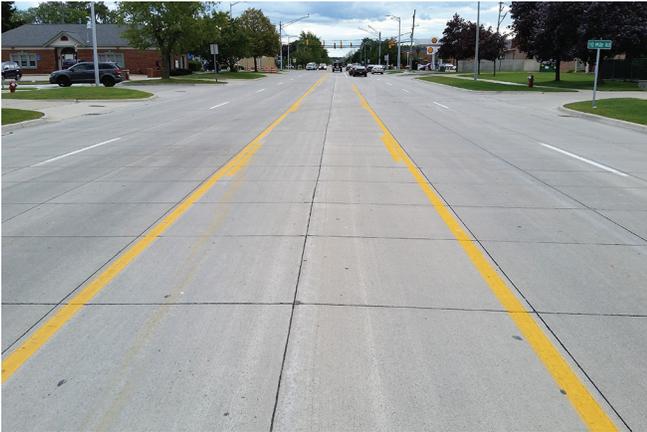
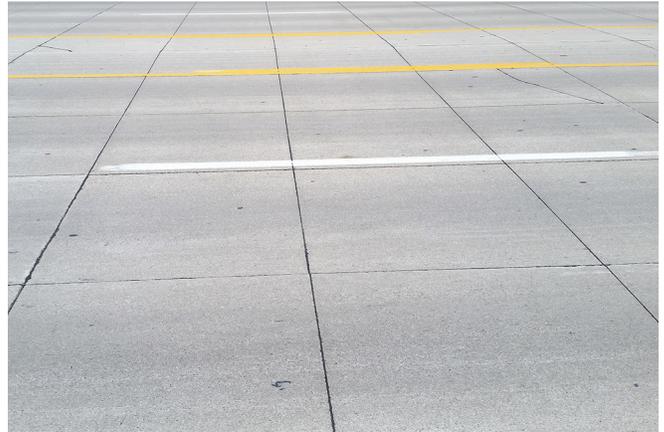
Figure 17. Michigan – Current condition

Current condition: Good performance, some minor cracking at gaps and off some structures and one isolated location with a few shattered panels; the concrete pieces are held in place by the fabric, there is no faulting, and these panels will need to be replaced at some point

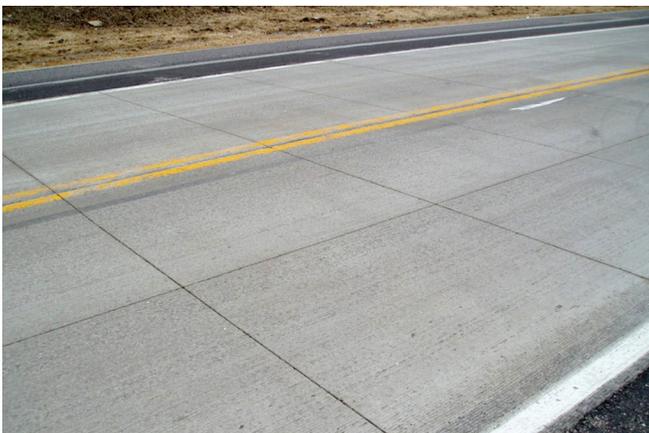
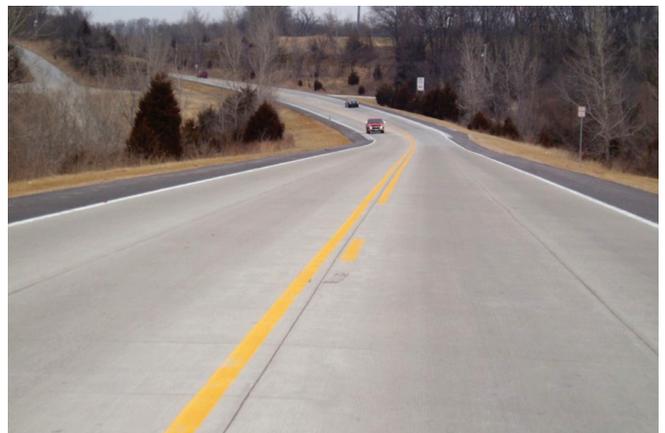
Note: Both the 12 oz/yd² and 15 oz/yd² separations appear to be performing equally at this point.

Figure 22. Missouri – Current condition

Current condition: The overlay is in excellent condition;

November 2015 survey indicated only 69 of the 9,768 panels were cracked or spalled for a 0.7% failure rate after 7 years of service; no faulting observed

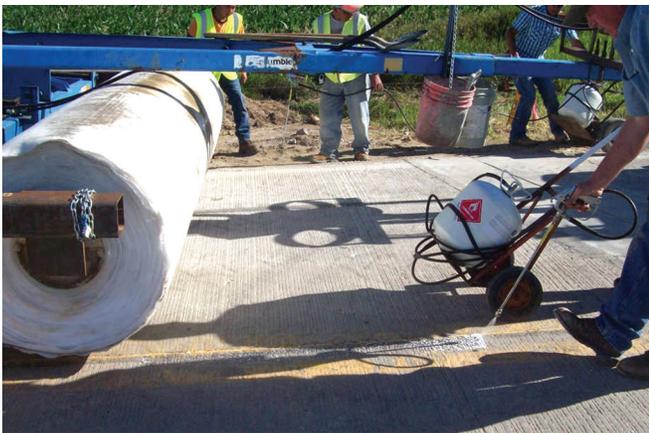
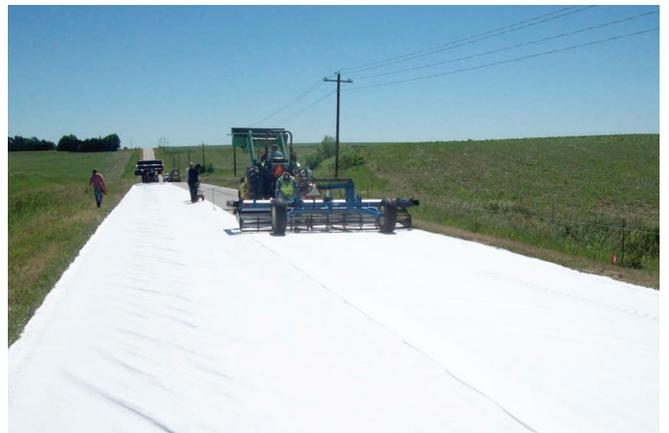
Figure 24. Nebraska – Geotextile fabric placement during overlay placement

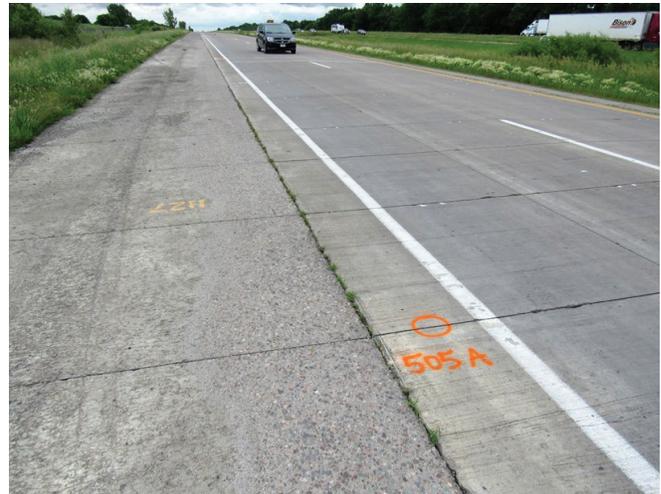
Figure 33. MnROAD Test Section 505 – 5 in. UBOL on standard fabric – June 2016

In 2011, two thin unbonded concrete overlay test sections containing a geotextile fabric separation were constructed at the MnROAD facility (sections 505 and 605 in Figure 26). Both sections consist of 5 in. thick concrete panels placed on a 15 oz nonwoven geotextile fabric, placed on an existing 7.5 in. thick concrete pavement. Panel sizes range from 6 ft long by 6.5 ft wide in the passing lane, to 6 ft long by 7 ft wide in the driving lane. Subjected to interstate traffic levels of more than 1 million equivalent single axle loads (ESALs) per year, as well as the extreme climate of central Minnesota, these test sections have performed exceptionally well. As of 2017, only 1 of the 192 panels has a crack, and transverse joint faulting is minimal. See Figures 33 through 36.

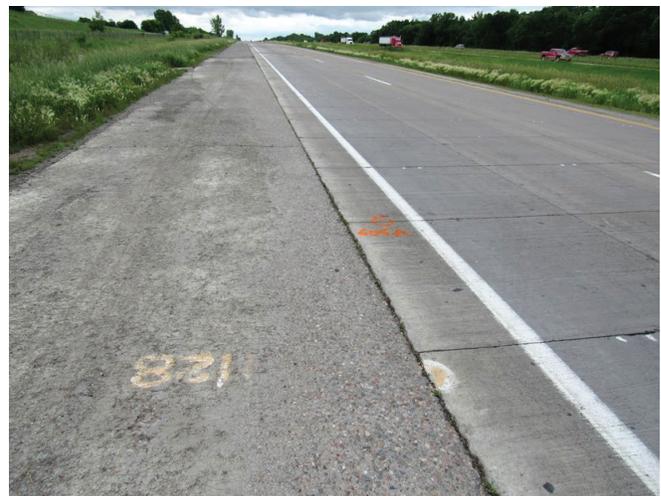
Figure 34. MnROAD Test Section 605 – 5 in. UBOL on standard fabric – June 2016

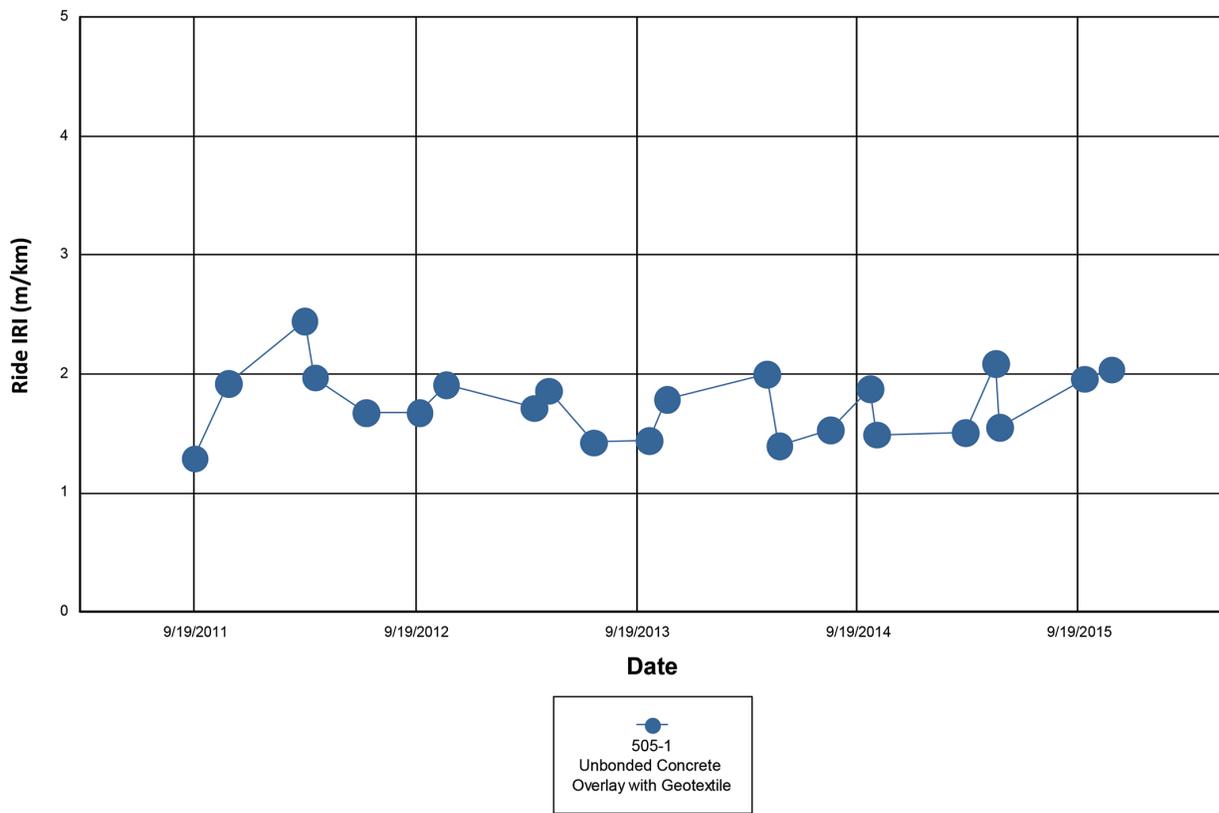
Figure 35. MnROAD Pavement Performance (Ride-IRI) Report: Test Section 505

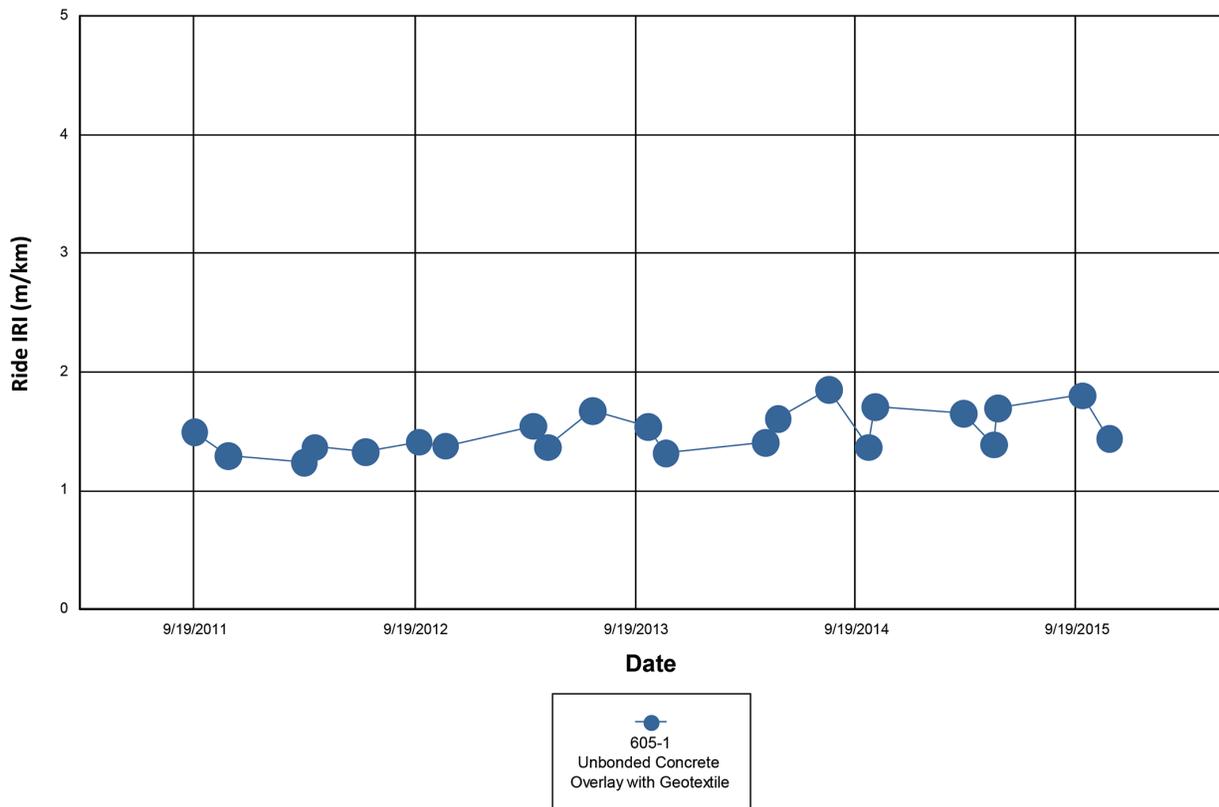
Figure 36. MnROAD Pavement Performance (Ride-IRI) Report: Test Section 605

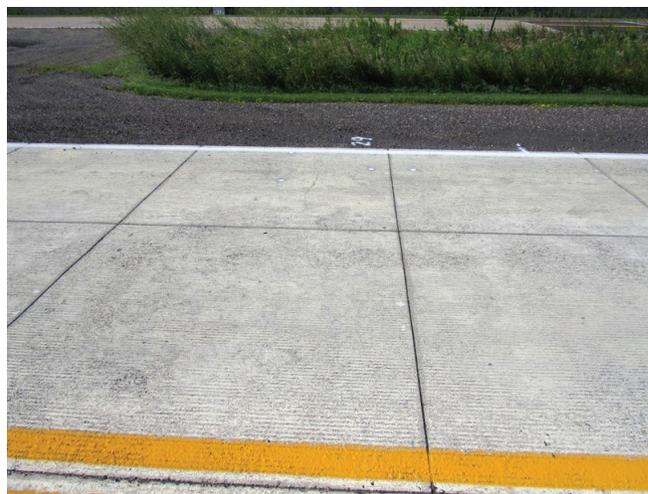
Figure 37. MnROAD Test Section 140 – 3 in. fiber-reinforced concrete UBOL on thin fabric – August 2015

Performance of these sections remains very good, with minimal numbers of transverse and longitudinal cracks appearing in both sections. These cracks have remained tight, likely due to the fiber-reinforced concrete in the overlay. Despite the seemingly excessive deflection of the panels, particularly on the standard weight fabric, faulting of the transverse joints remains minimal as of 2017. See Figures 37 through 40.

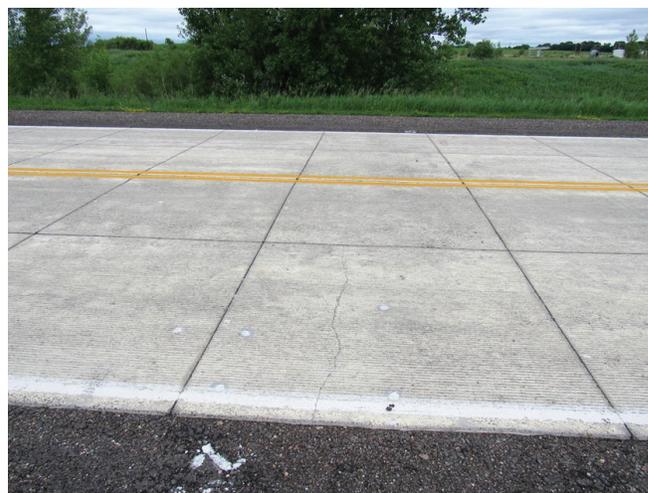
Figure 38. MnROAD Test Section 240 – 3 in. fiber-reinforced concrete UBOL on standard fabric – June 2016

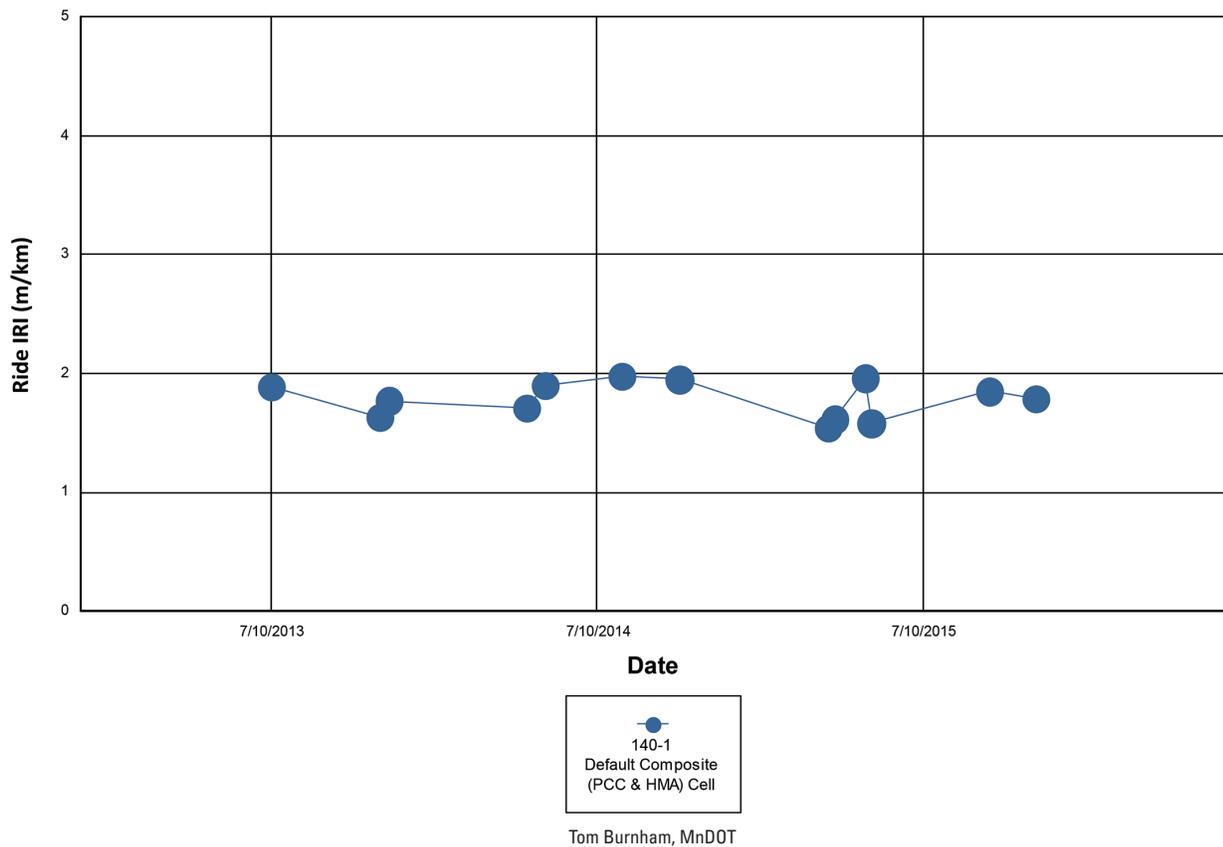
Figure 39. MnROAD Pavement Performance (Ride-IRI) Report: Test Section 140

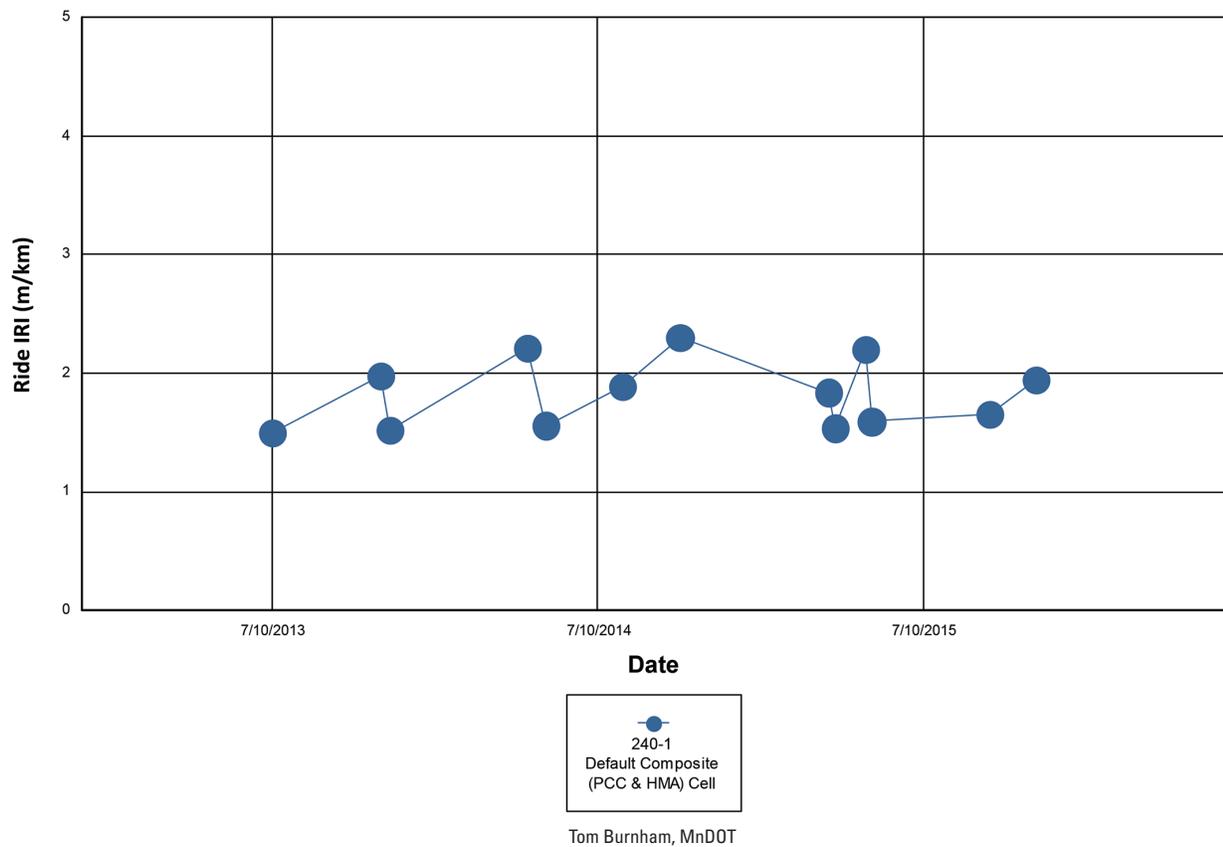
Figure 40. MnROAD Pavement Performance (Ride-IRI) Report: Test Section 240

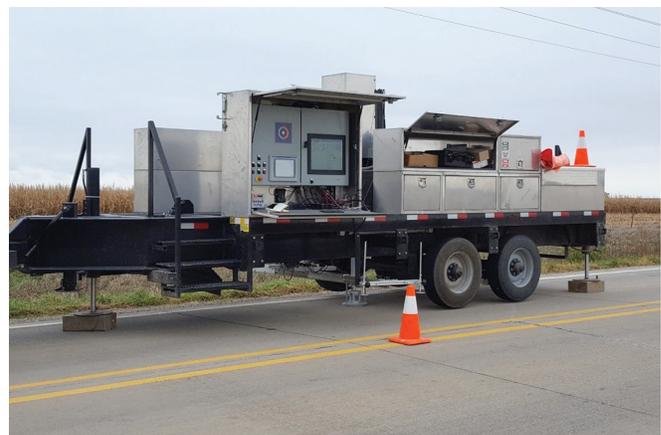
Figure 42. APLT equipment setup on the Poweshiek, Iowa CR V-18 project

- In 2016, the National CP Tech Center conducted an in situ evaluation of geotextile and HMA separation layers using automated plate load testing (APLT) on a project built in 2008–2009 on CR V-18 in Poweshiek County, Iowa (White 2018) (see Figure 42).

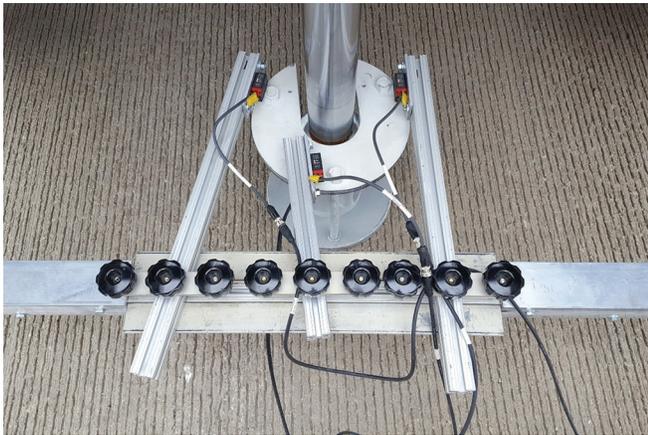
Figure 43. 12-in. diameter plate setup with reference beam for plate deflection measurements

Using cyclic APLT at five stress levels (50 psi to 150 psi), measurements were taken on four test locations where geotextile fabric was used and on two locations with an HMA interlayer (see Figure 43).

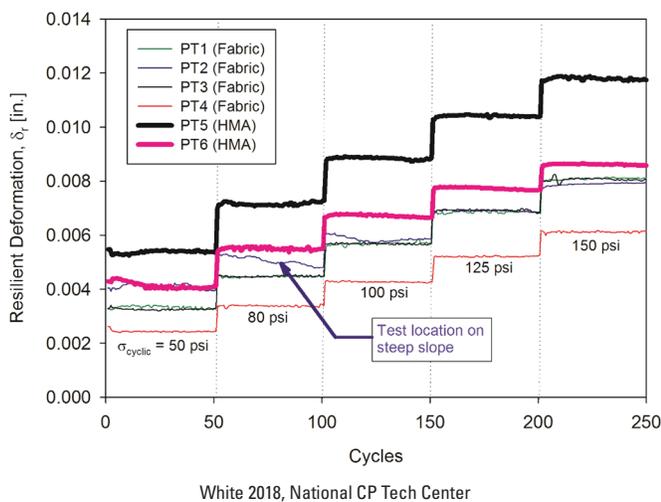
Figure 44. Resilient deformation (δ_r) results for the five stress sequences at all test points

The results indicated that the composite resilient modulus was 40% higher and the permanent deformation was lower in the geotextile sections than in the HMA layer sections (see Figures 44 and 45).

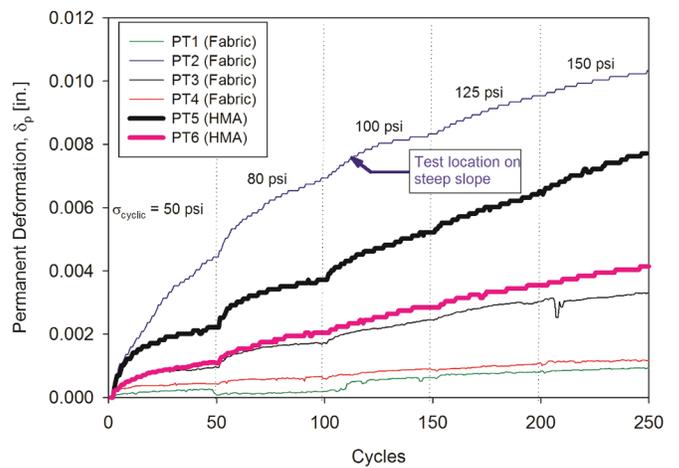
Figure 45. Permanent deformation (δ_p) results for the five stress sequences at all test points

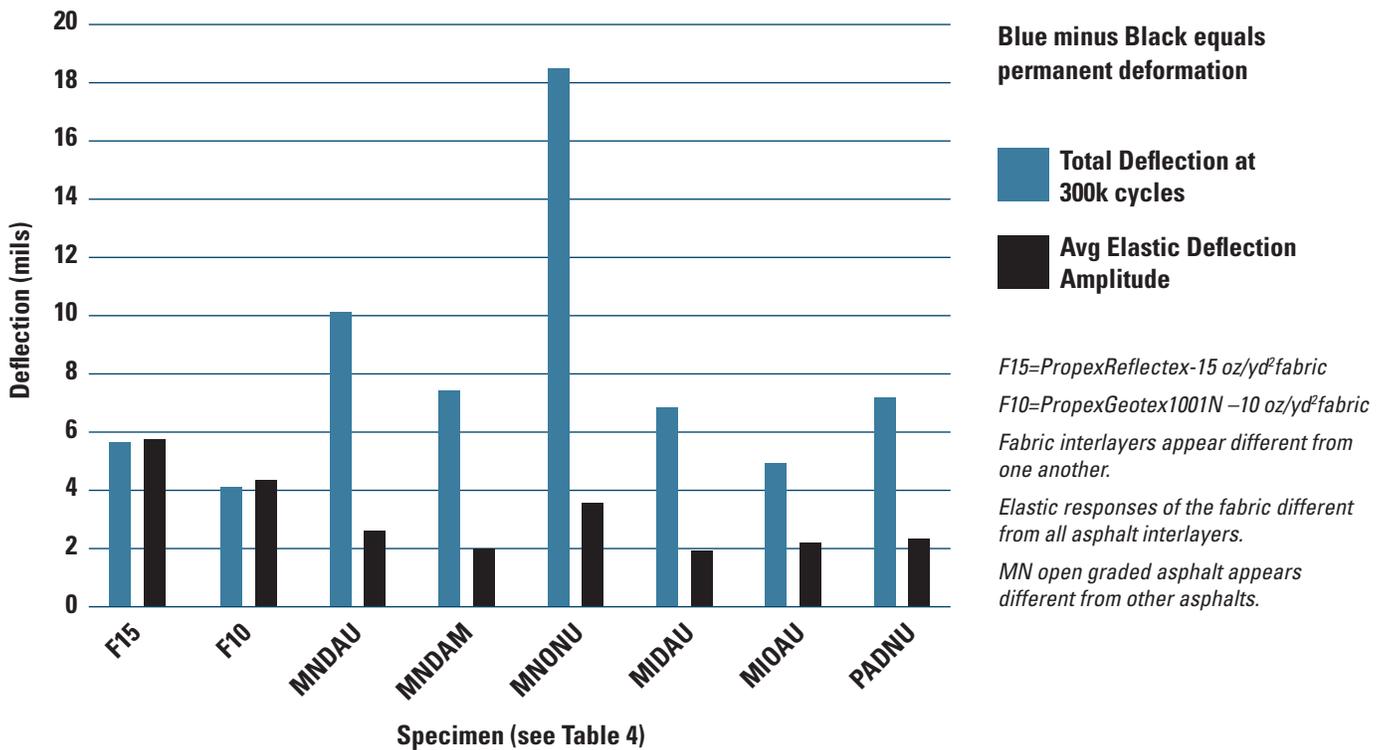
Figure 46. TPF-5(269) elastic deflection and permanent deformation test results

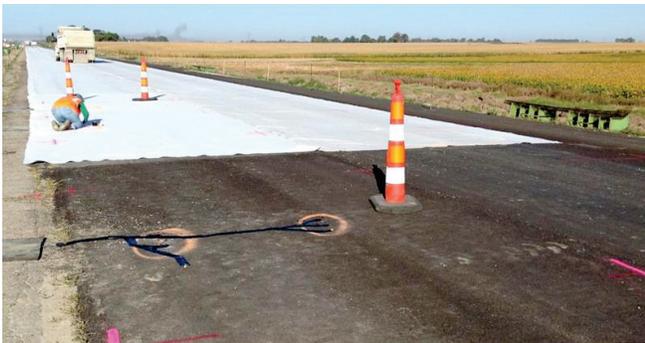
Figure 47. Light-colored geotextile fabric used as a separation layer for an unbonded overlay

“In colder weather (spring and fall) a black-colored separation layer helps maintain a warmer temperature for the placement of the overlays because it has carbon molecules that absorb ultraviolet energy. This is not, however, desirable in hot weather conditions, particularly when the fabric reaches 110°F or greater. Cooling the fabric with a water mist is then required under this condition. To prevent heat absorption, white-colored fabric has been developed recently to help reflect ultraviolet energy in hot and sunny weather (see Figure 47).

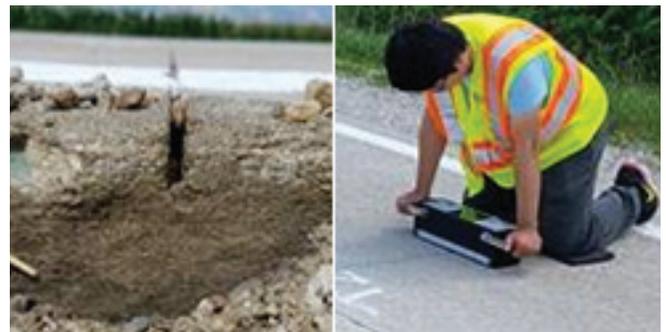
Figure 48. Lack of crack deployment at a sawed contraction joint (left) and ultrasonic pulse echo imaging of concrete overlays to analyze crack deployment (right)

Analytical investigation and field testing are being performed to determine the optimum joint spacing for thin concrete overlays based on the following testing parameters: concrete overlay type, thickness, joint spacing, and the use of synthetic macrofibers (see Figure 48).
