Concrete Pavement Distress Assessments and Solutions

IDENTIFICATION, CAUSES, PREVENTION & REPAIR

Guide for Concrete Pavement Distress Assessments and Solutions: Identification, Causes, Prevention, and Repair

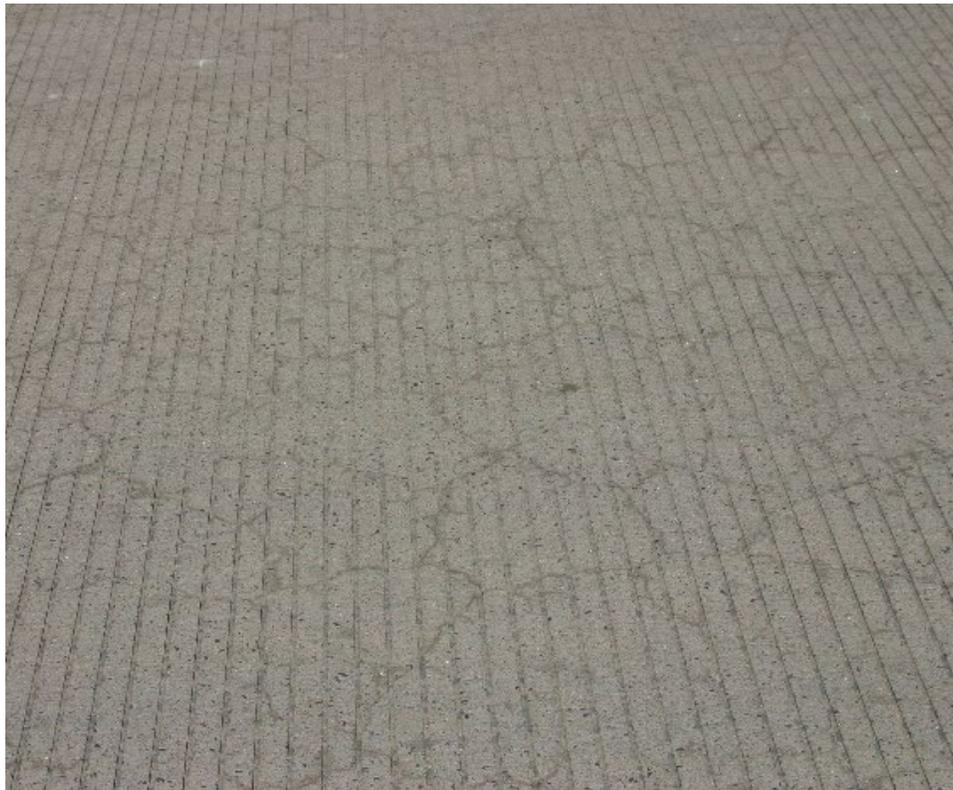
Figure 2.1 Common surface defects

a. Map cracking

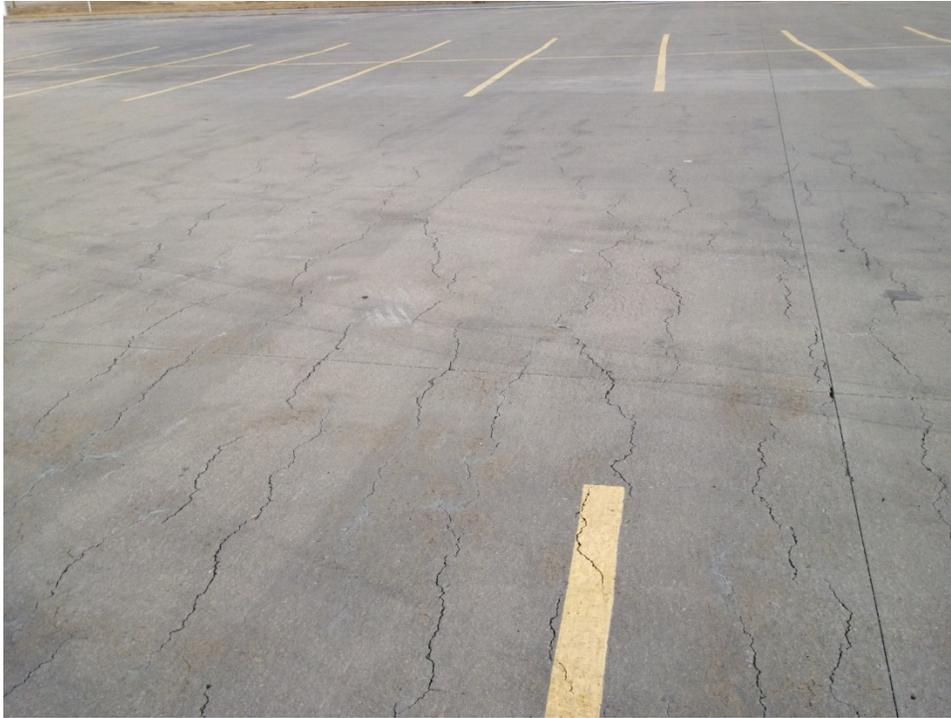
b. Plastic shrinkage cracking
National Concrete Pavement Technology Center

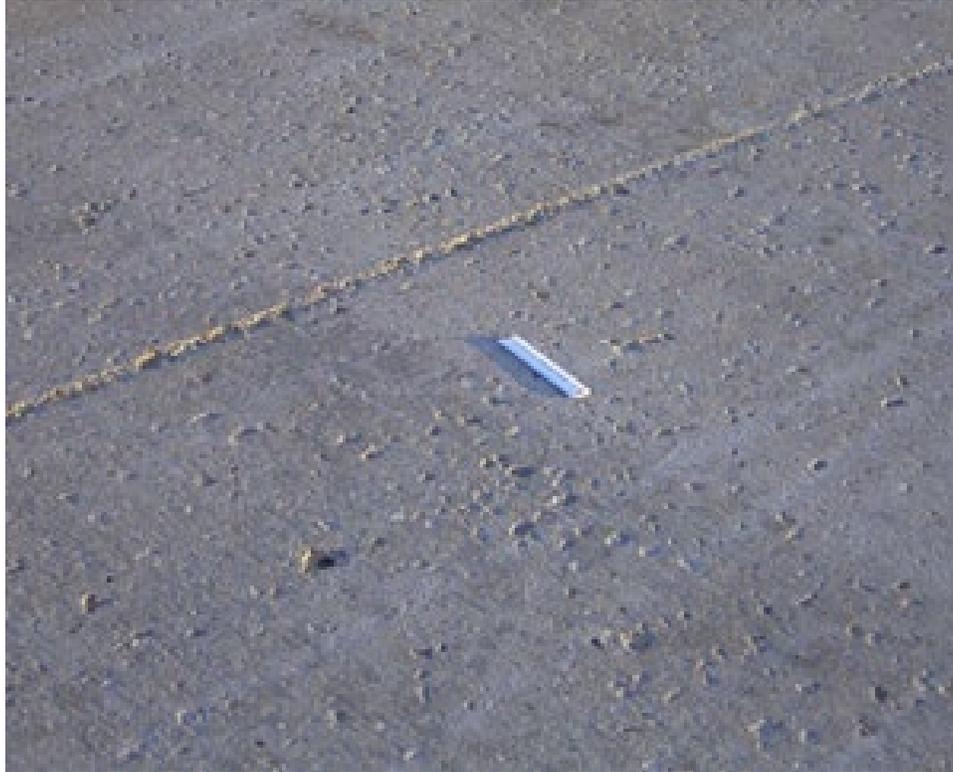
f. Popouts

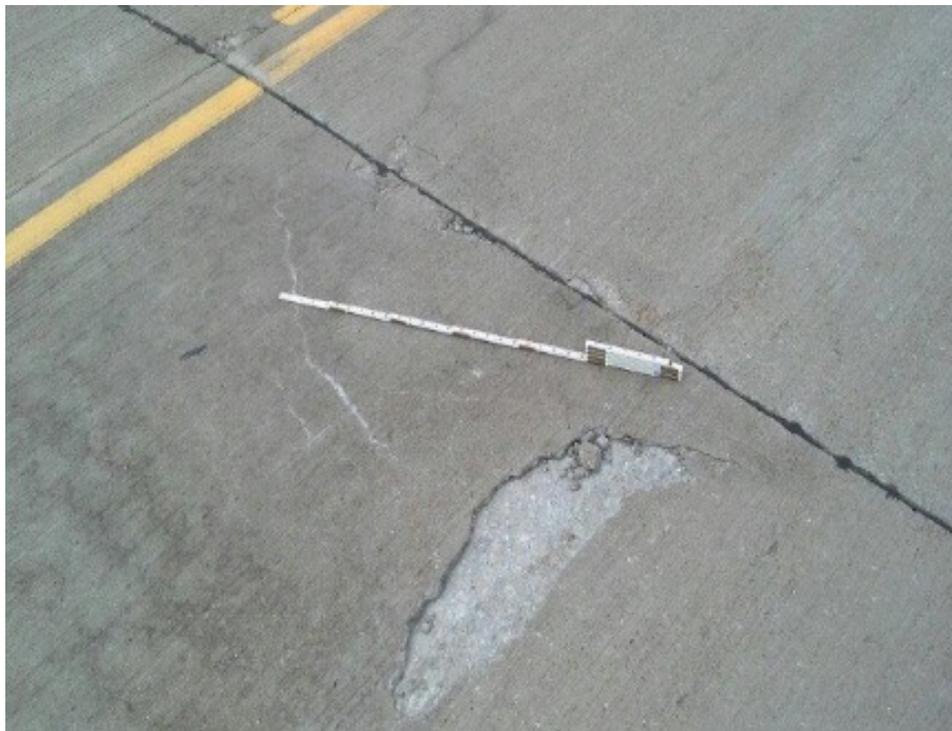
Figure 3.1 Delamination in concrete pavements

a. Localized delamination in a conventional concrete pavement

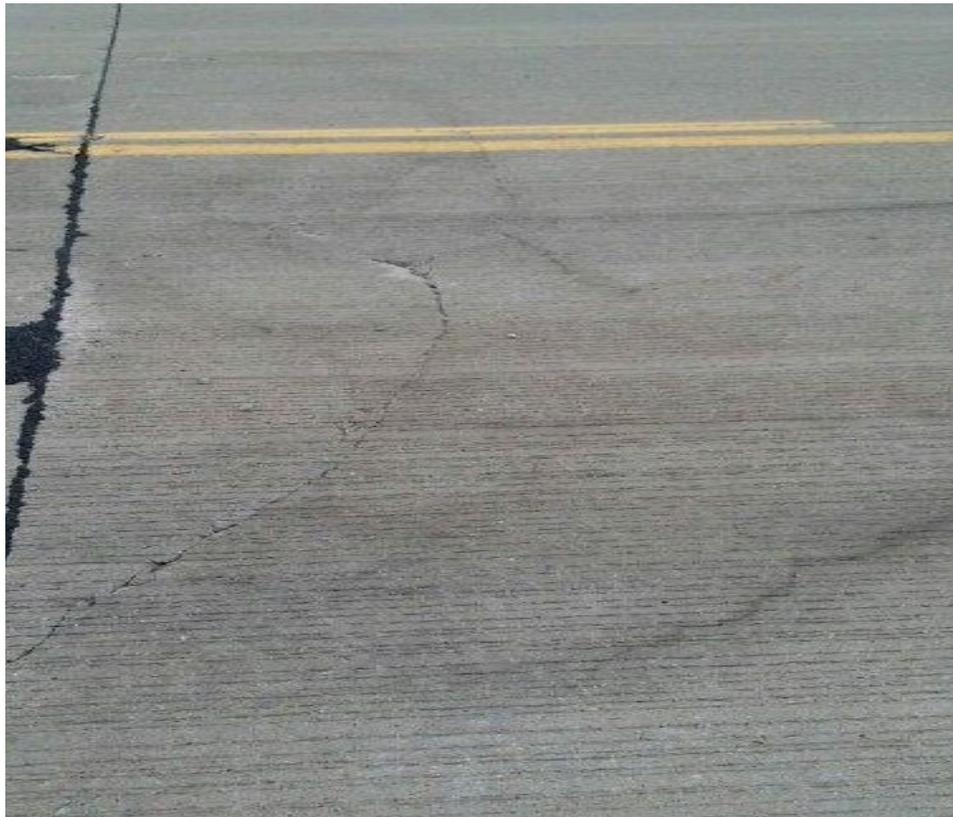
c. Delamination and resultant cracking adjacent to transverse joint
Michael Rodwell, Mahaska County, Iowa

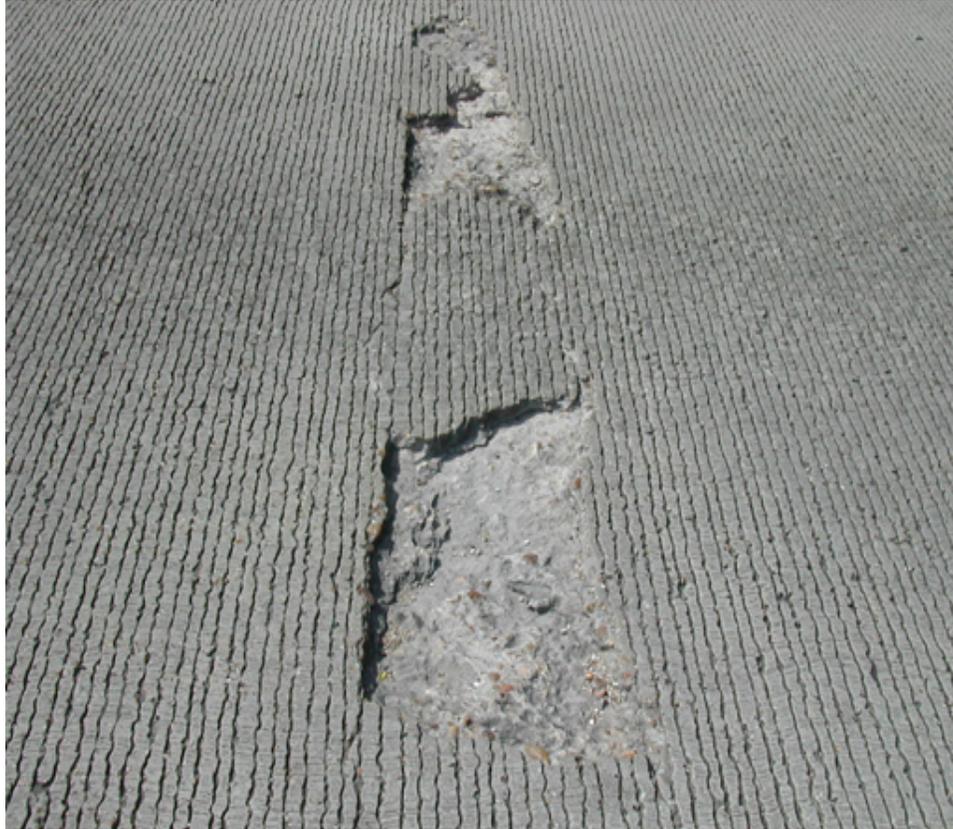
d. Delamination of CRCP
Texas DOT

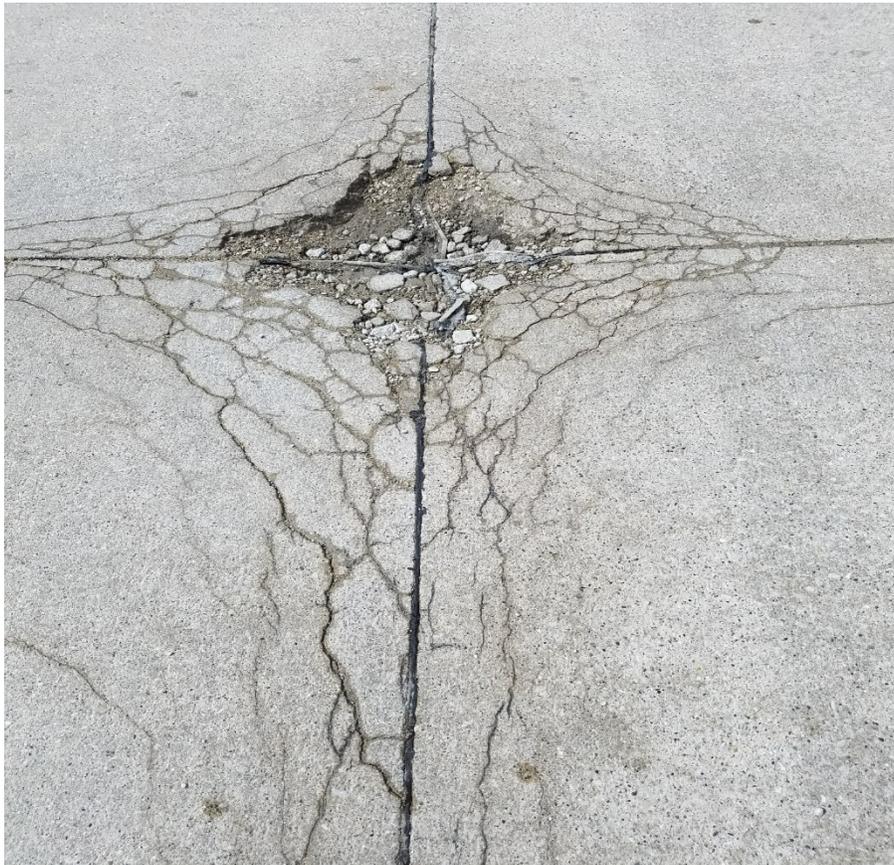
Figure 4.1 Various MRDs in concrete pavements

a. D-cracking

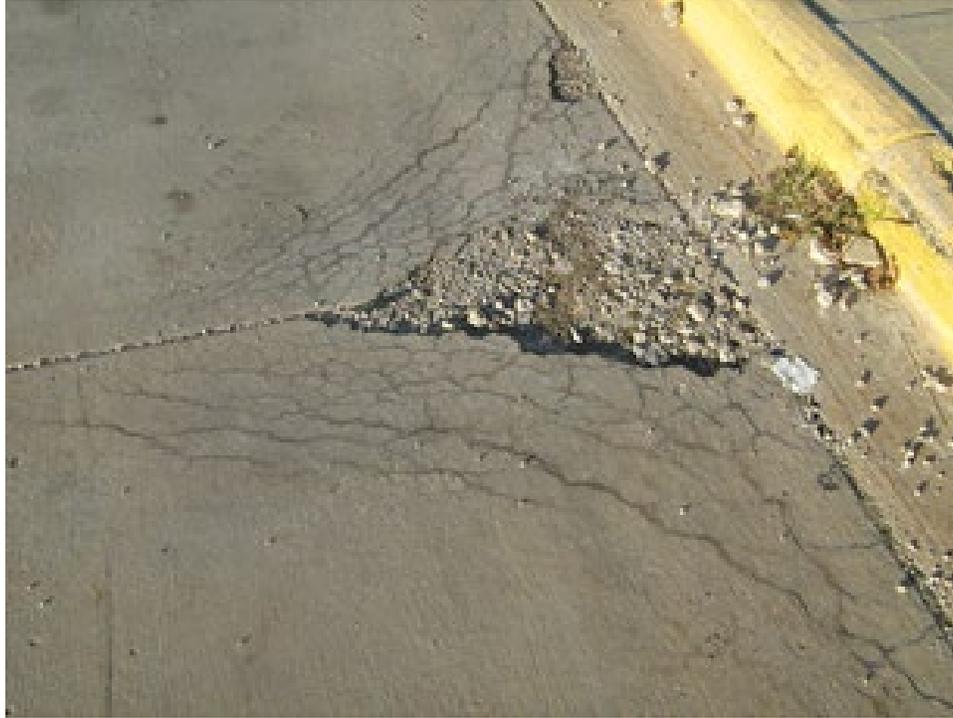
b. D-cracking

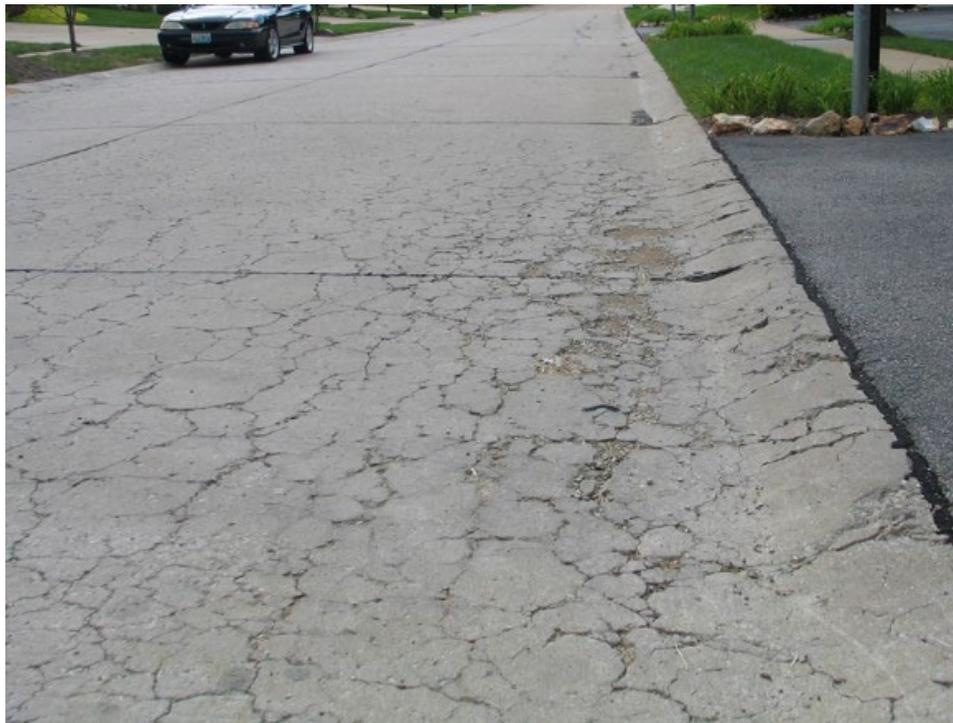
c. ACR

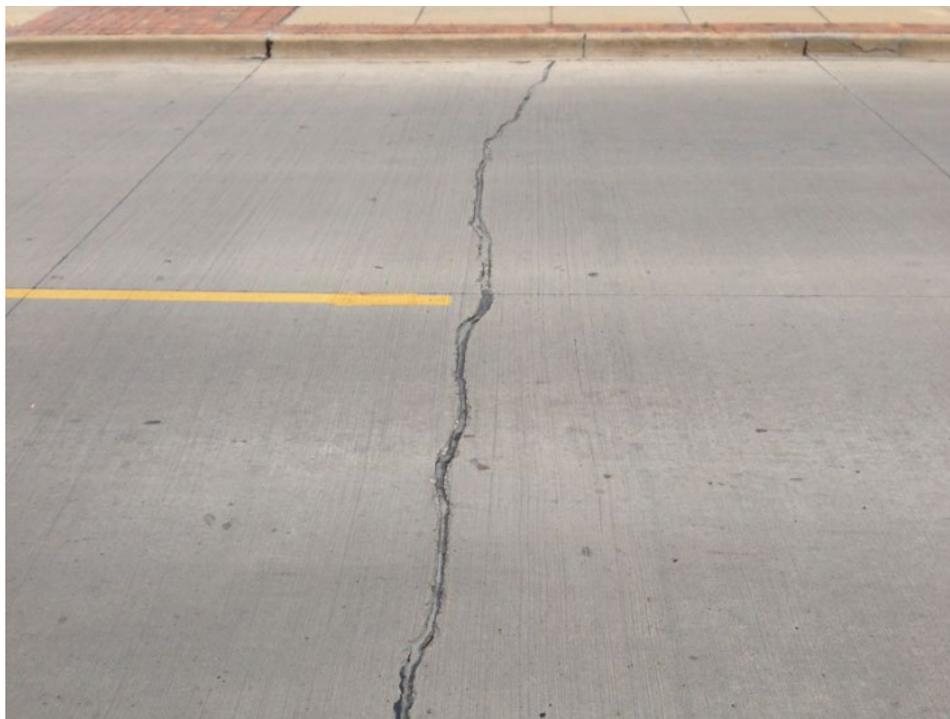
Figure 5.1 Transverse and diagonal cracking in concrete pavements

a. Transverse crack on JPCP

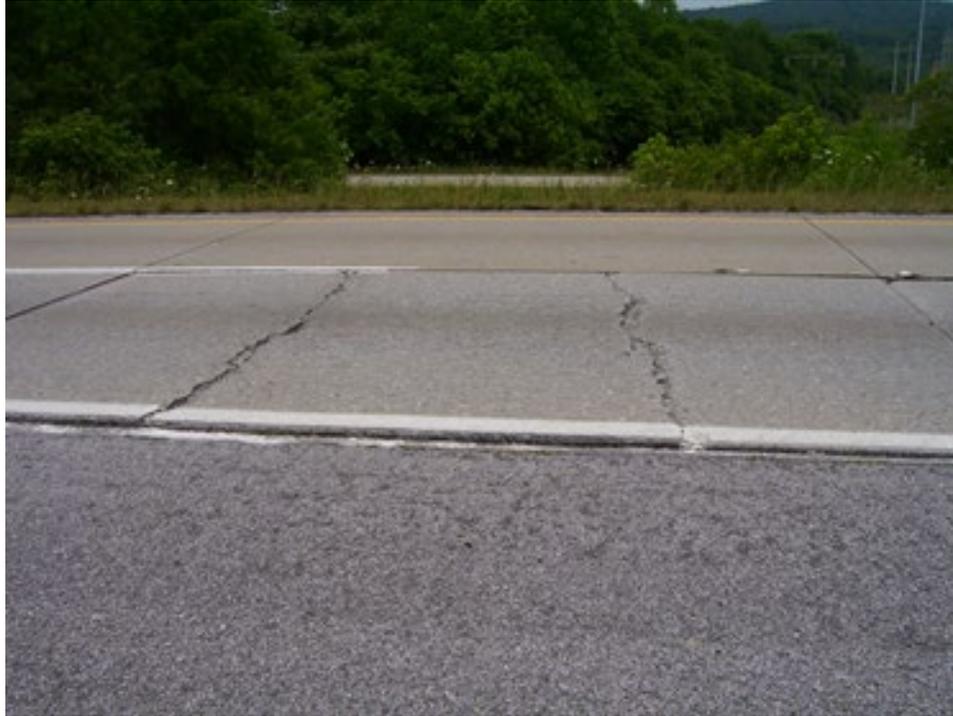
b. Multiple transverse cracks on JPCP
©2018 Applied Pavement Technology, Inc.

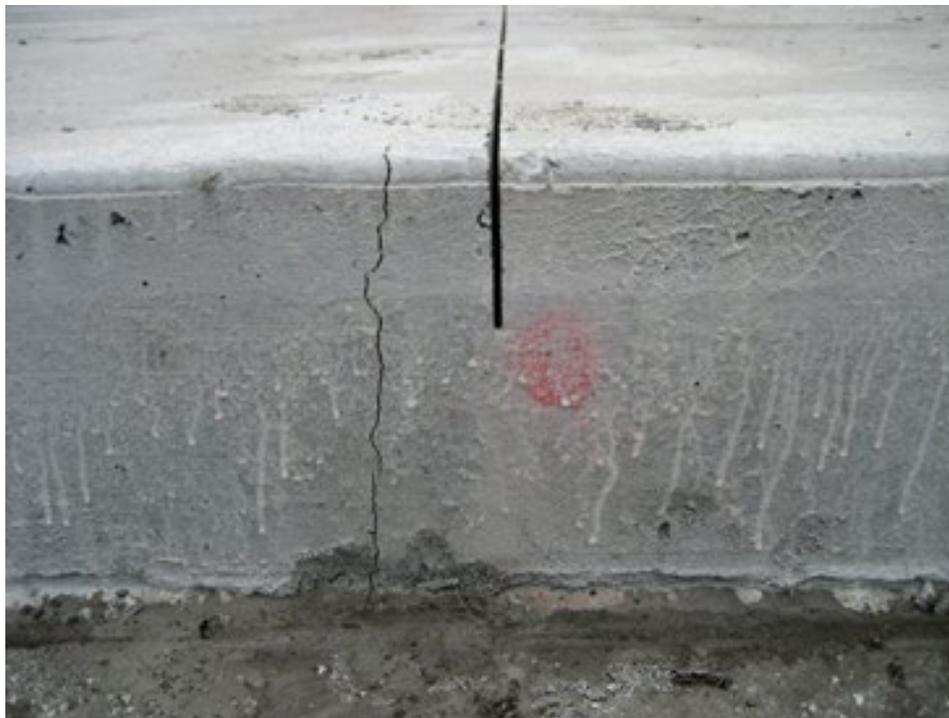
b. Slab cracking occurring parallel to weakened plane saw cut

Figure 5.10a shows a proper saw cut and the crack that has developed beneath it, whereas Figure 5.10b illustrates the development of a parallel crack that may be the result of late sawing or inadequate depth of sawing.

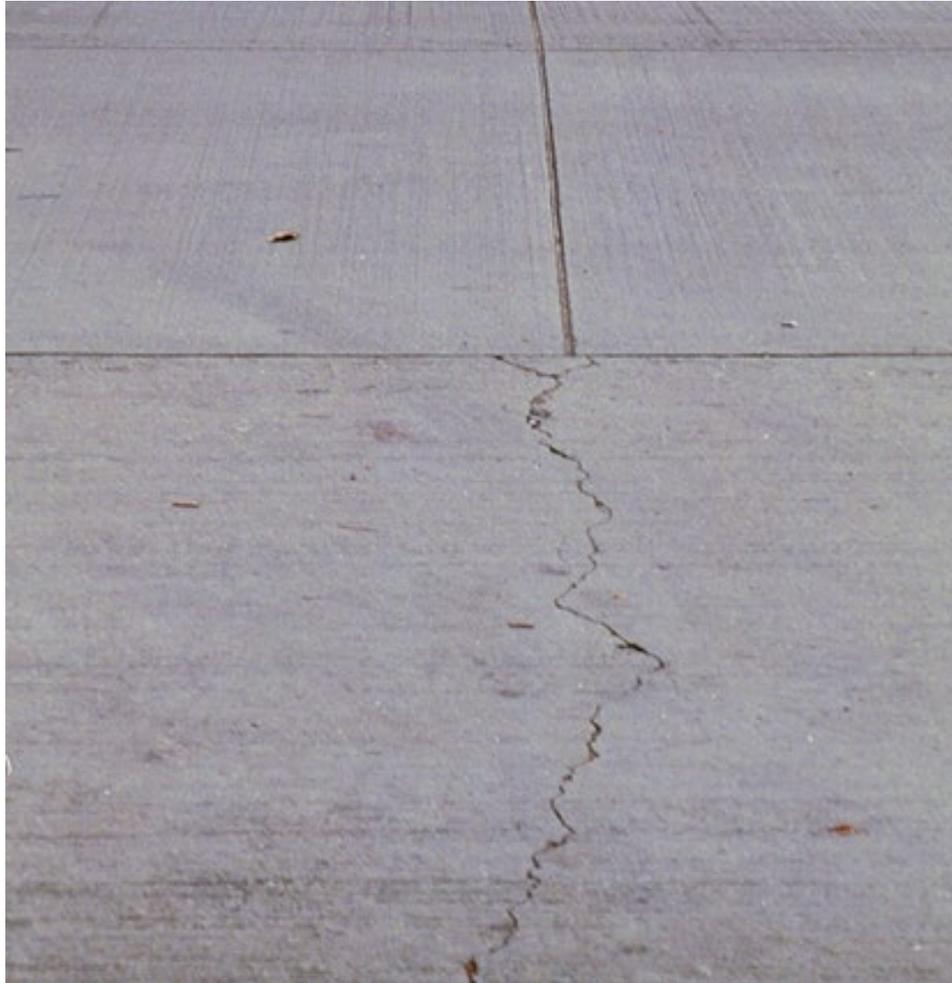
Figure 5.12 Transverse sympathy cracks

a. Sympathy crack from transverse joint in adjoining lane

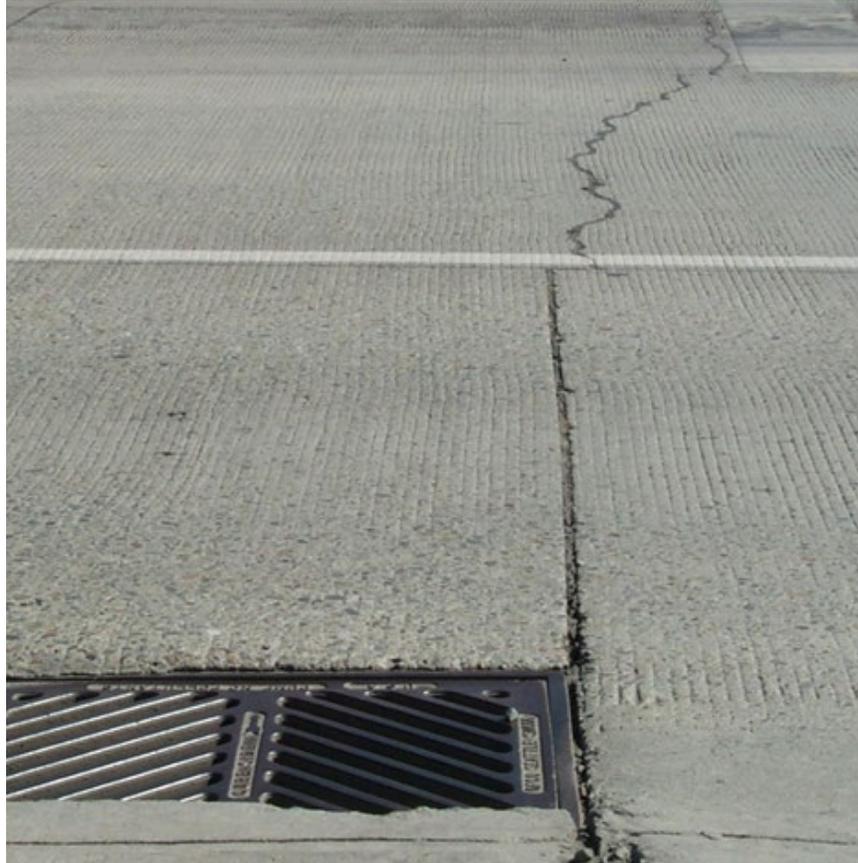
b. Sympathy crack from joint aligning with catch basin

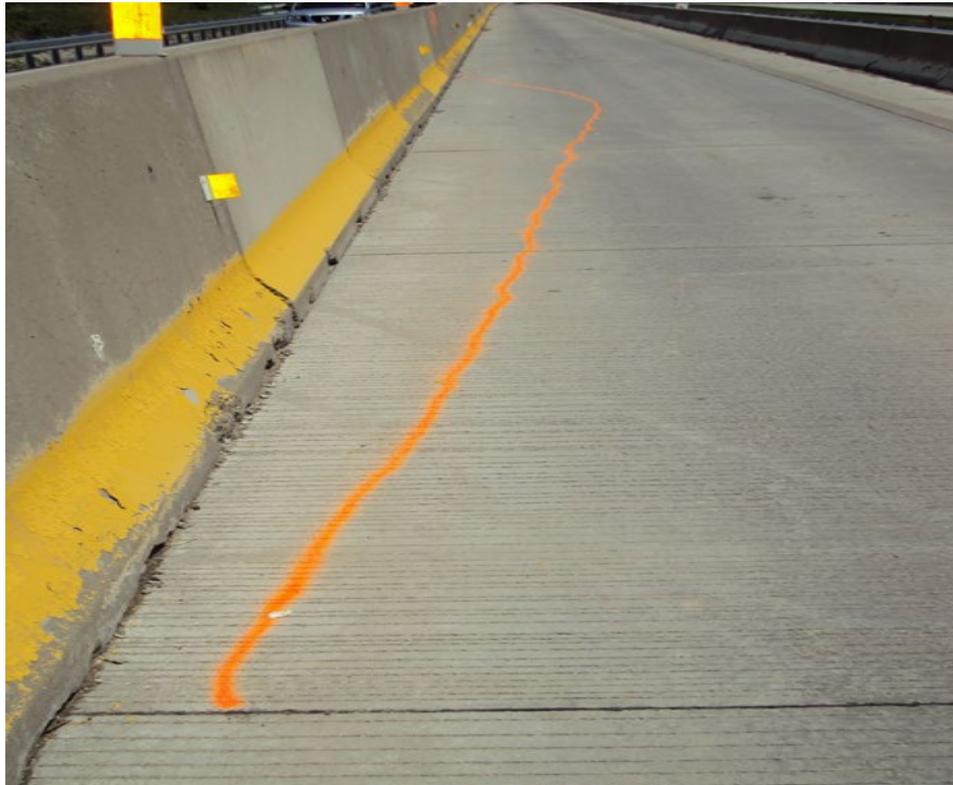
e. Longitudinal crack along centerline joint with possible late sawing

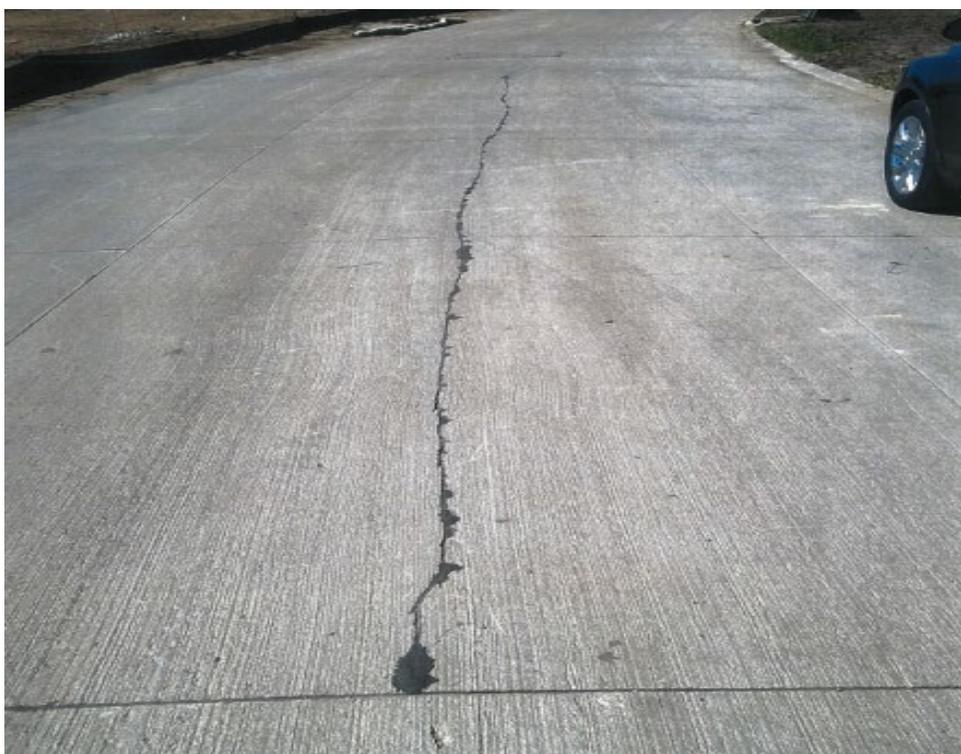
Figure 6.3 Longitudinal cracking due to inadequate saw cut depths of the quarter-point longitudinal joints

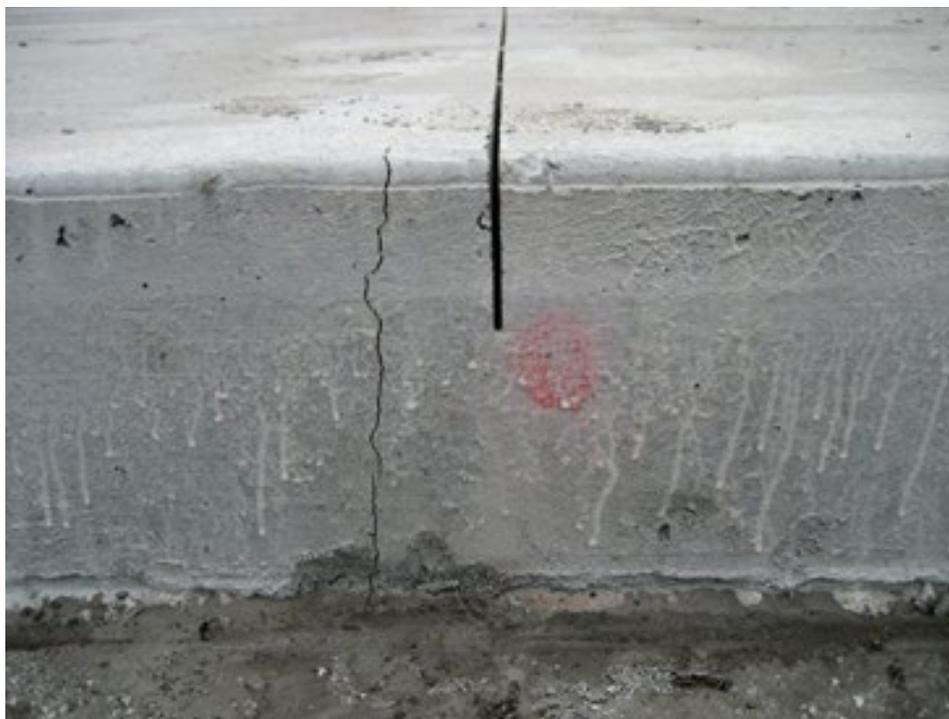
b. Slab cracking occurring parallel to weakened-plane saw cut, possibly due to late sawing or inadequate saw cut depth

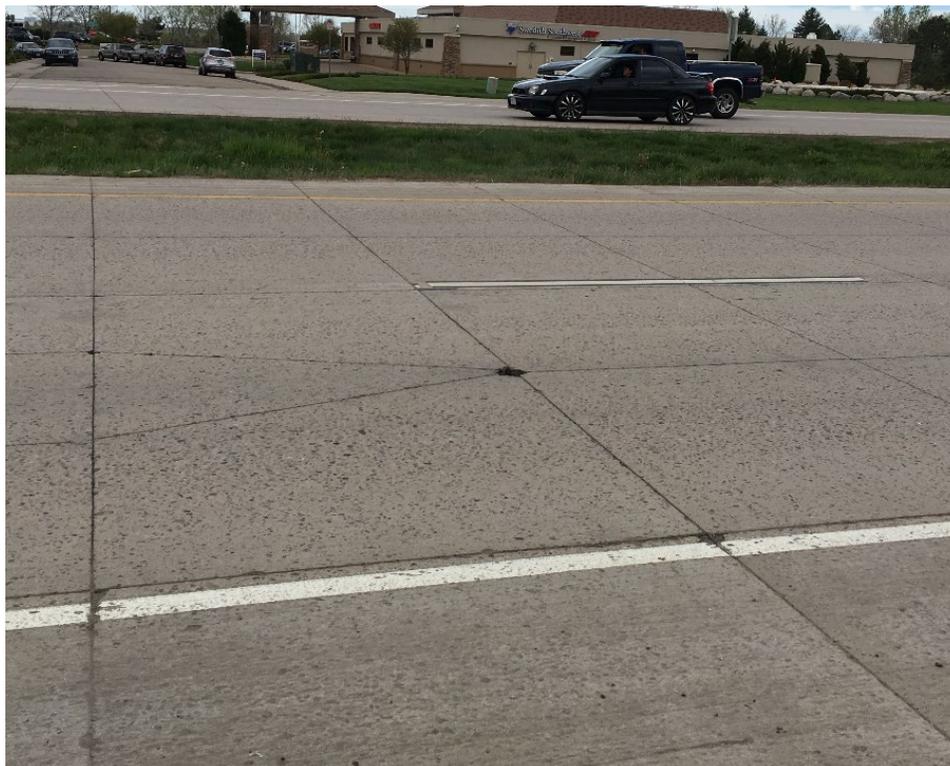
Figure 6.10 Transition between varying longitudinal joint patterns using core hole and diagonal joints to avoid sympathy cracking

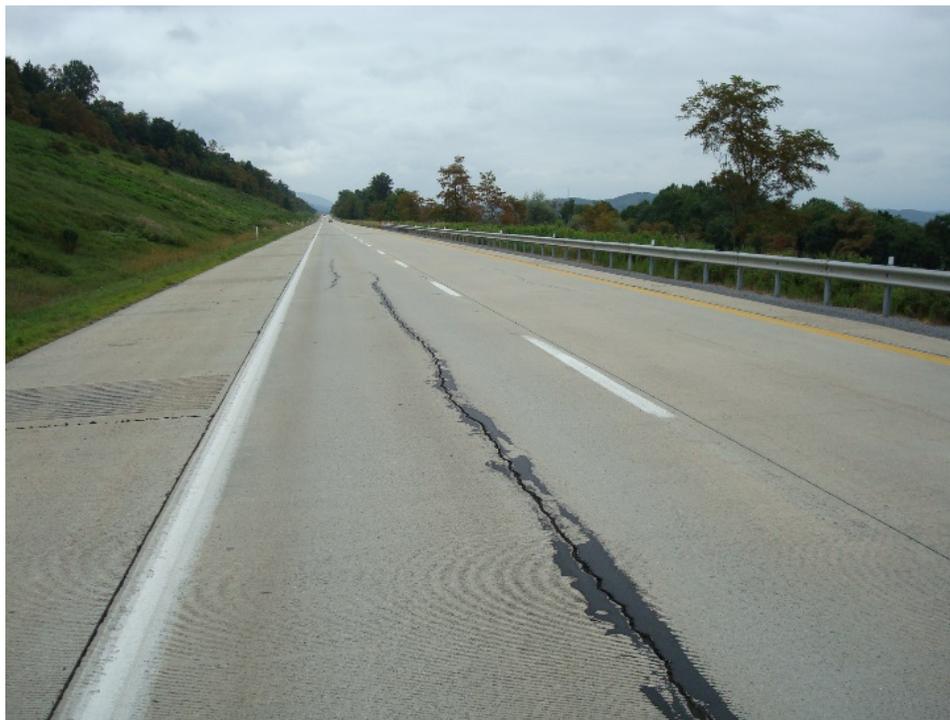
Figure 6.14 Longitudinal crack in over-failed strand in post-tensioned concrete pavement on Pennsylvania I-99

This type of failure is difficult to prevent by any means other than the use of good prestressed pavement design and construction techniques, including the grouting of tendon ducts after tensioning to reduce the chance of corrosion-induced tendon failure.

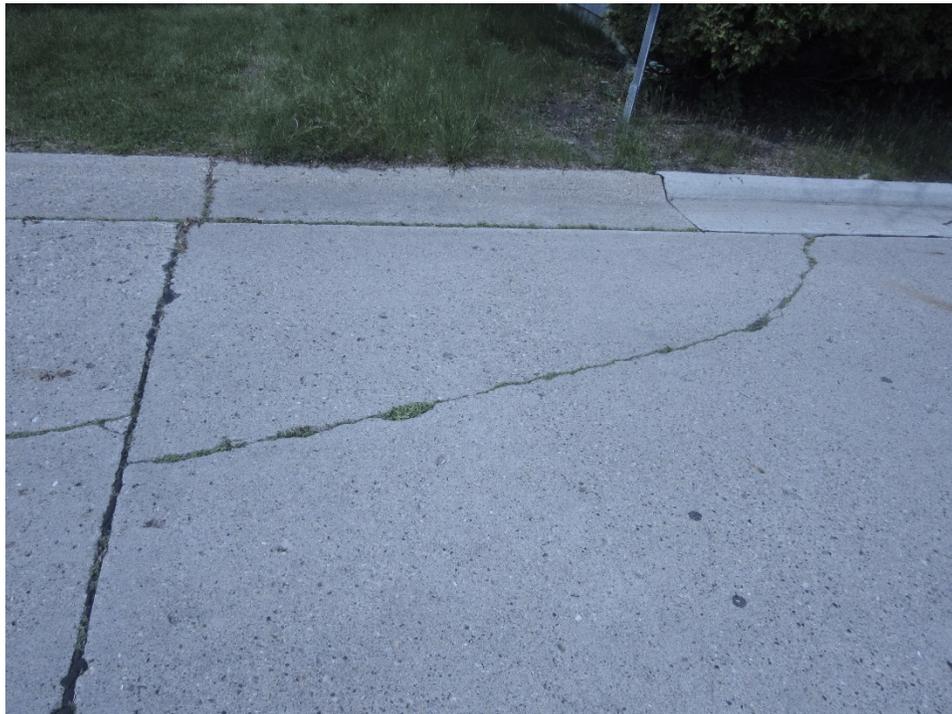
d. Medium-severity corner crack

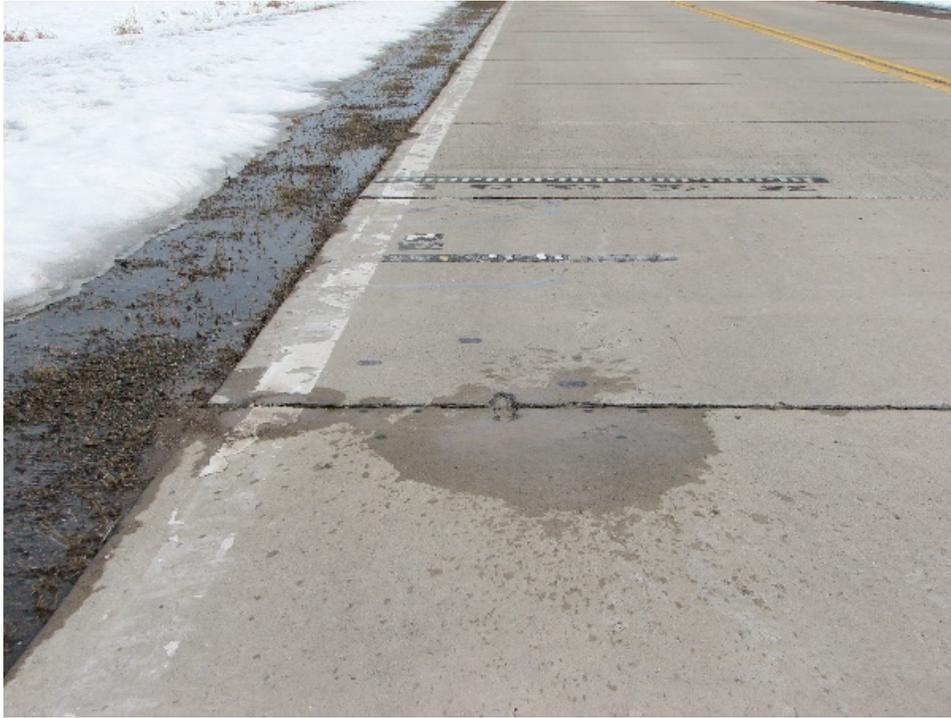
Figure 7.4 Water that has been ejected from a transverse joint under a moving wheel load

Water ejected vertically through the joint sometimes carries fine material eroded from the base or subgrade, which is deposited on the shoulder (see Figure 7.5) and may be a visible indicator of lost support.

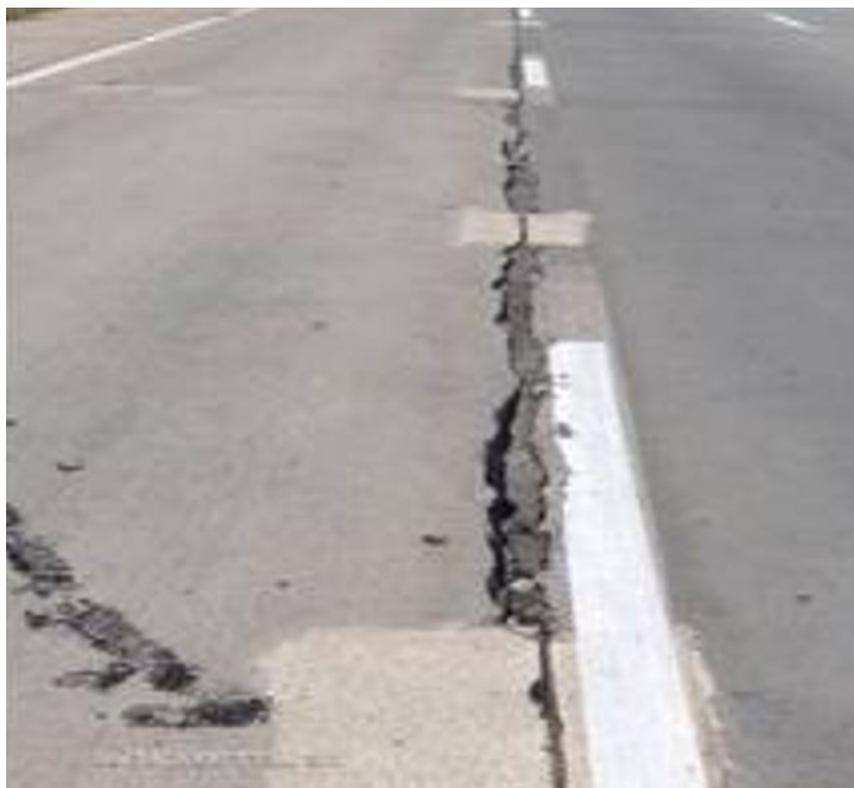
Figure 8.1 Common spalling of joints and cracks

a. Freeze-thaw damage

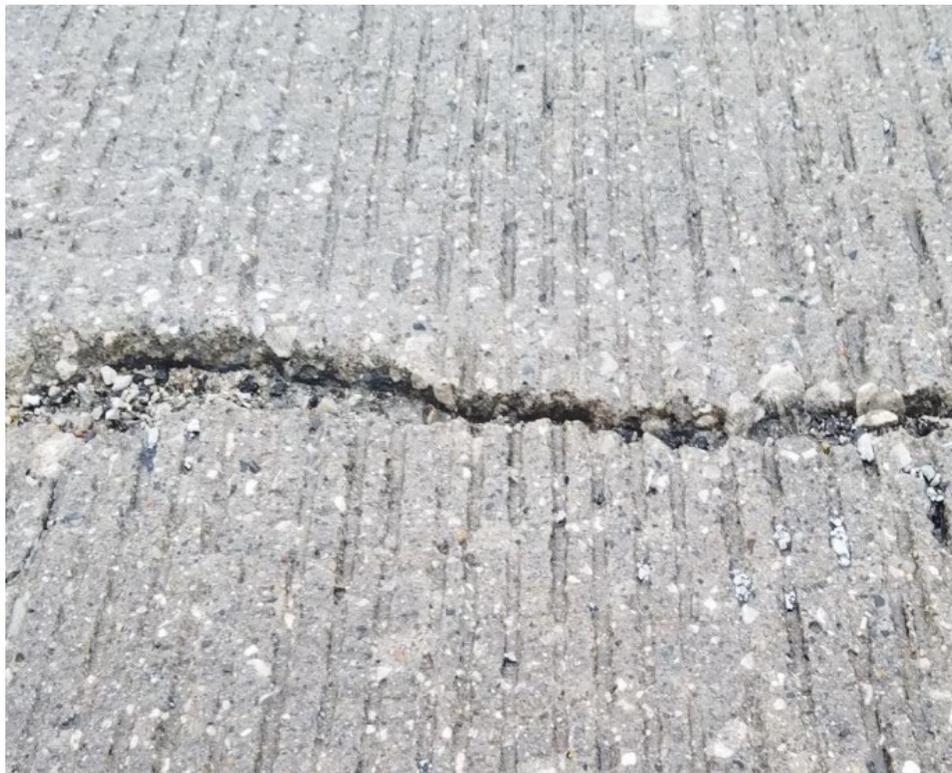
Figure 8.13 Deflection spalling of crack due to inadequate consolidation of the subgrade

Subgrade softening and base compression over time and occasional weak concrete at a joint caused by inadequate consolidation during construction can cause deflection spalling. This can sometimes occur at a construction joint if low quality PCC is used to fill in the last bit of slab volume, or if dowels are improperly aligned. See Figure 8.13.

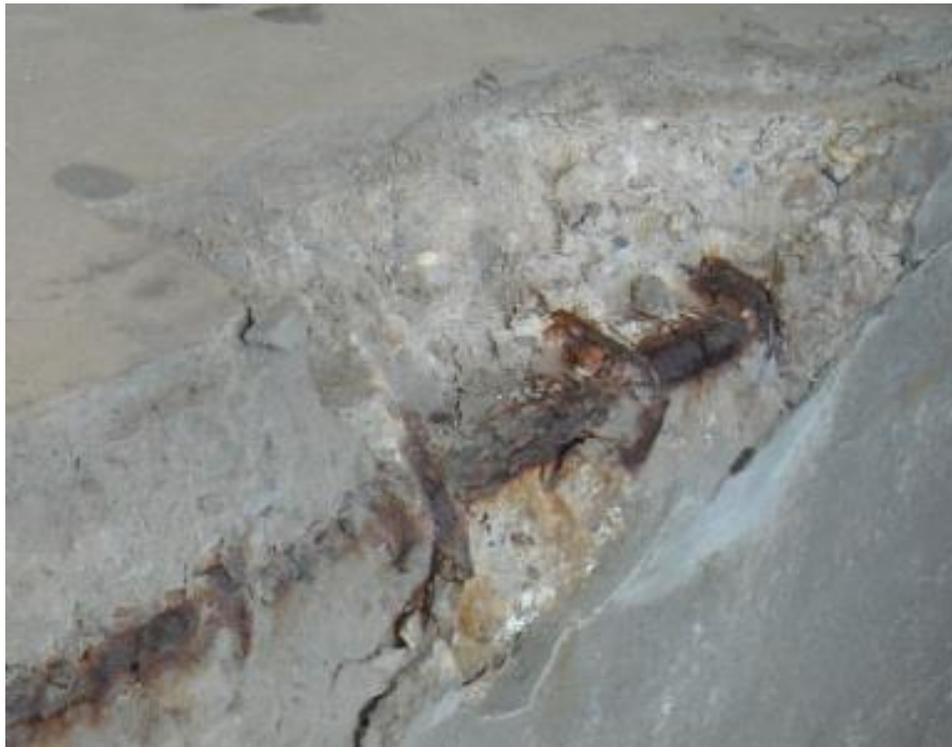
b. Close-up view of corrosion of reinforcing steel causing spalling

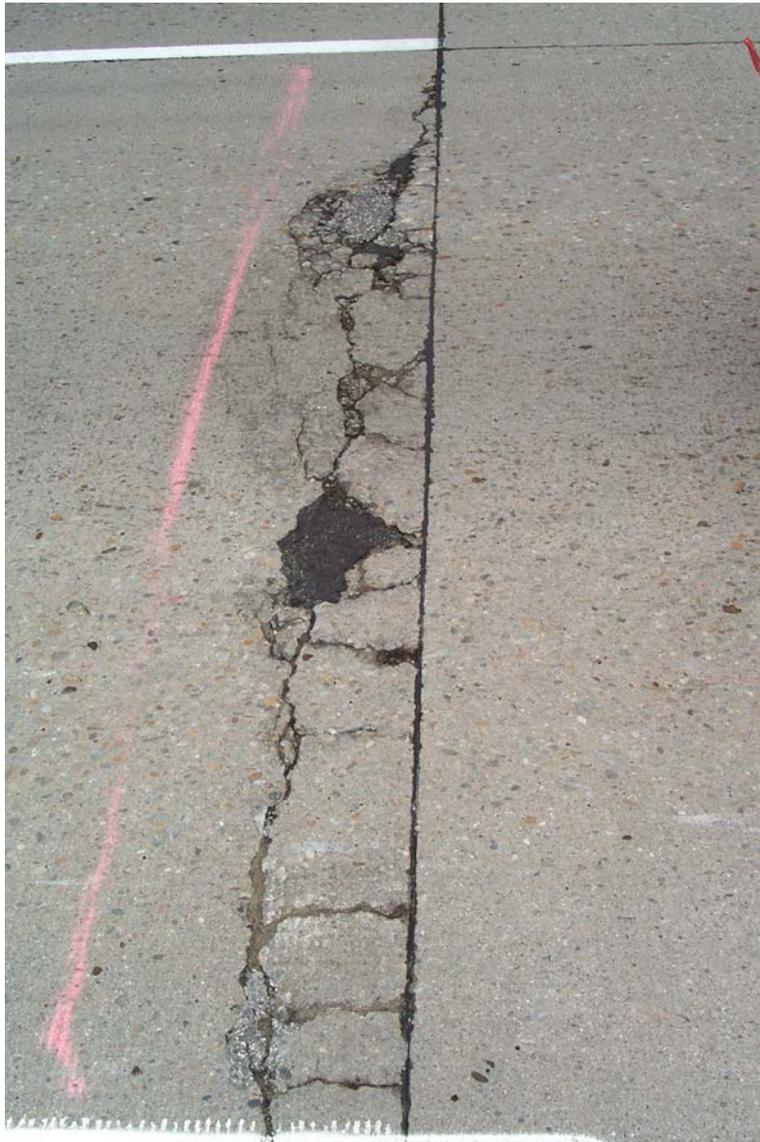
Figure 8.17 Spalling from dowel bar misalignment

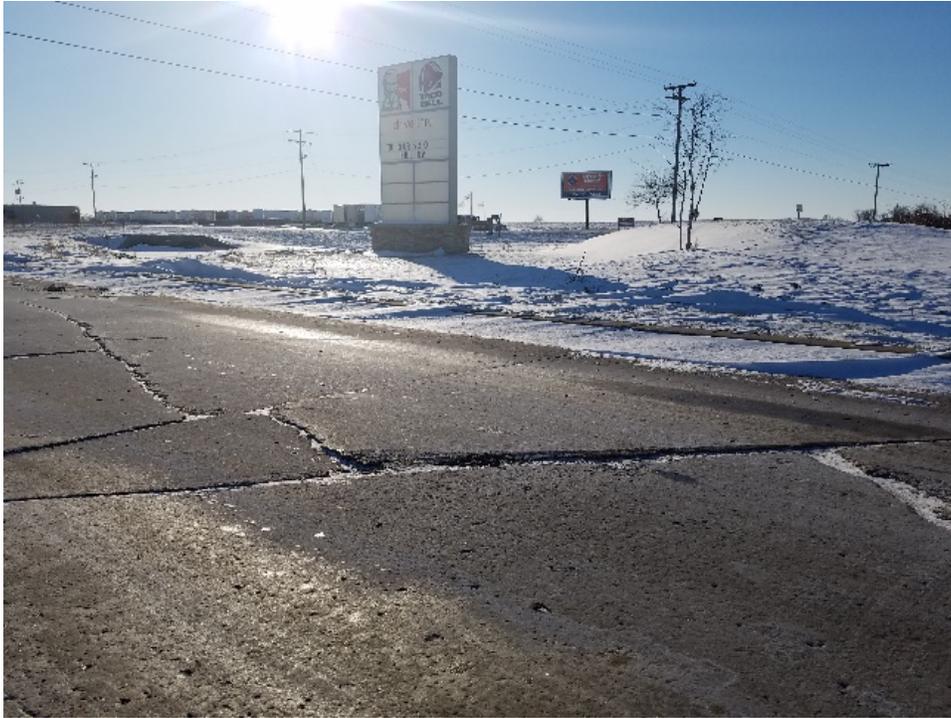
e. High severity cracking due to frost heave of the subgrade soil

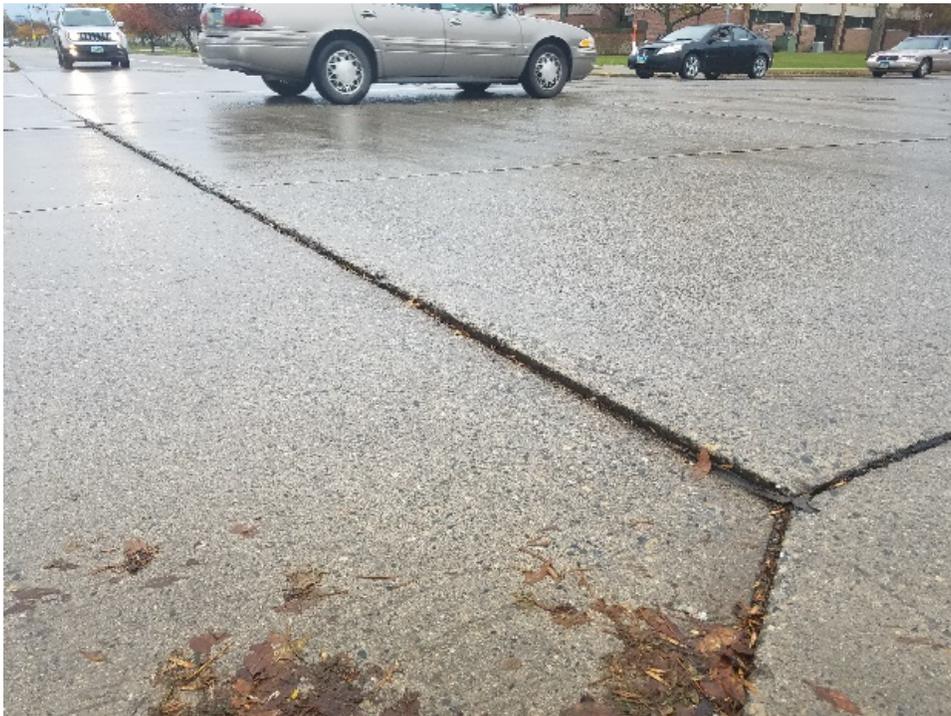
f. Settlement due to subgrade soil movement under traffic

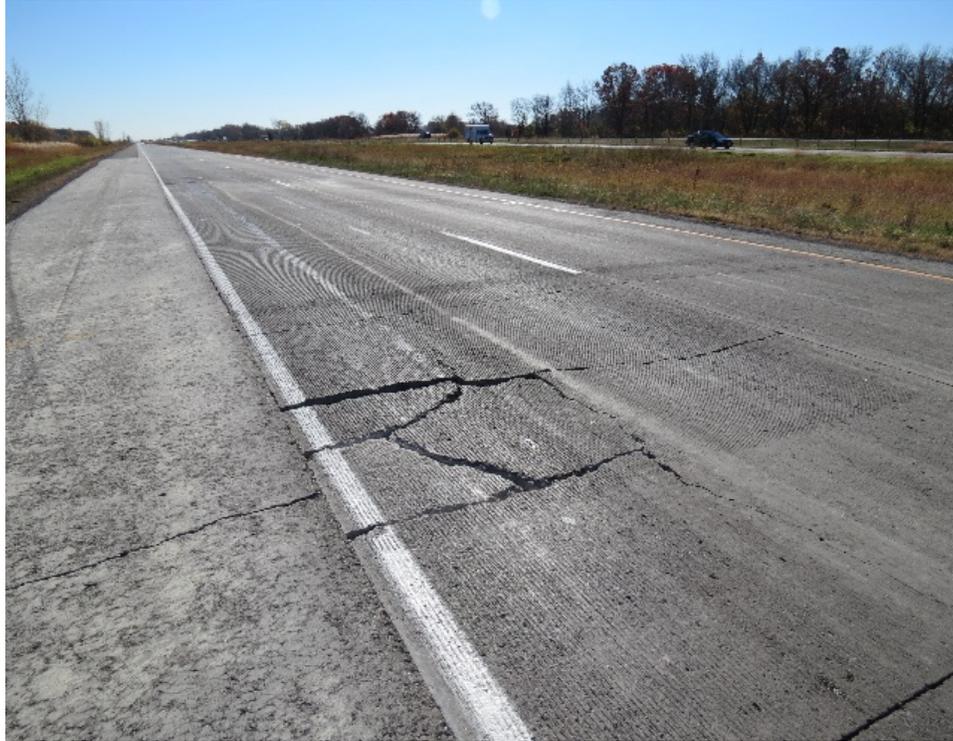
g. High severity cracking due to settlement and loss of support
Tom Burnham, Minnesota DOT

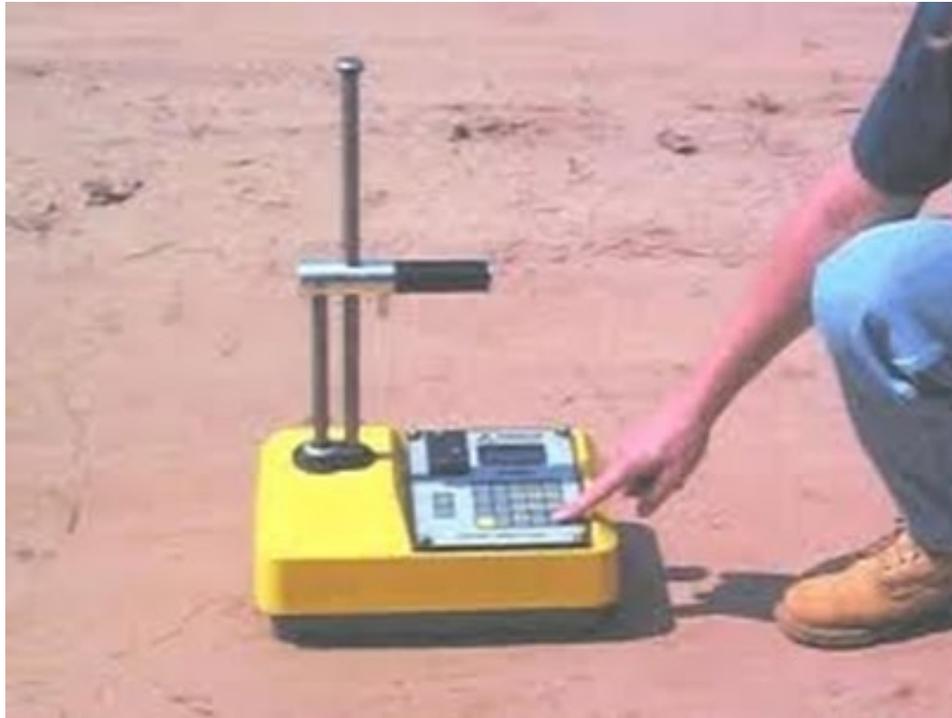
Figure 12.8 Compaction verification

a. Nuclear density gauge to determine in-place density

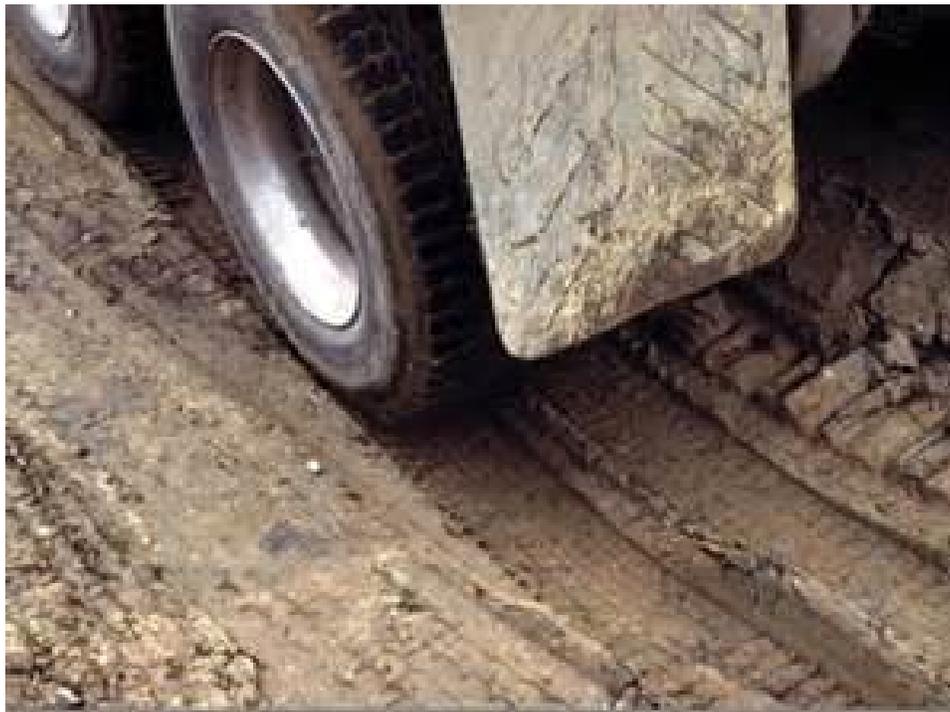
c. Proof rolling used to determine weak areas in the subgrade and/or base/subbase

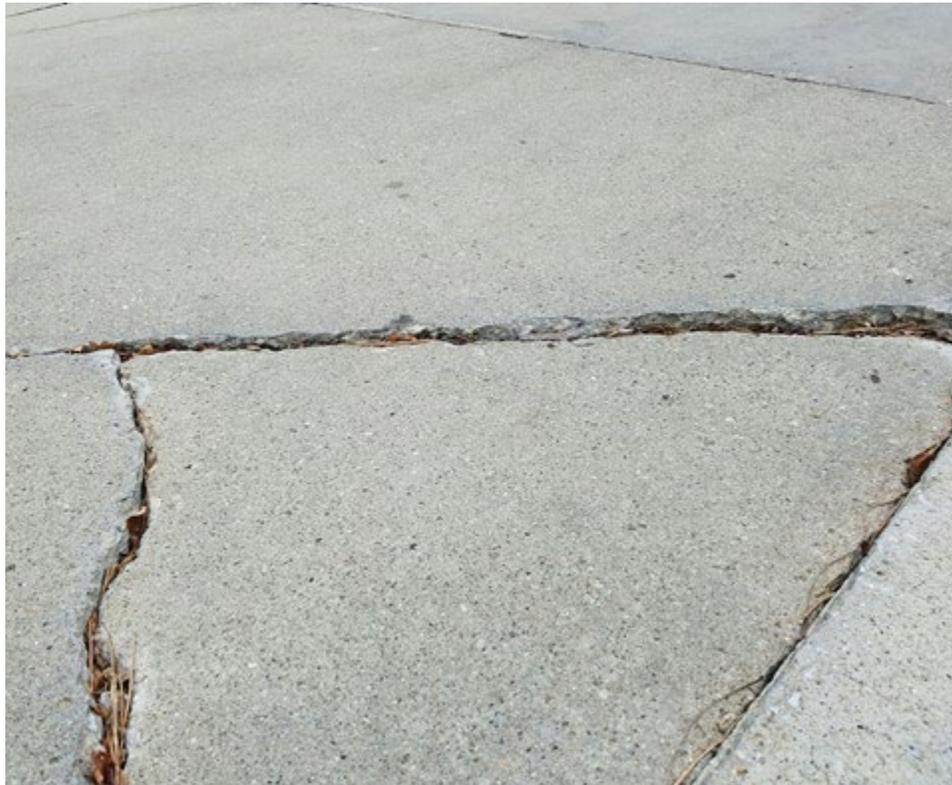
Figure 12.12 Localized settlement due to subgrade movement (consolidation)
