Concrete Pavement Distress Assessments and Solutions

IDENTIFICATION, CAUSES, PREVENTION & REPAIR

Guide for Concrete Pavement Distress Assessments and Solutions: Identification, Causes, Prevention, and Repair

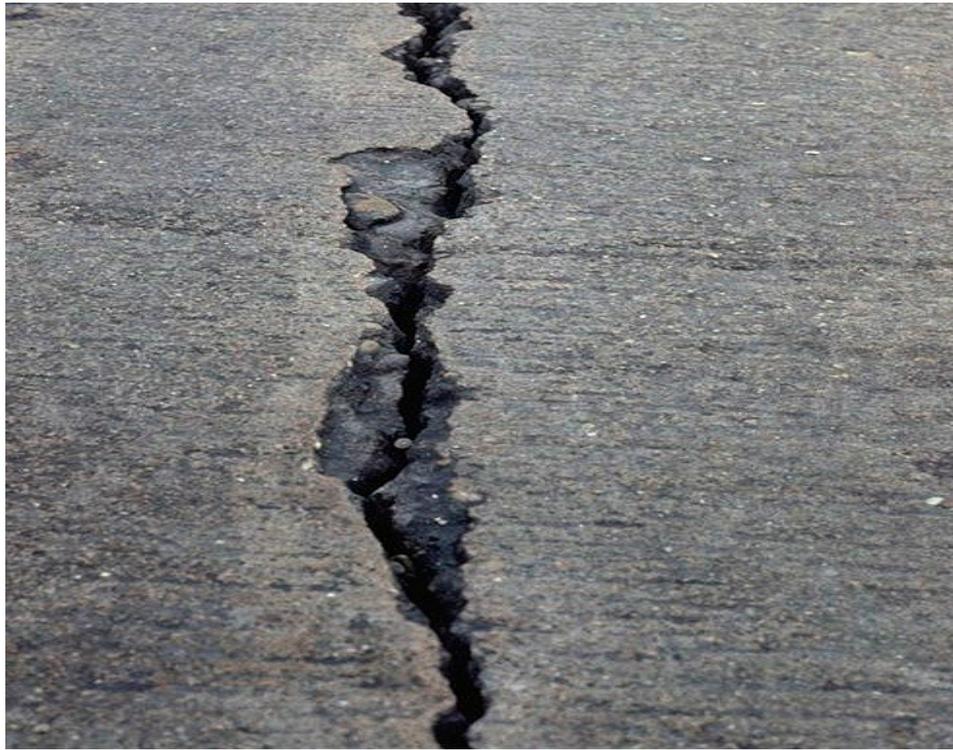
Figure 13.3 Specific CRCP distresses

a. High severity transverse cracking in CRCP

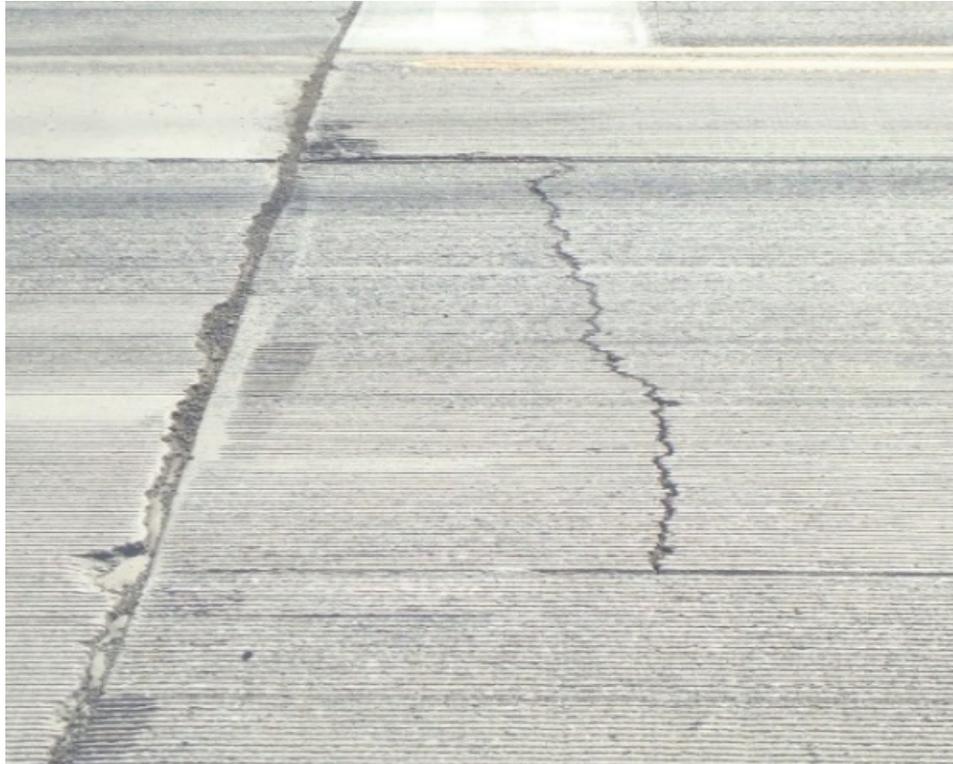
c. Reflective crack over unrepaired transverse crack near transition

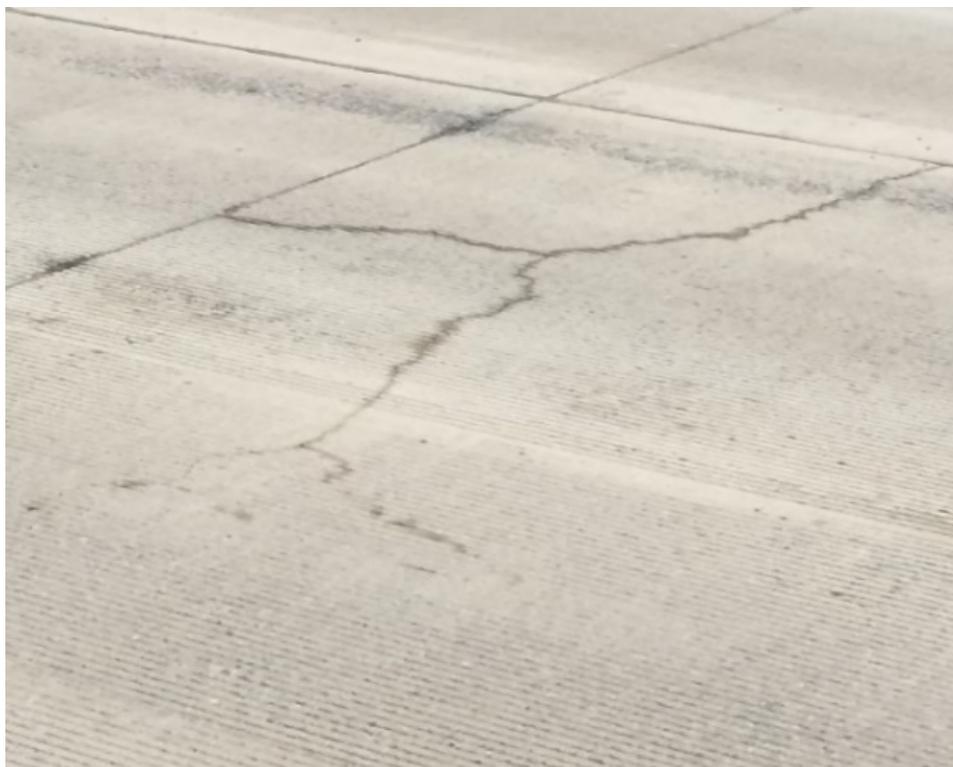
d. Multiple panel cracks near panel end due to debonding

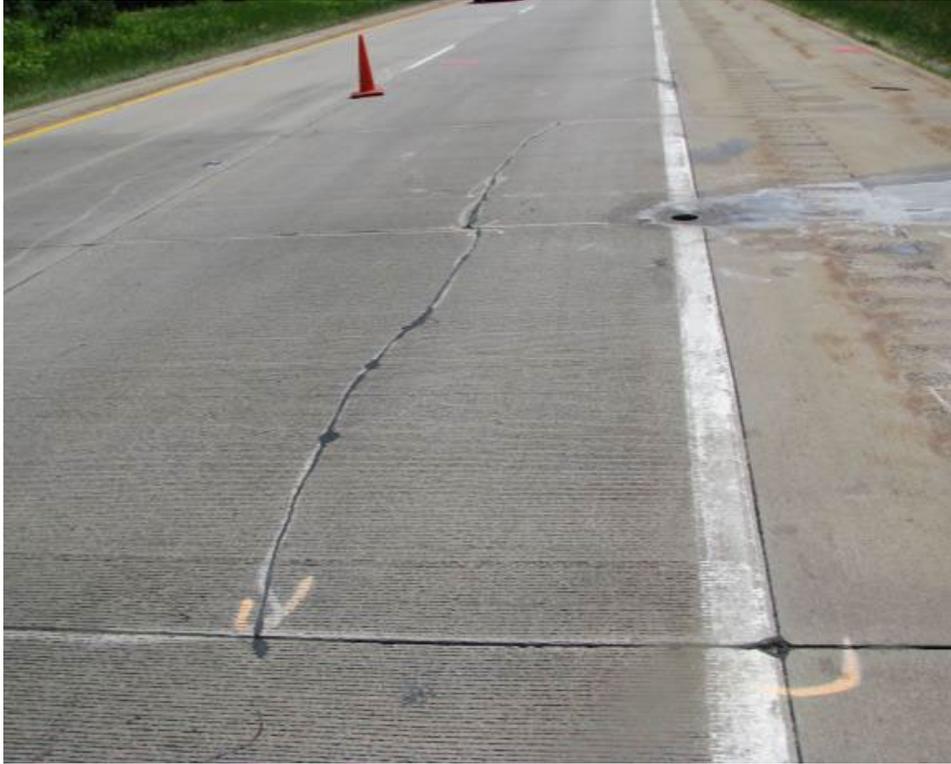
e. Longitudinal crack due to overlay fatigue after debonding

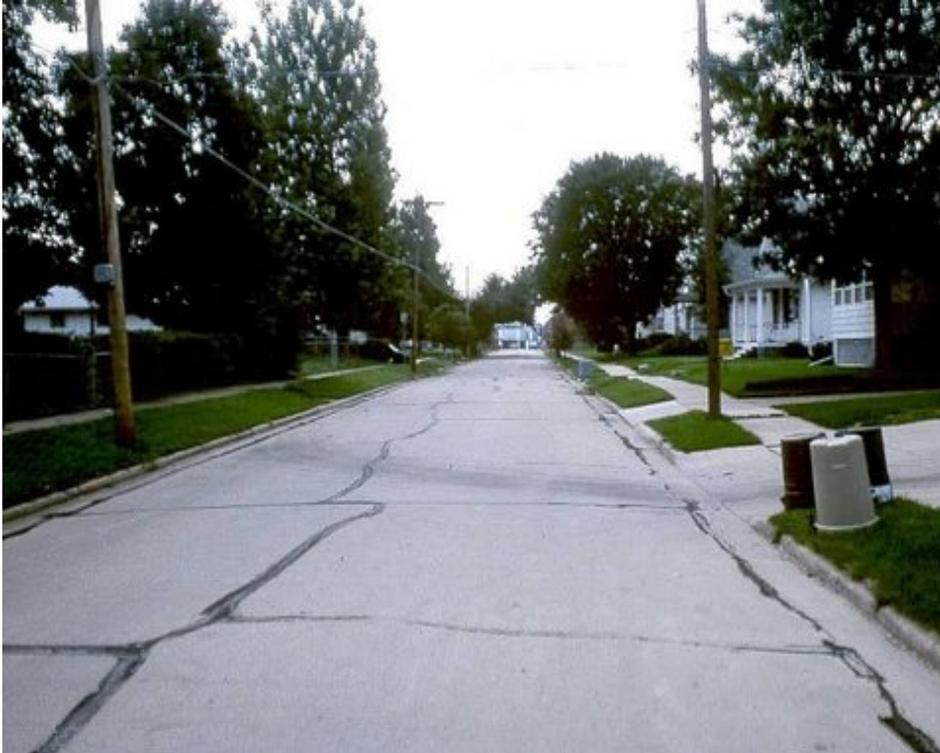
f. Reflective transverse and longitudinal cracking due to no placement of overlay joints

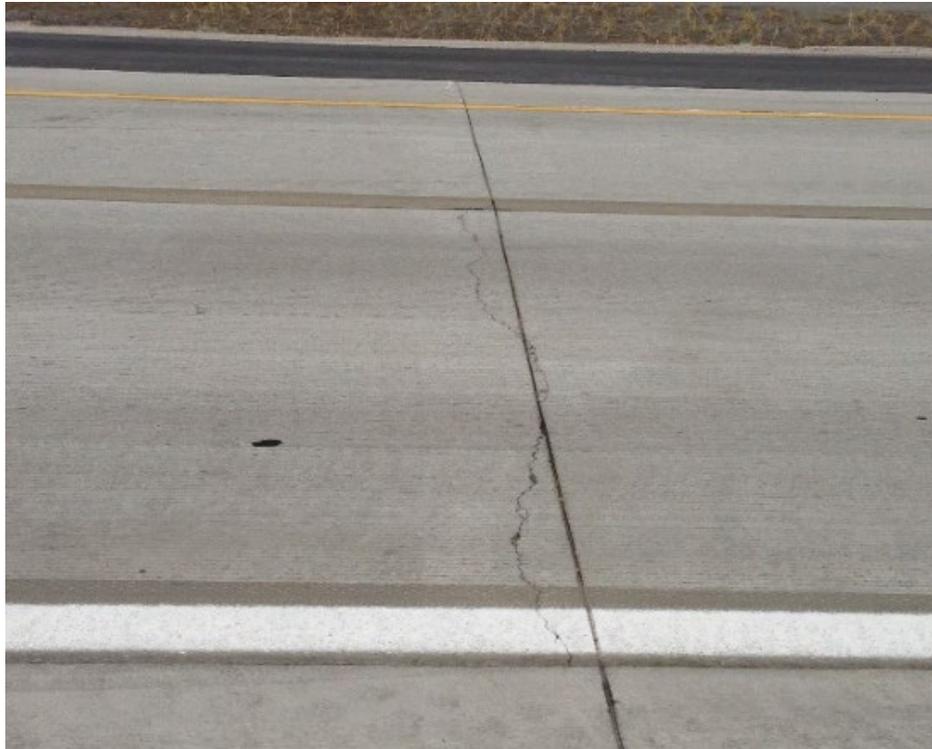
g. Joint spalling, possibly due to late sawing or saw cut not directly over existing pavement joint/crack
Todd LaTorella, Missouri/Kansas Chapter, American Concrete Pavement Association

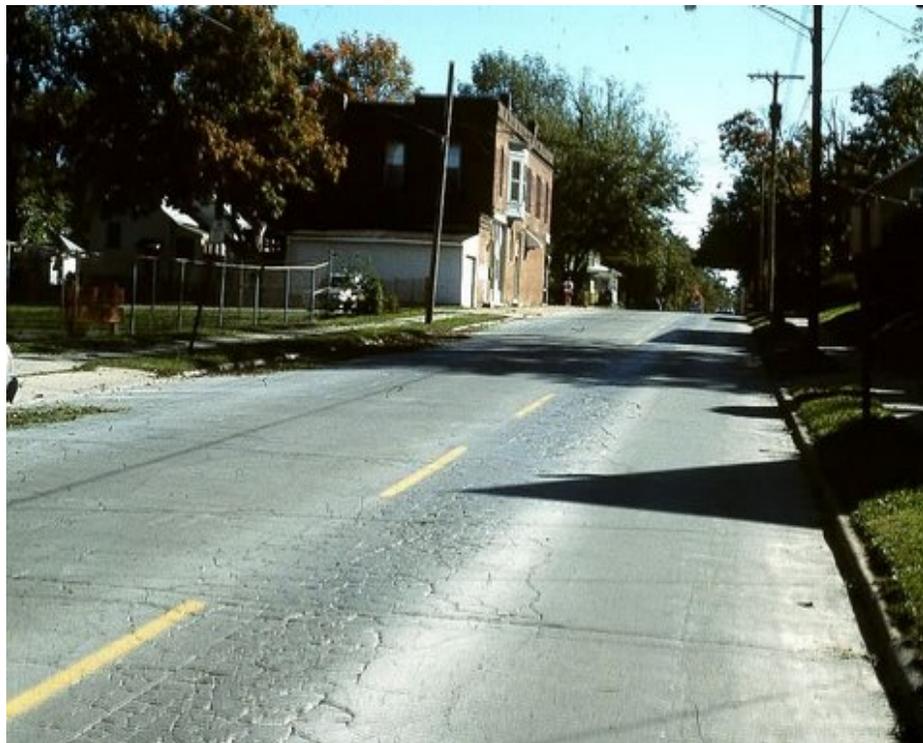
h. Longitudinal wheel path cracking due to debonding and fatigue cracking of overlay
Randy Riley, Illinois Chapter, Inc. – American Concrete Pavement Association

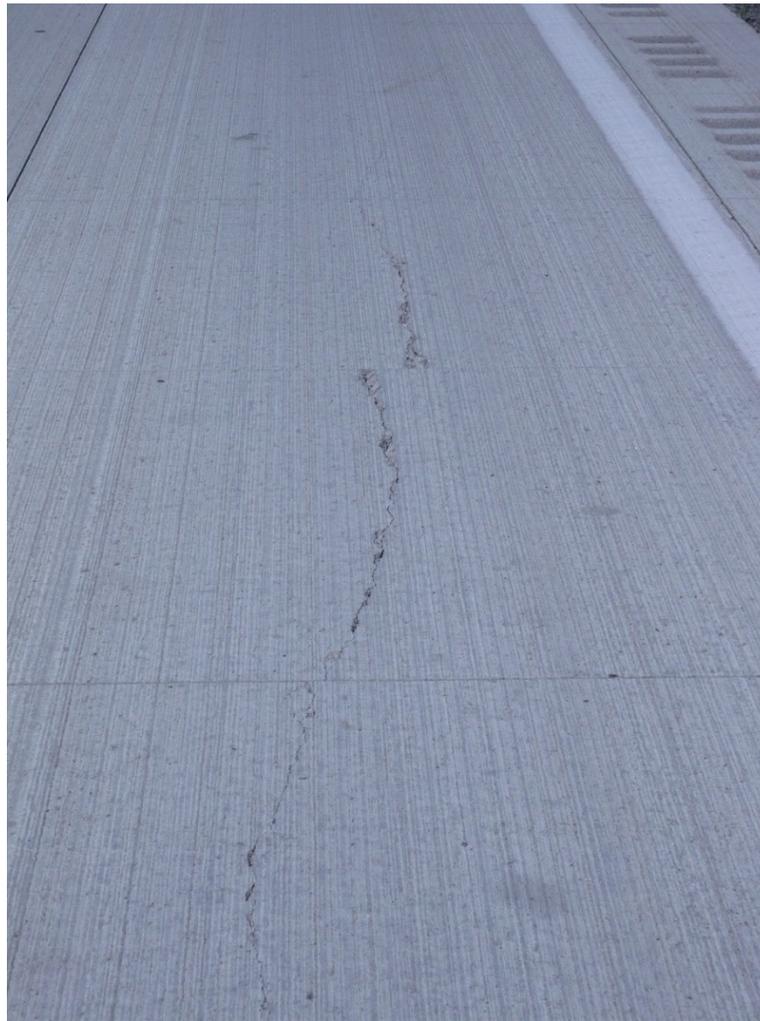
Figure 17.7 Erosion of asphalt due to water intrusion, causing a longitudinal crack in the wheel path of a UBCOA

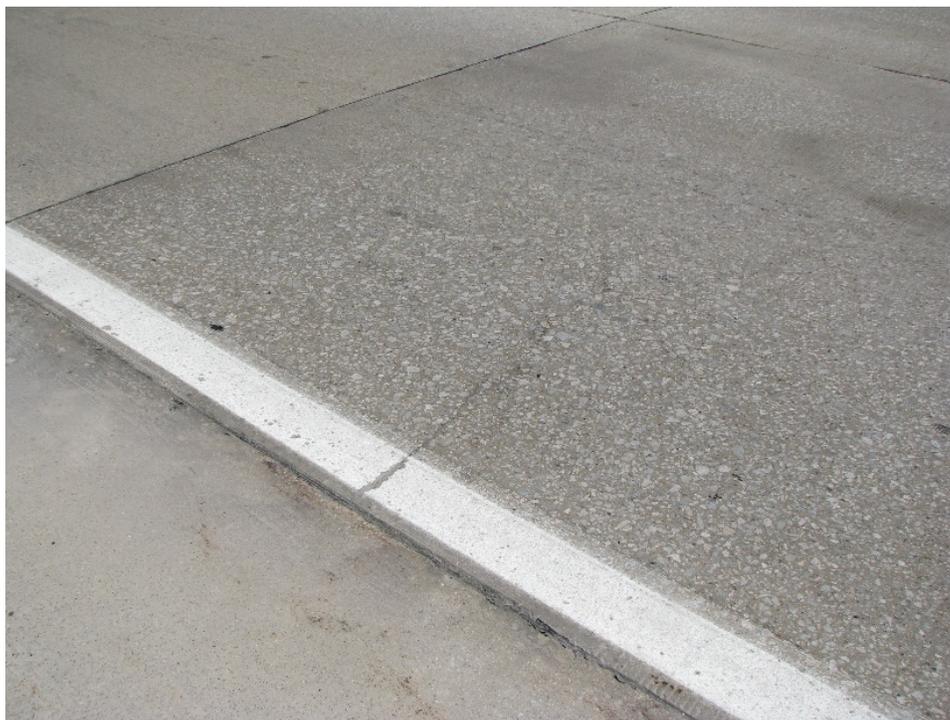
Figure 17.8 Corner cracking of UBCOA

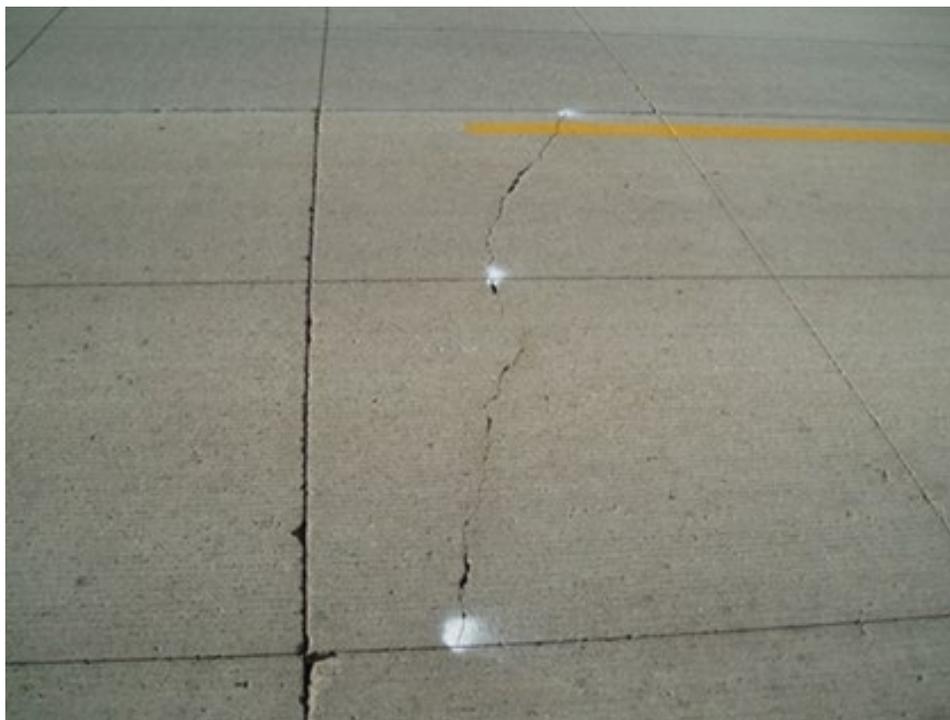
Figure 17.9 Mid-panel cracking due to inadequate support from the underlying HMA

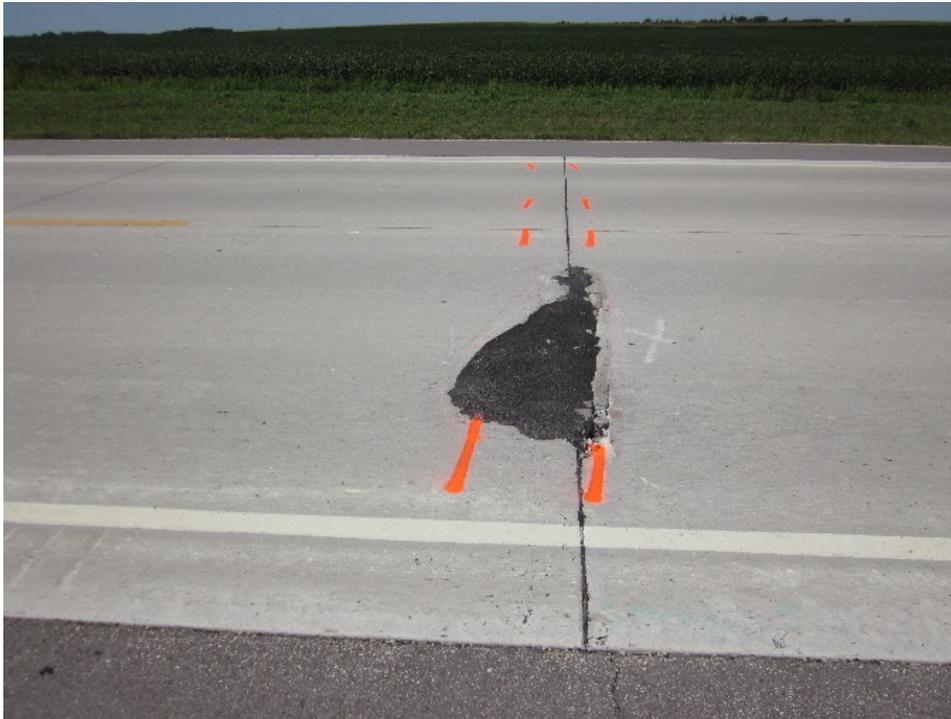
Figure 17.10 Transverse cracking due to misaligned dowels*

*The patch and the orange pavement marking (from ground penetrating radar (GPR)) clearly shows the distress occurring where the dowel bar basket moved outside the joint proper.

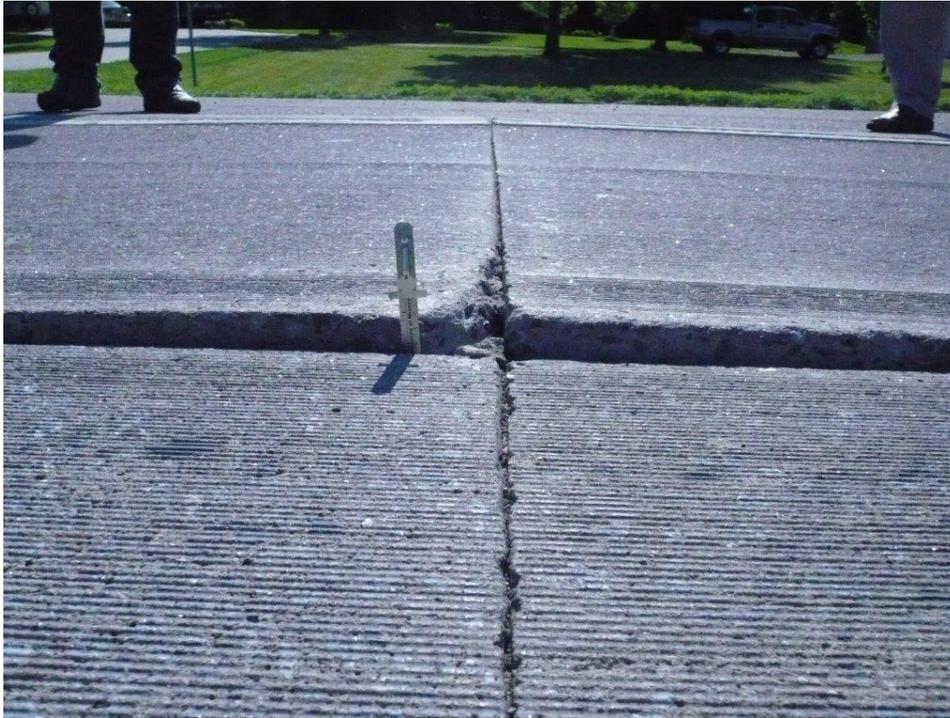
Figure 17.12 Blowup of a UBCOA

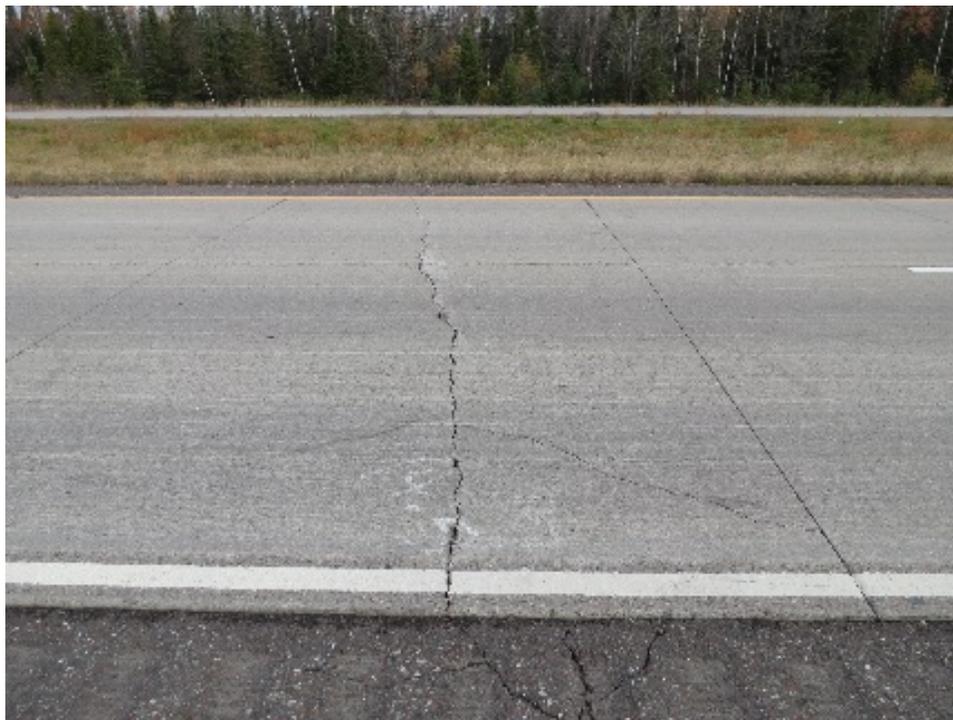
d. Transverse reflective cracking of UBCOC

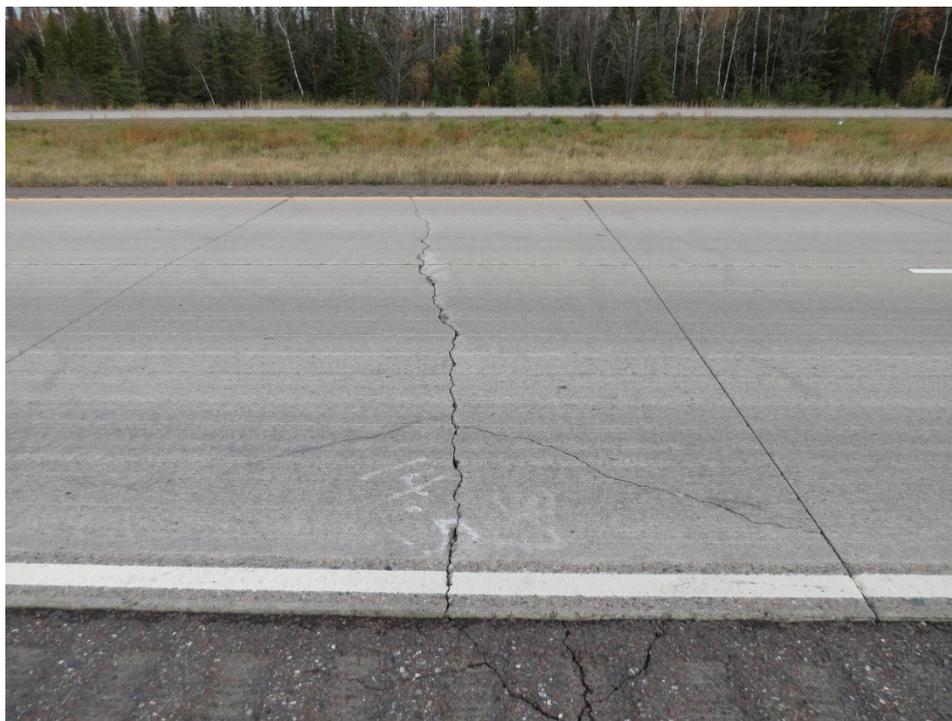
Figure 18.7 Transverse reflective cracking of UBCOC

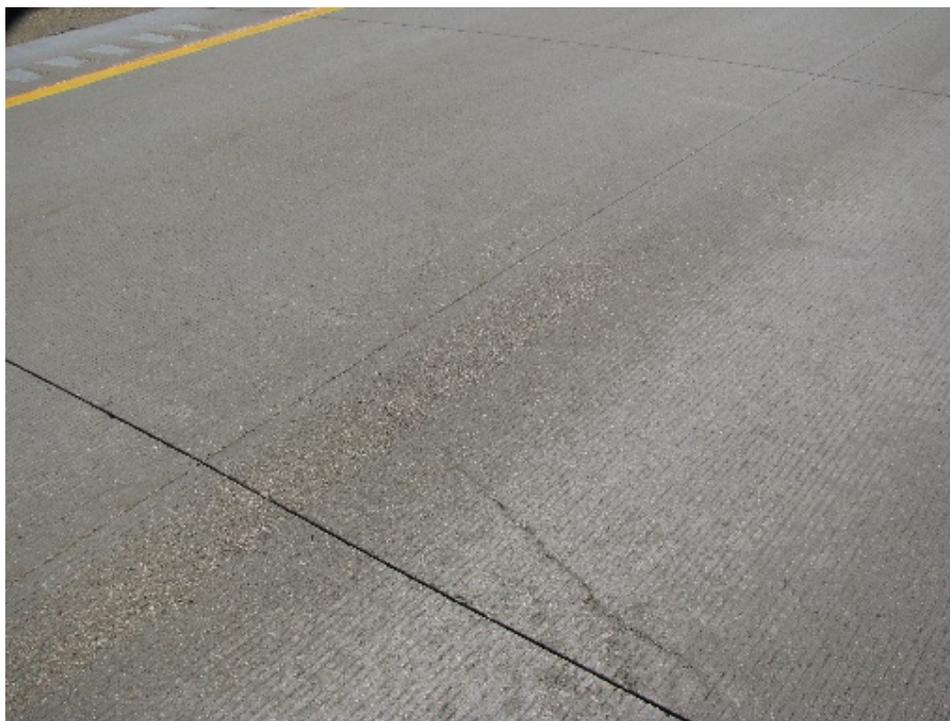
Figure 18.8 Irregular reflective cracking due to wrinkled geotextile separation layer

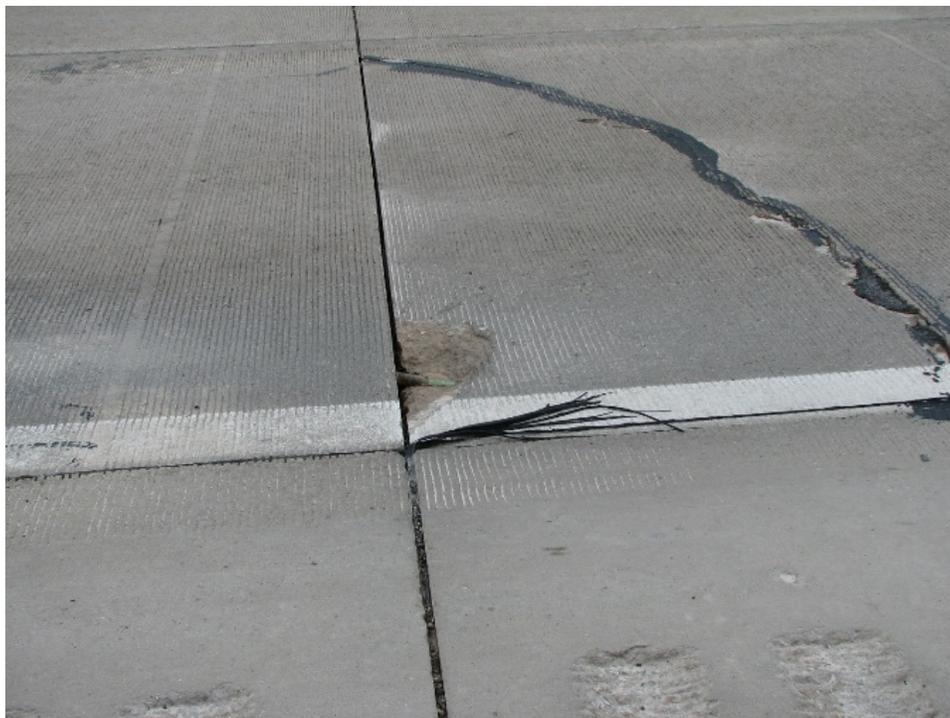
Figure 18.11 Transverse cracking due to misaligned dowels

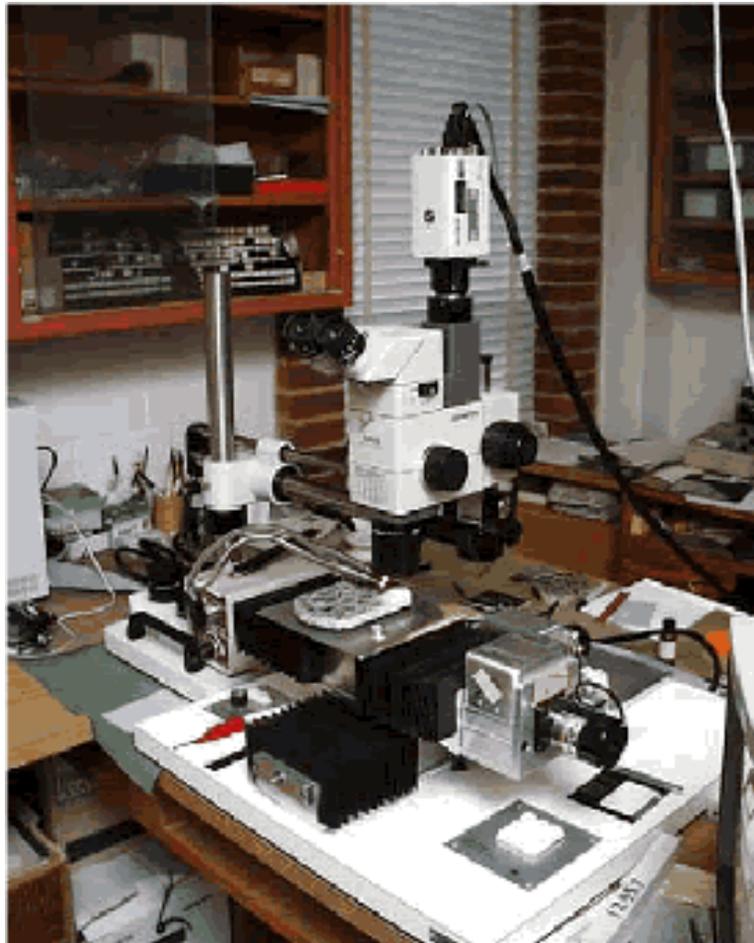
Figure 19.23 Air void testing apparatus
