# Increase Service Life at Bridge Ends through Improved Abutment and Approach Slab Details and Water Management Practices

**Final Report  
October 2023**

**Sponsored by**  
Iowa Highway Research Board  
(IHRB Projects TR-722 and TR-739)  
Iowa Department of Transportation  
(InTrans Projects 17-605 and 17-637)

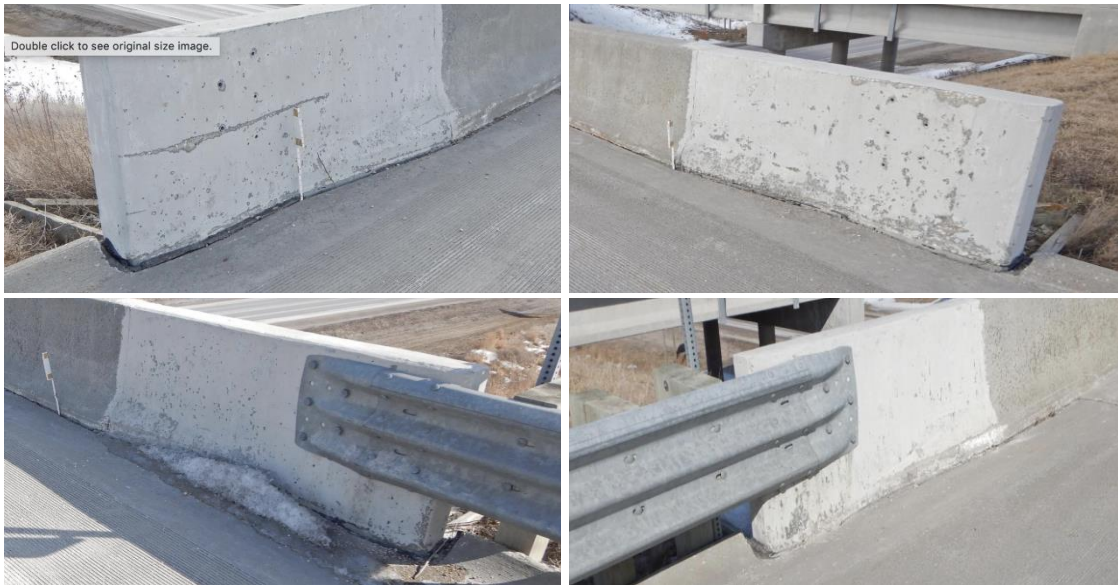
**Figure 2.41. Bridge inspection photographs—barriers**

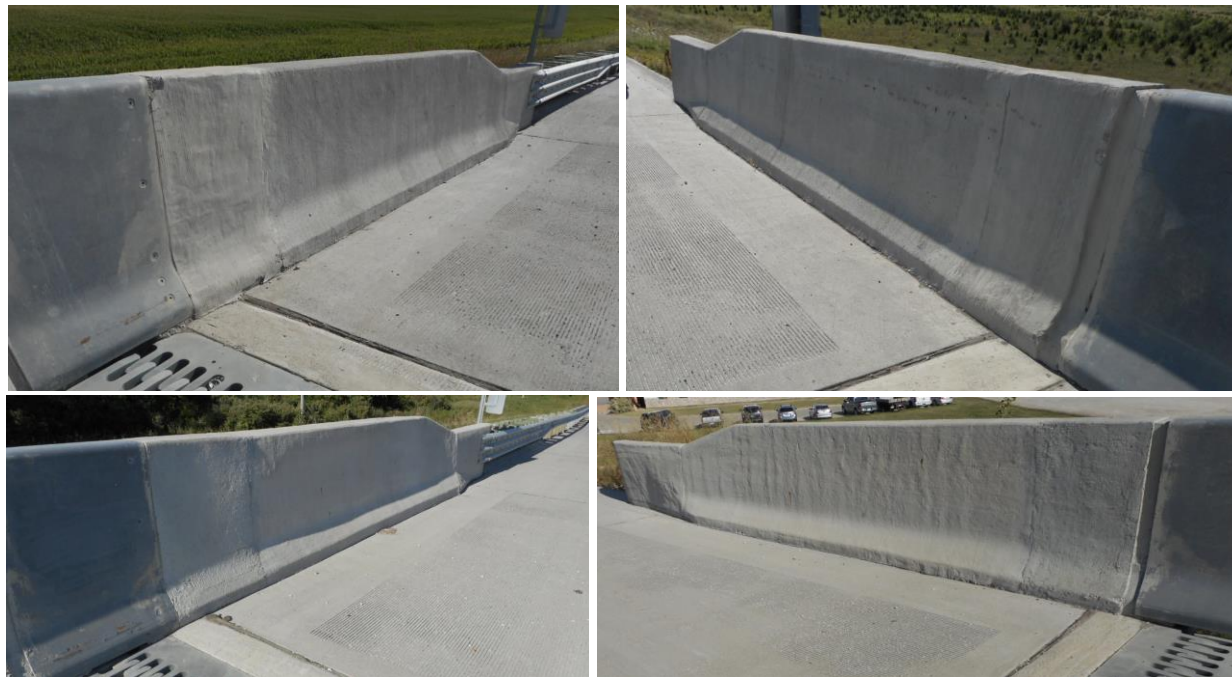
finger joint bridge, the barriers all look good, and there are no signs of settlement or cracking. The finger joint, as stated earlier, appears to be in good condition, and the inspection sheets provide no comments indicating otherwise. No photographs of the approach slab were provided, so we assumed that there is no transverse cracking or other issues with the approach.

**Figure 2.47. Bridge inspection photographs**

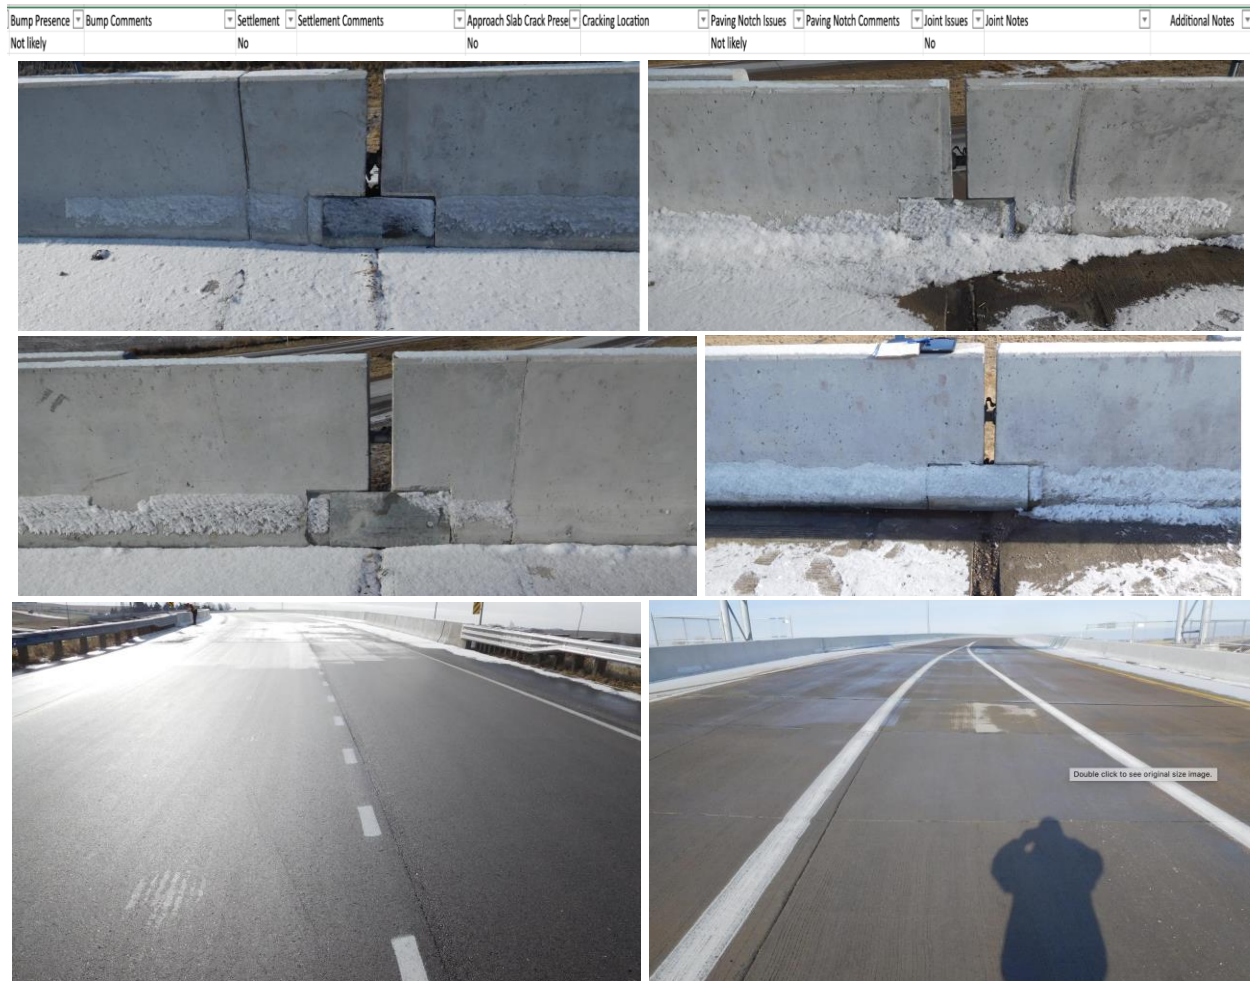
For the strip seal bridge, we carried out the same process of looking at photographs and the inspection sheets in order to determine whether any issues are present on the bridge (Figure 2.49). Looking at the barriers, there is no clear sign of cracking or settlement. As stated earlier, the joint appears to be in good condition, and there are no signs of cracking at the abutment. The inspection sheets confirm this good condition. The approach slabs show no signs of transverse cracking. Note that this bridge is a good example of an instance when we could not get entirely clear information from the photographs. The barriers in this example are covered in snow, and there were no past reports available.

**Figure 2.49. Bridge issues table and bridge inspection photographs**

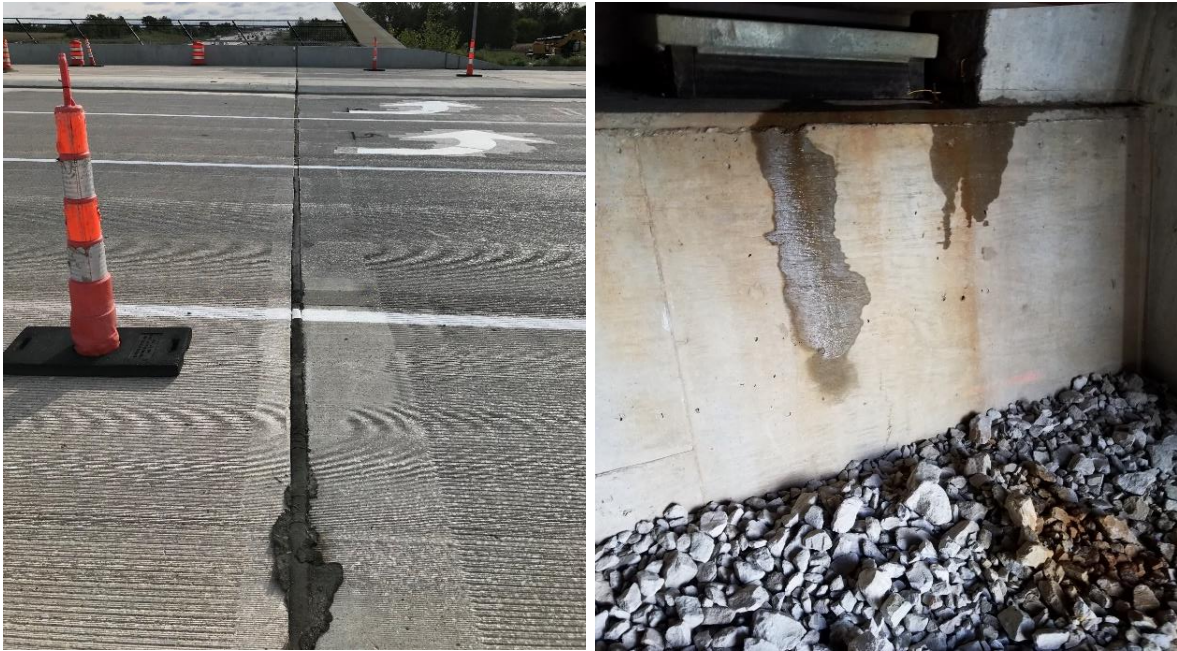
the joint. The south embankment appeared to be in adequate condition apart from a large void at the southwest corner of the bridge at the end of the wingwall. The void measured 22 in. deep and was estimated to be about 2 ft square in size. The embankment was not landscaped due to the interchange project and earthwork under construction, so it was unclear if that was a reason for the area not being filled with soil or if it was created by erosion.

**Figure 3.1. South bridge-deck-to-approach-slab joint with excess sealant (left) and water and abutment staining at the outermost girder (right)**

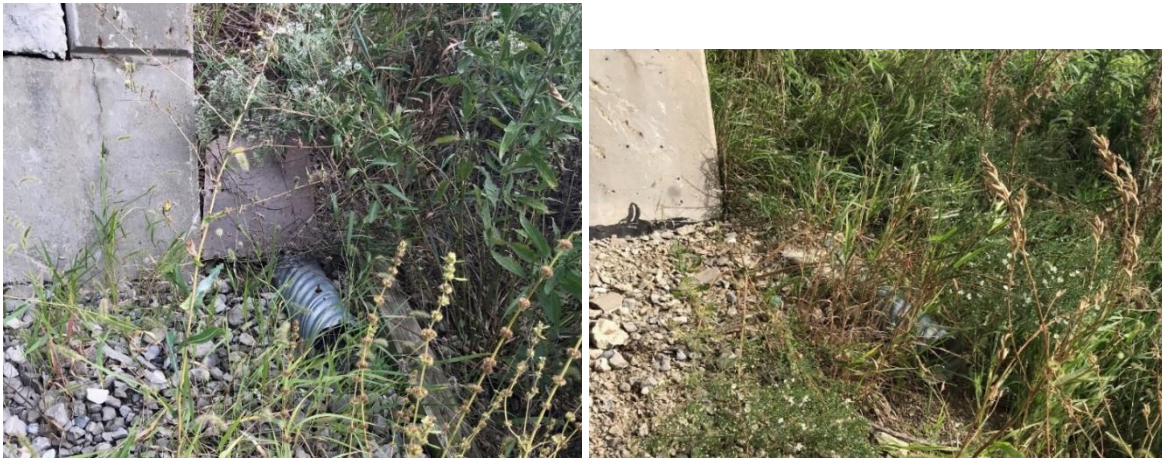
were very close to becoming blocked, with debris piling up at the outlet and the northwest drain completely closed (Figure 3.9). In areas with pavement shoulders, there was visible settlement relative to the concrete panels.

**Figure 3.9. Blocked embankment drainage (left) and additional blocked embankment drainage (right)**

Abutment drainage was largely free of debris and able to drain water from behind the abutments should it infiltrate the deck joints. A single bridge, 310 Jasper Southbound, had drain exits for which the openings were very close to becoming blocked, with debris piling up at the outlet and the northwest drain completely closed.

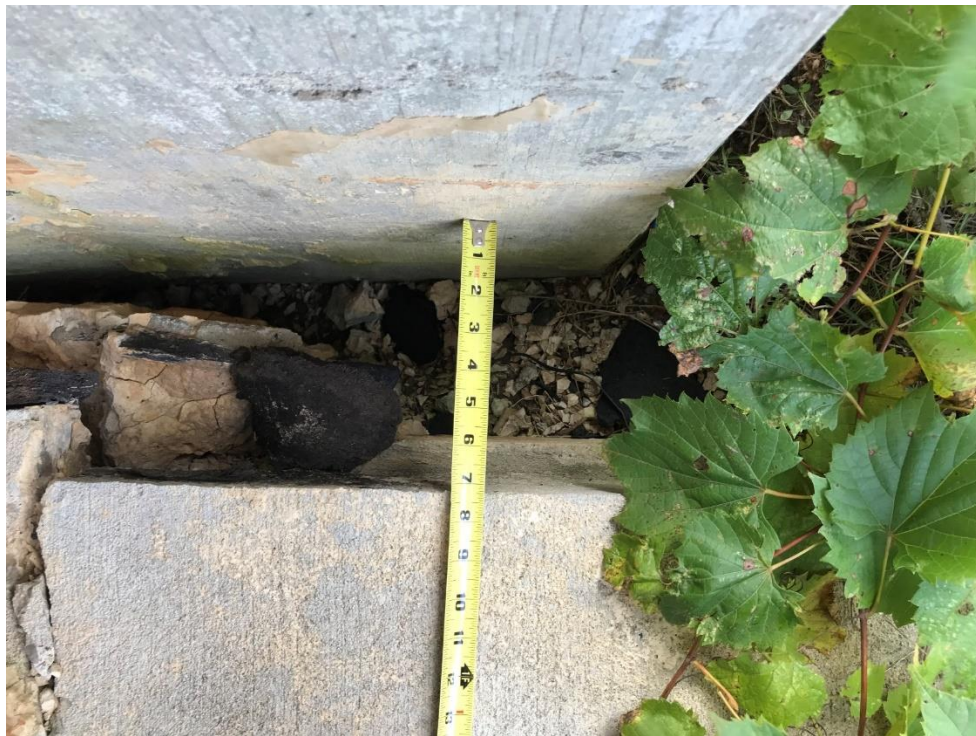
At the west corner of the south abutment, there was a large void at the corner of the abutment that measured 23 in. deep (Figure 3.12, Figure 3.13). The end of the tape measure used to assess the void was able to hook onto the underside of the concrete abutment.

**Figure 3.12. Horizontal void created by the embankment pulling away from the abutment**

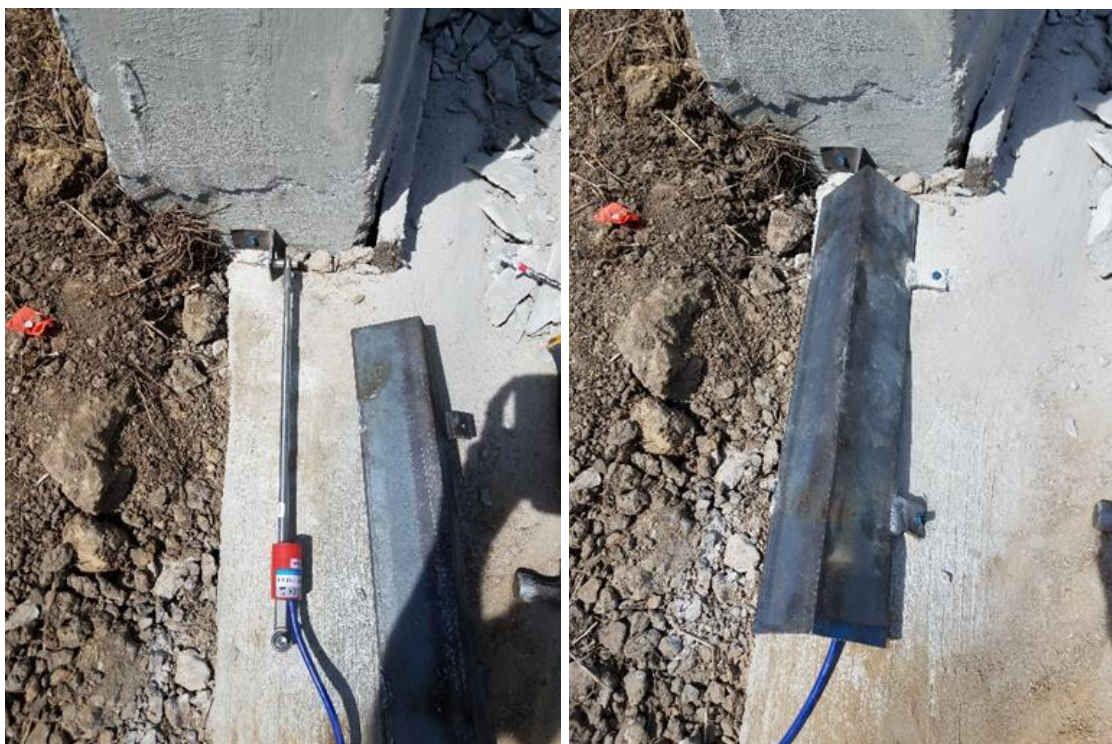
Crackmeters were installed at the approach slab surface with the approval of the Iowa DOT, and protective covers were fabricated using a steel angle to prevent damage by snowplows (Figure 4.6). Since the crackmeters were placed under the barrier, they would not be hit by traffic or snowplows. Crackmeters were installed per the Geokon manual and set at 25% of maximum extension. Since installation occurred in the summer, it was anticipated that the bridge would experience almost entirely contraction, thus opening the joints between the abutment and approach slabs.

**Figure 4.6. Jasper County 118—crackmeter without protective cover (left) and crackmeter with protective cover installed (right)**

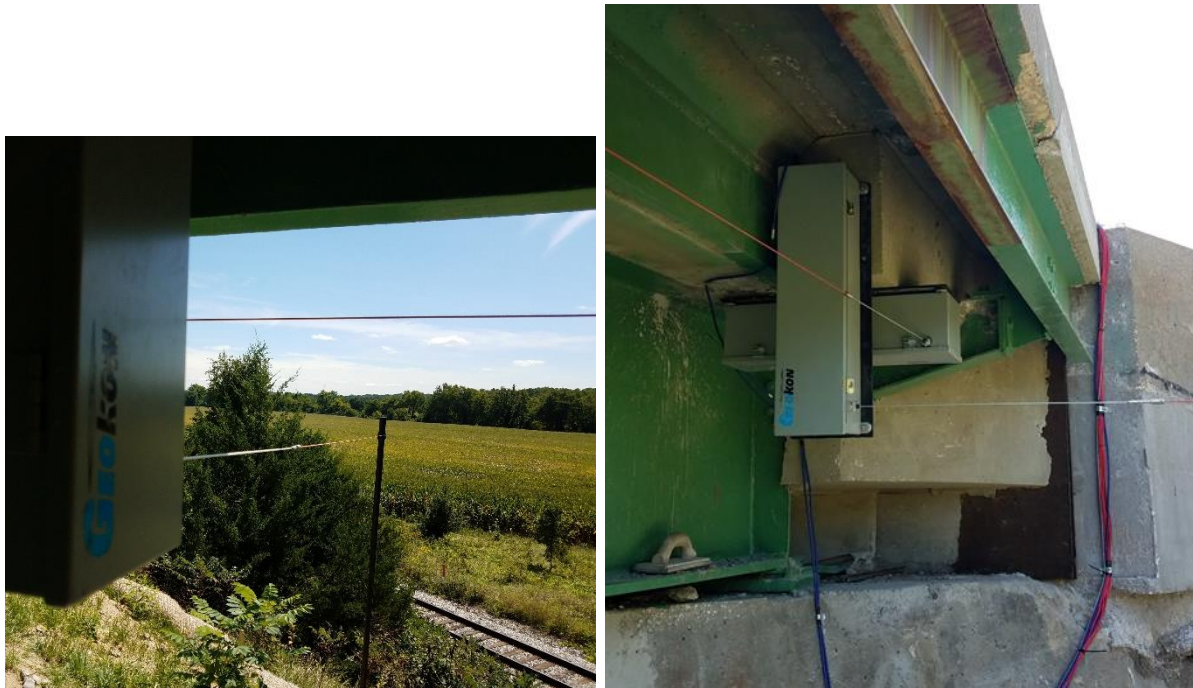
Since Jasper County 118 was only being partially reconstructed with no effect on the substructure, it was determined that a reference post should yield satisfactory results. During construction, a layer of embankment was removed and replaced to improve erosion protection, but the depth was limited. The method used a 1 1/2 in. steel pipe driven 5 ft into the ground to reach frost depth and act as a reference post (Figure 4.7, left). The Geokon 4427 sensor was attached to the bridge abutment using concrete screws and a coupler attached to a cable that spanned the distance to the reference post. At each acute bridge corner, two displacement meters measure in orthogonal directions to measure longitudinal and transverse displacement (Figure 4.7, right).

**Figure 4.7. Jasper County 118—displacement transducer with reference post (left) and longitudinal and transverse displacement transducers attached at the acute bridge corner (right)**

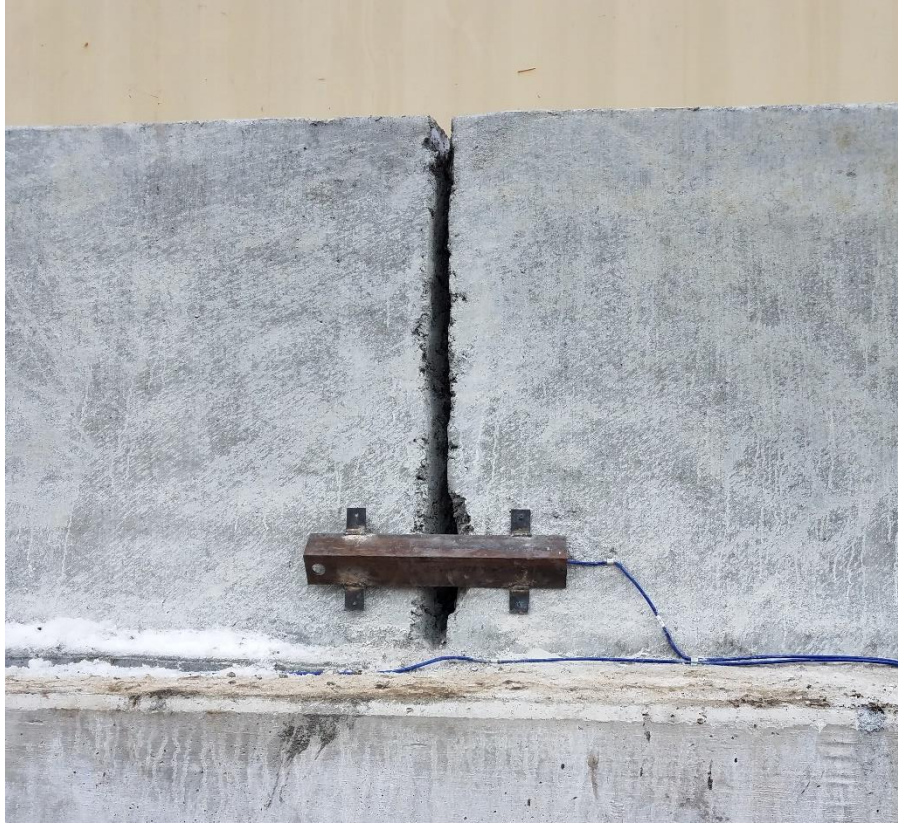
**Figure 4.27. Story County 118—crackmeter installation across the barrier rail joint**

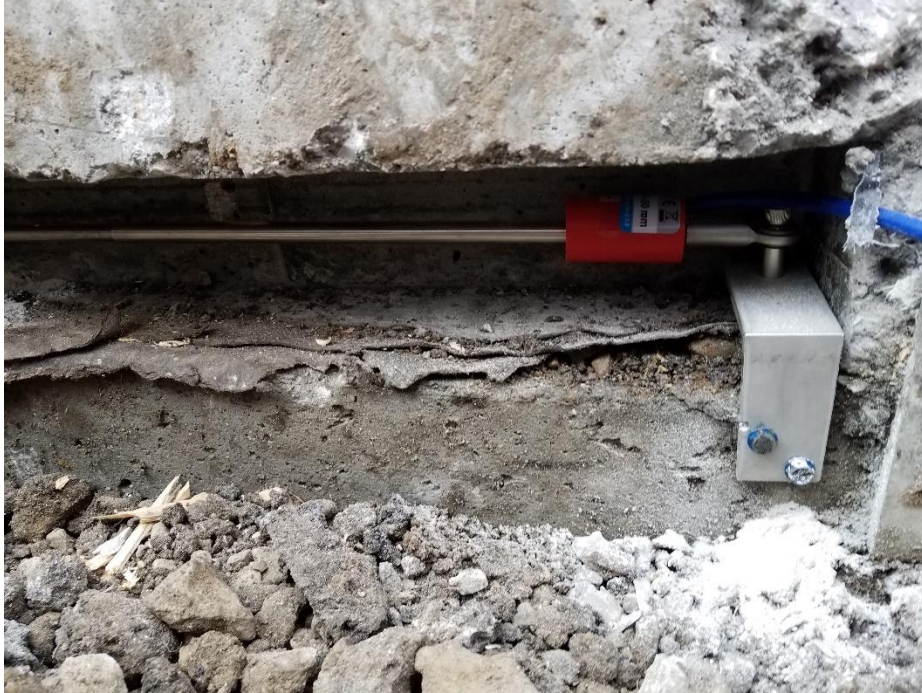
**Figure 4.28. Story County 118—crackmeter approach slab side blackout location**

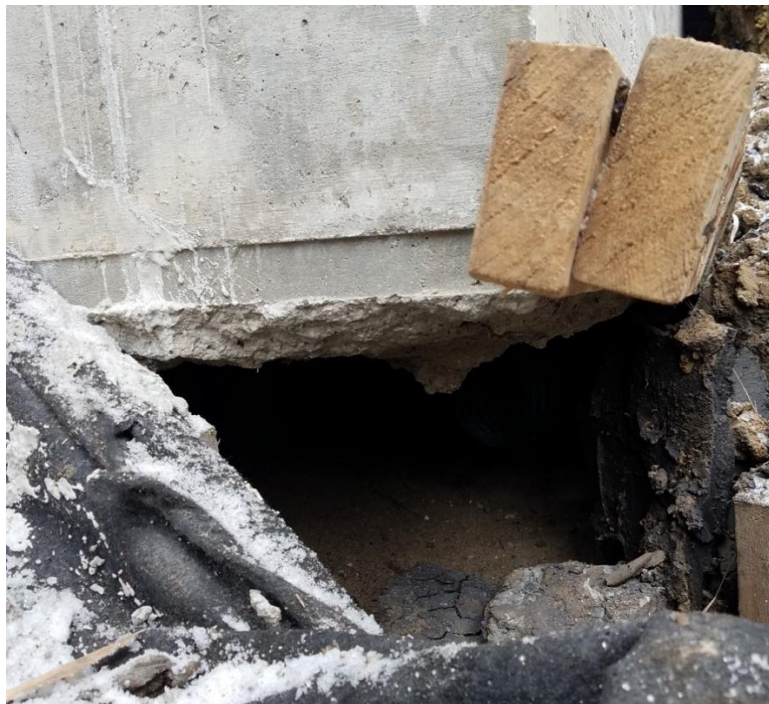
**Figure 4.44. Story County 118—large void under the south abutment corner**

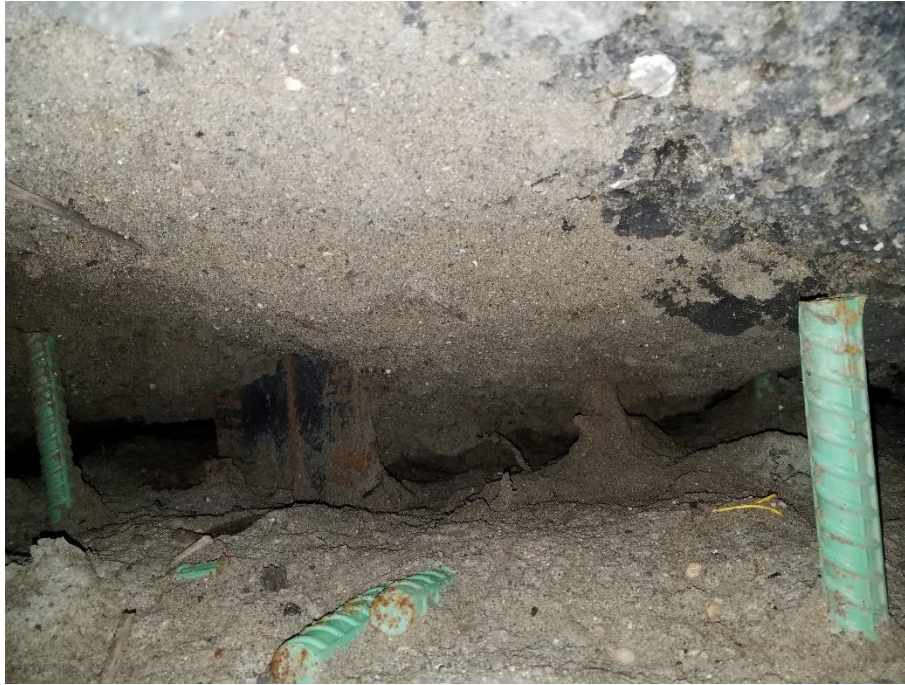
**Figure 4.45. Story County 118—visible exposed rebar and foundation pile**

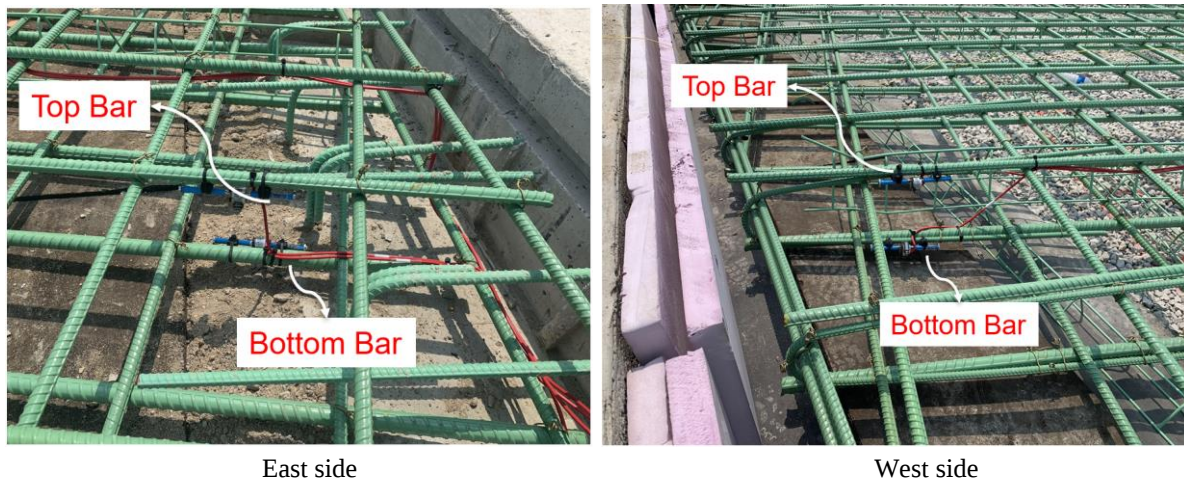
**Figure 4.64. Butler County 118—strain gauges installed on the longitudinal rebar**
