Assessment, Repair, and Replacement of Bridges Subjected to Fire

**Final Report
August 2022**

IOWA STATE UNIVERSITY
Institute for Transportation

Sponsored by
Iowa Department of Transportation
(InTrans Project 20-734)
Federal Highway Administration

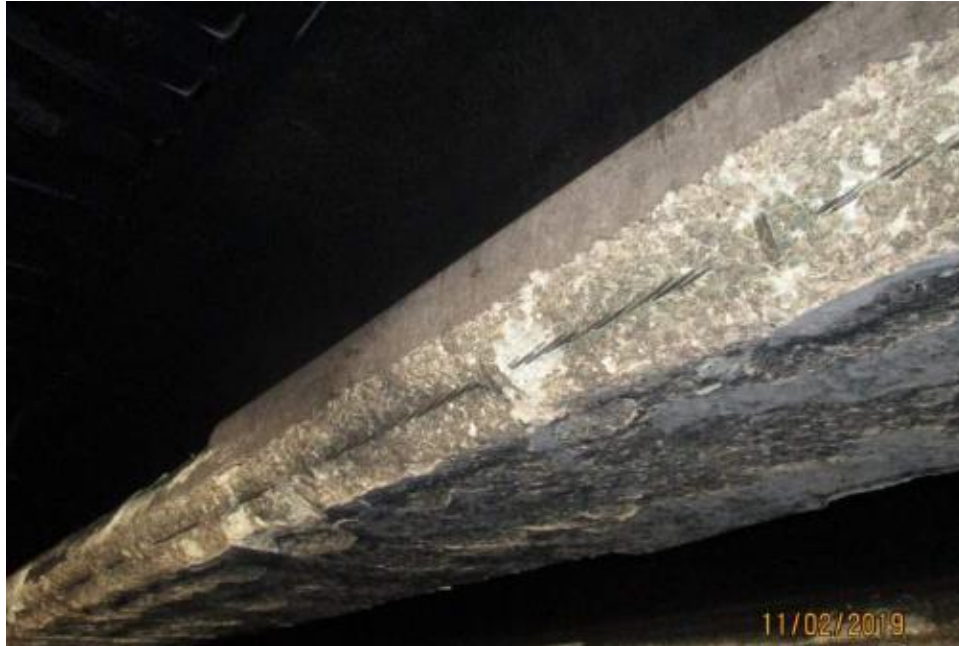
Figure 2. Concrete spalling on concrete girder

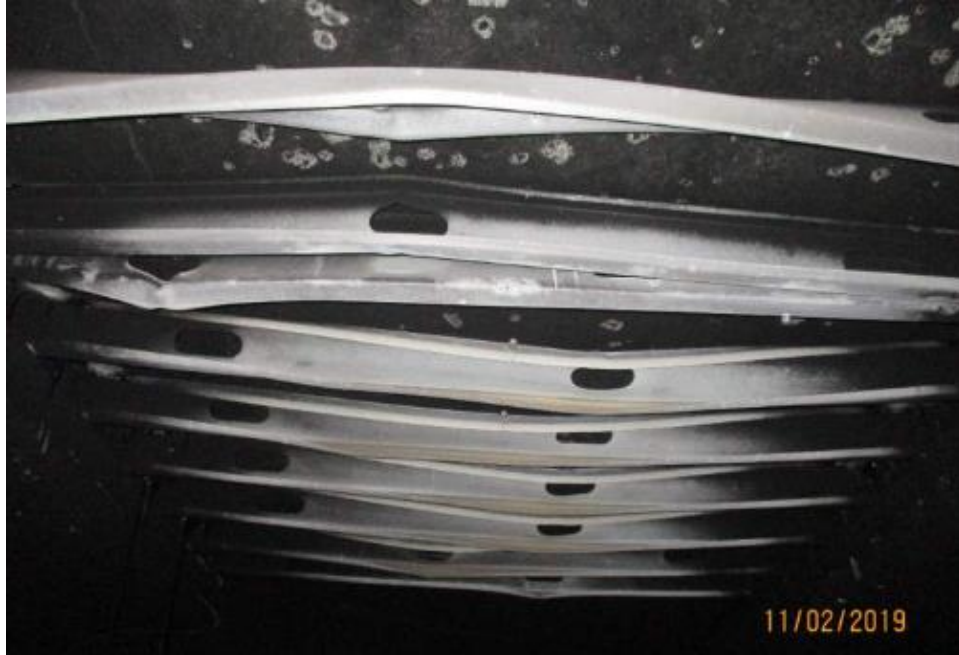
Figure 4. Melted polycarbonate stay-in-place forms

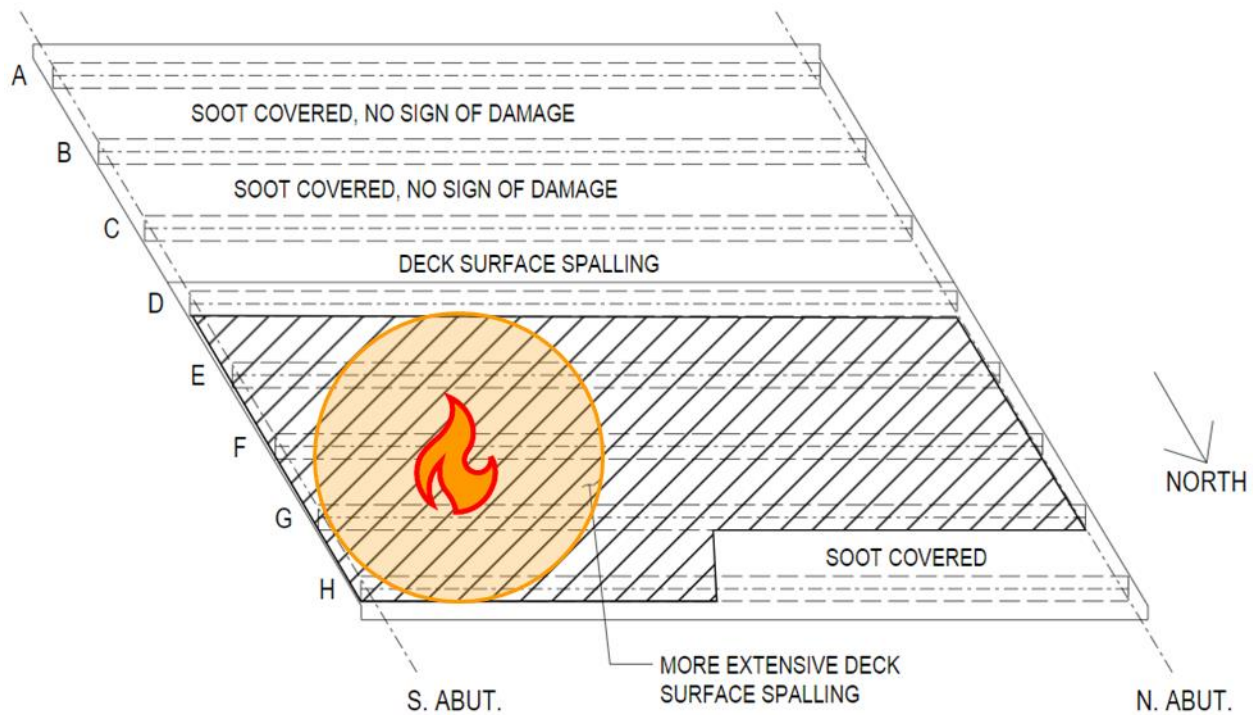
Each girder was visually assessed and selected based on the apparent level of damage incurred: one low-level, one mid-level, and one higher-level. The goal was to compare and contrast apparent levels of damage and assess the impacts each had on the serviceability and strength of the girder. Girders B, E, and G were selected for this study because of the relative damage each incurred. Girder B was the least damaged, whereas Girders E and G incurred greater amounts of damage (e.g., bottom flange spalling). Figure 9 shows the approximate location of the fire epicenter based on the levels of damage observed.

Figure 9. Bridge fire epicenter

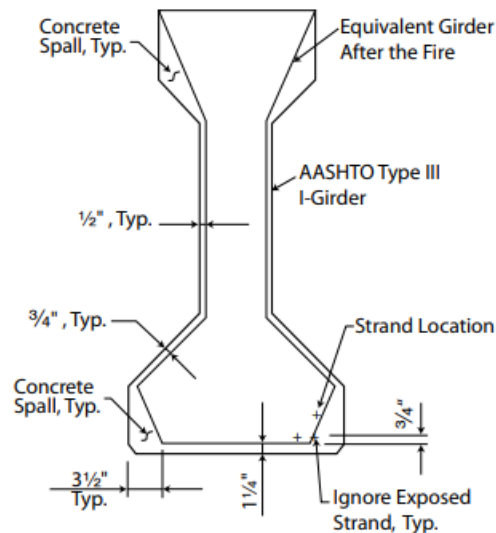
Davis et al. (2008) stated that the fire-damaged girders did not show any visible signs of loss of prestressing force due to no sagging or flexural cracks being present. However, the great amount of spalling and dull tones from the hammer test indicated a significant amount of delamination. This is important to note as spalling and delamination together can indicate a loss of internal strength properties through significant exposure of reinforcement. Figure 13 shows the reduced girder section.

Figure 13. Girder cross section after fire damage

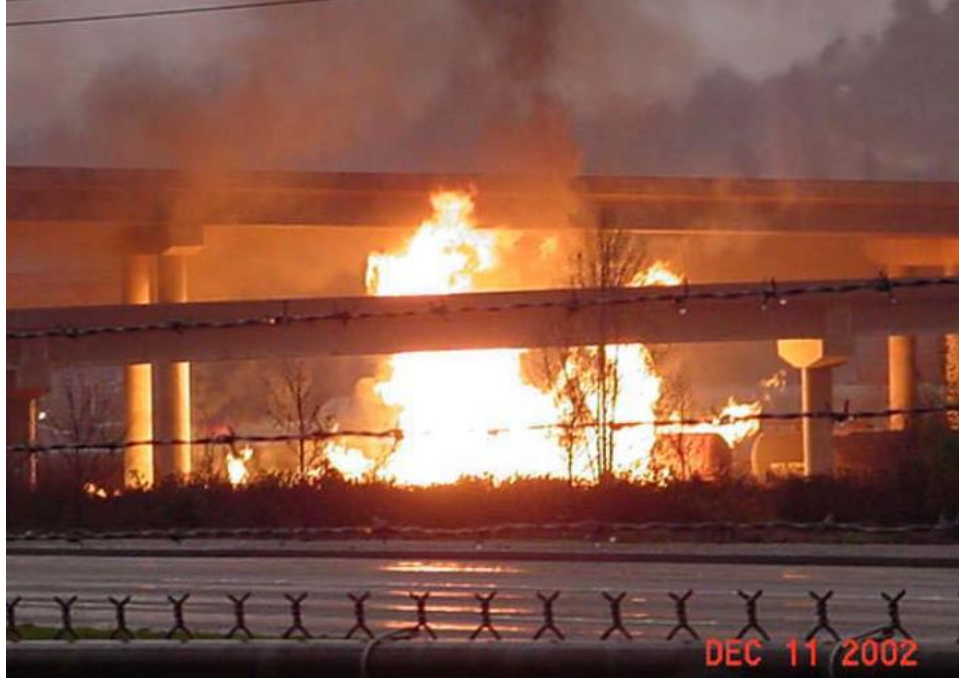
Figure 14. Tanker fire on Puyallup River railroad bridge

Span 8 was where most of the damage occurred as the fire fully engulfed this section for an hour. Stoddard (2004) noted four concrete color variations on the bottom flanges of the girders in Span 8. These color variations correspond to changes in concrete condition states, as illustrated in Figure 15.

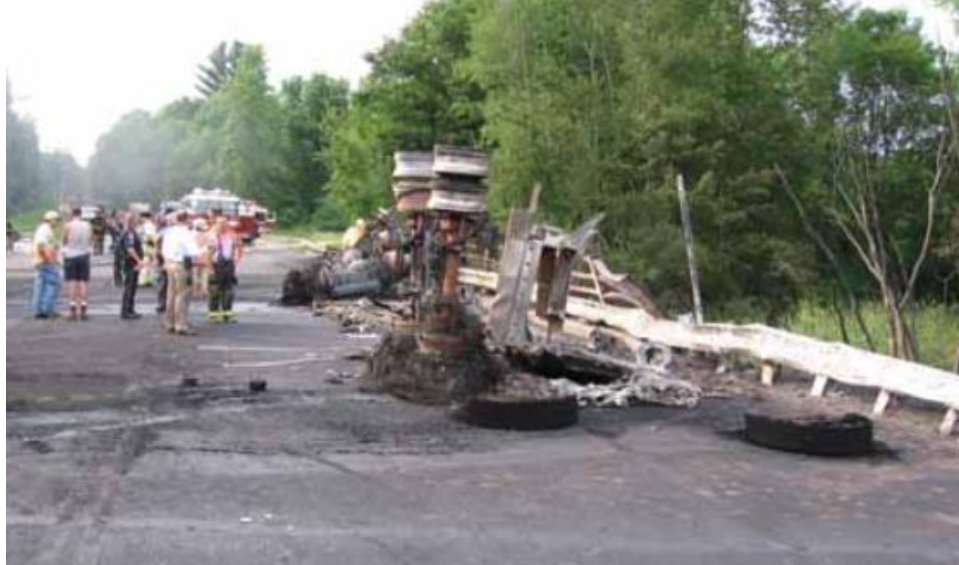
Figure 16. Tanker truck remains on US 7 Bridge in southwestern Connecticut after fire

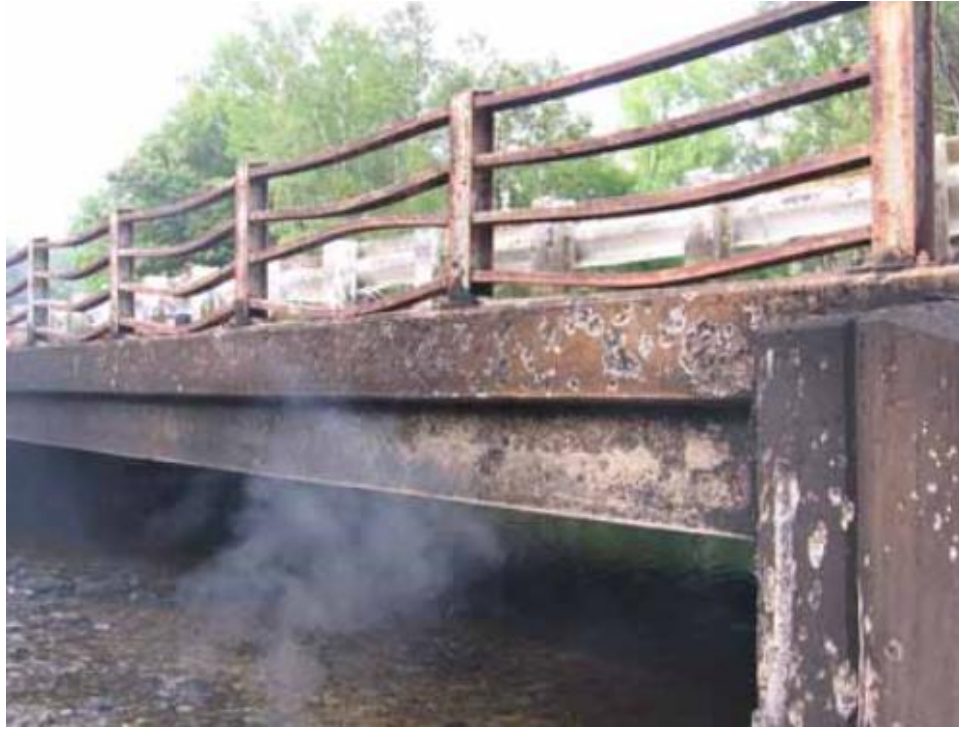
Figure 17. US 7 Bridge fascia after fire

Visual examination and lack of nondestructive means to determine the strength of the prestressing strands deemed the bridge to be insufficient; therefore, the Connecticut DOT (CTDOT) made the decision to replace all of the beams in the superstructure.

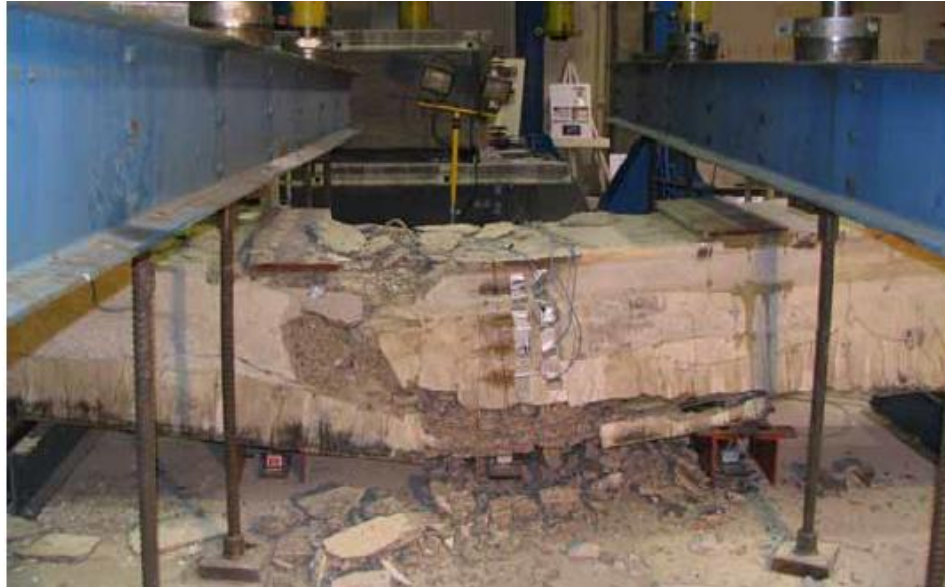
Figure 20. US 7 Beam #14 failure

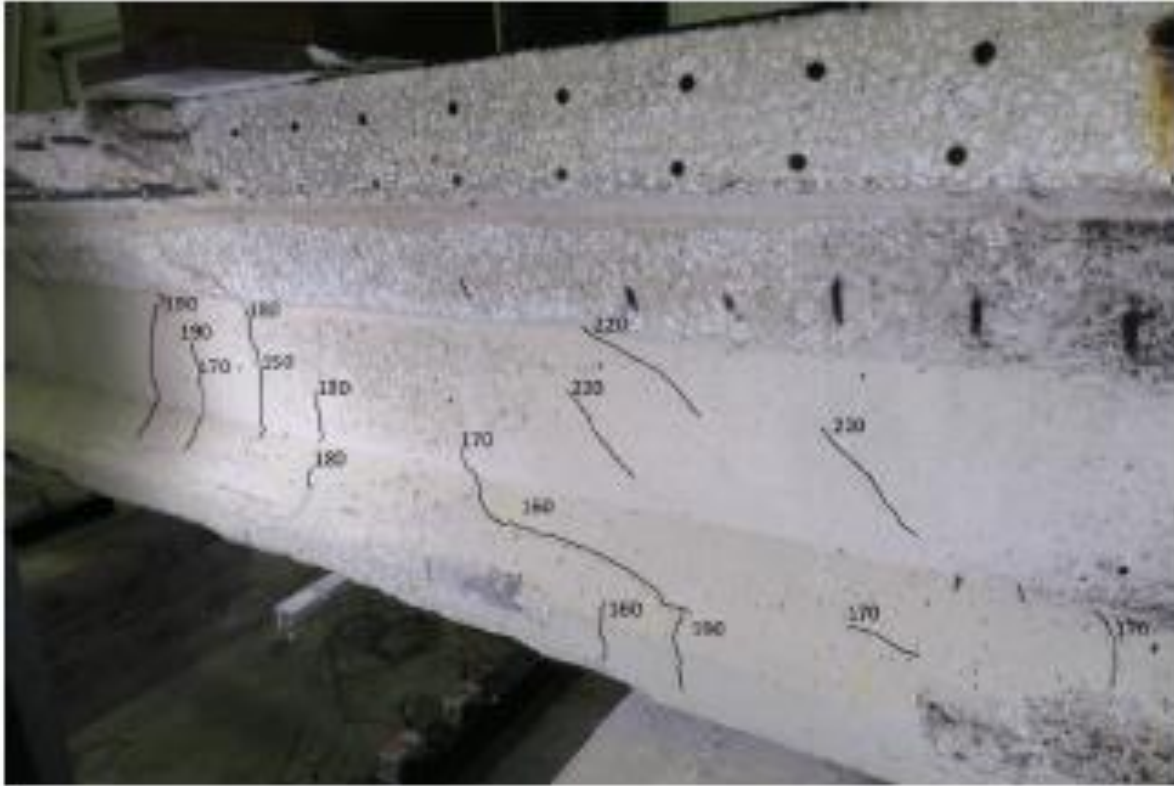
For the flexure-controlled ambient load test, vertical flexural cracks were observed near the loading point at a load of 140 kips. As the load increased, more flexural cracks developed. The shear-controlled ambient load test had an observed shear crack at 160 kips and additional shear cracks developed as the load increased. For the pool-fire flexure-controlled and shear-controlled load tests, spalling occurred due to the fire before testing began. However, additional cracks developed during loading as seen in Figure 24.

Figure 24. Beam C7 cracking at 220 kips for I-469 Bridge over Feighner Road

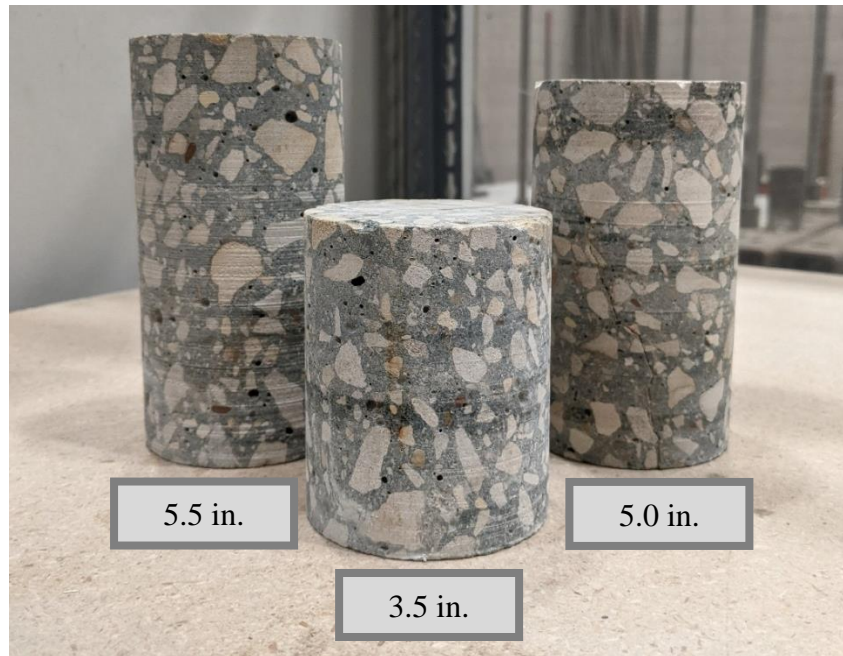
Figure 33. Concrete cylinder core samples for compression tests

The first sample was 3.5 in. tall, and the second and third samples were 5 in. and 5.5 in. tall, respectively. Apparent cracking was observed in the 5 in. cylinder prior to testing.

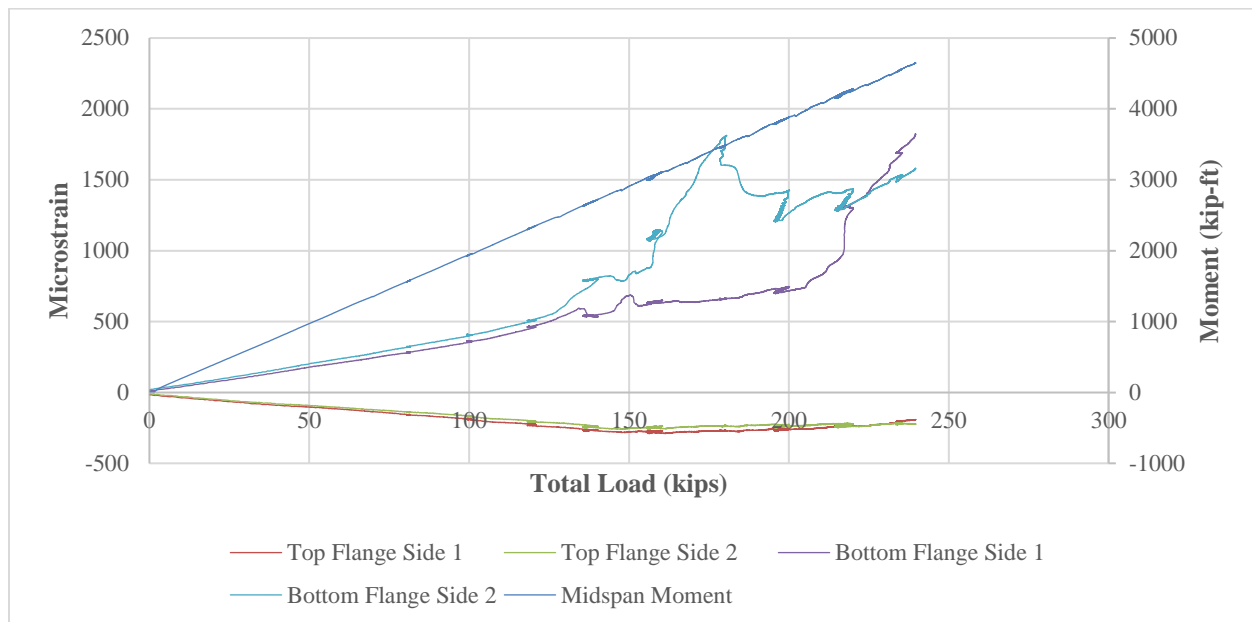
Figure 53. Midspan strain data for Girder B bending load test

The strain data collected at midspan corroborated the observation of crack initiation at this point of loading. As shown in Figure 53, the tensile strain data at the bottom flange consistently

increased, and the compression strain data at the top flange consistently decreased, up until the point of the girder yielding.

The maximum tensile strain achieved prior to the data becoming inconsistent was about 500 microstrain at the bottom flange.

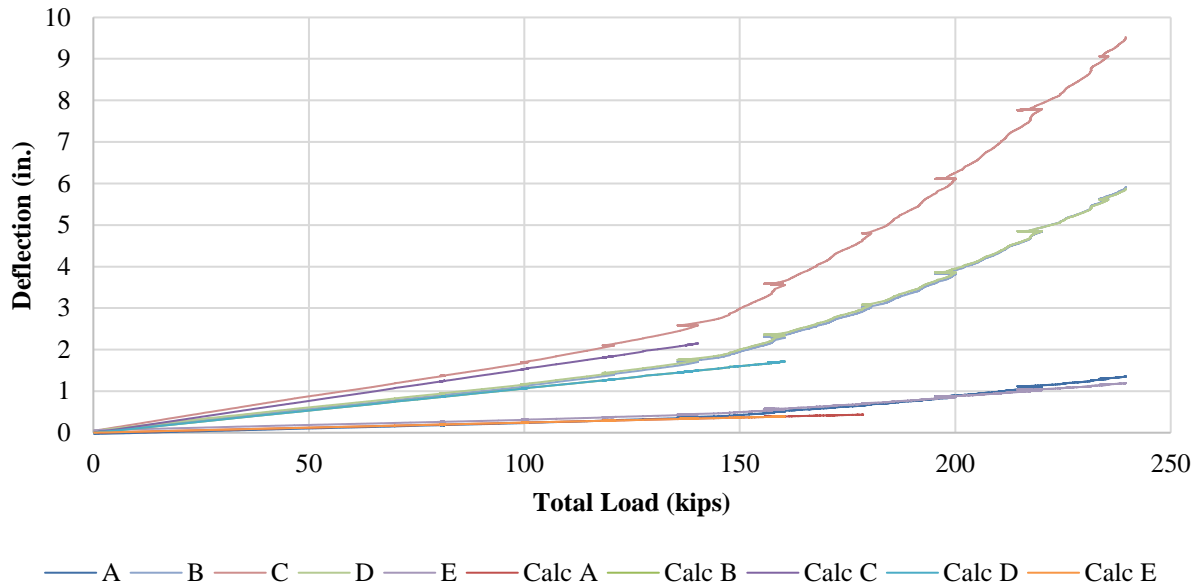
Figure 54. Actual vs. predicted deflection of Girder B

The deflection curves for Girder B at each point (A, B, C, E, and D) are shown in Figure 54, along with the predicted (elastic range only) deflection values using the plan dimensions and material properties.

The actual and predicted deflection values were nearly matched through the elastic range of loading. This is also shown in Figure 55, which compares the measured deflection to the predicted values at a total load of 100 kips or moment of 1,925 kip-ft.

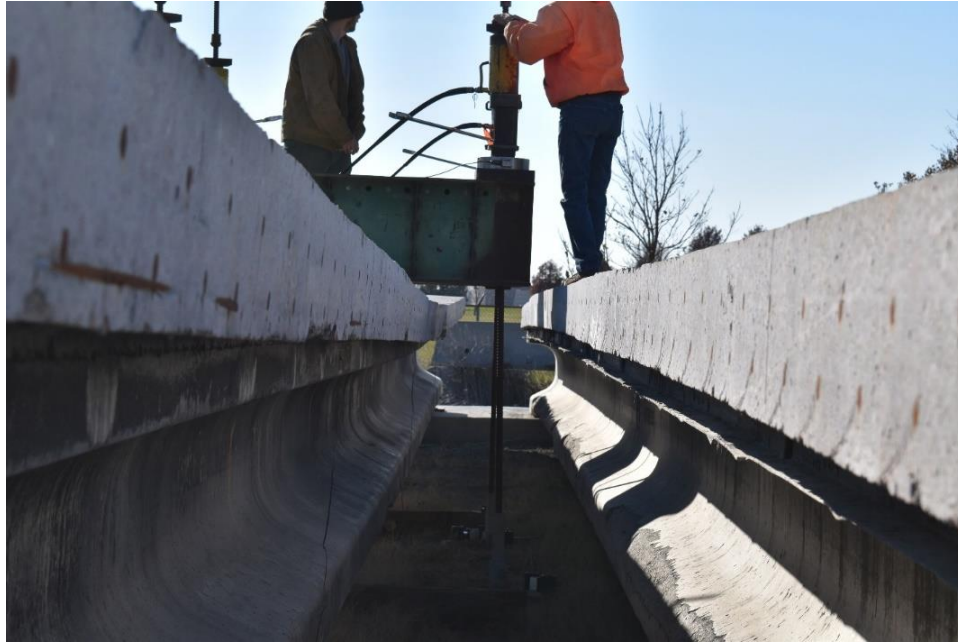
Figure 56. Deflected shape of Girder B at max loading

This value was chosen to ensure all sections were within the elastic range. The load test was ceased after reaching a midspan moment of about 4,600 kip-ft and a total midspan deflection of 9.5 in. or $L/107$. The deflected shape is shown in Figure 56 and can be contrasted with that of the adjacent girder.

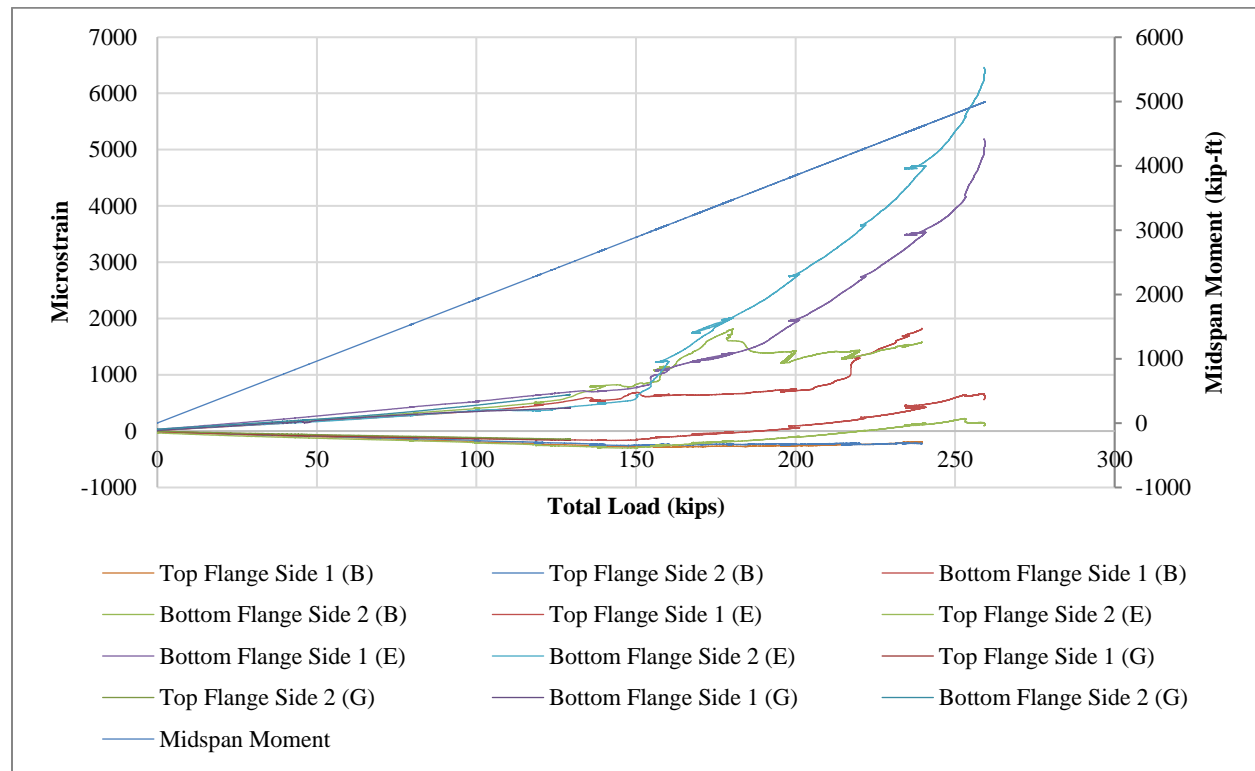
Figure 67. Combined strain results for Girders B, E, and G

Despite the apparent varying levels of damage between the girders (area and depth of concrete spalls), the tensile and compressive strain values were relatively consistent between tests up to the point of yielding.

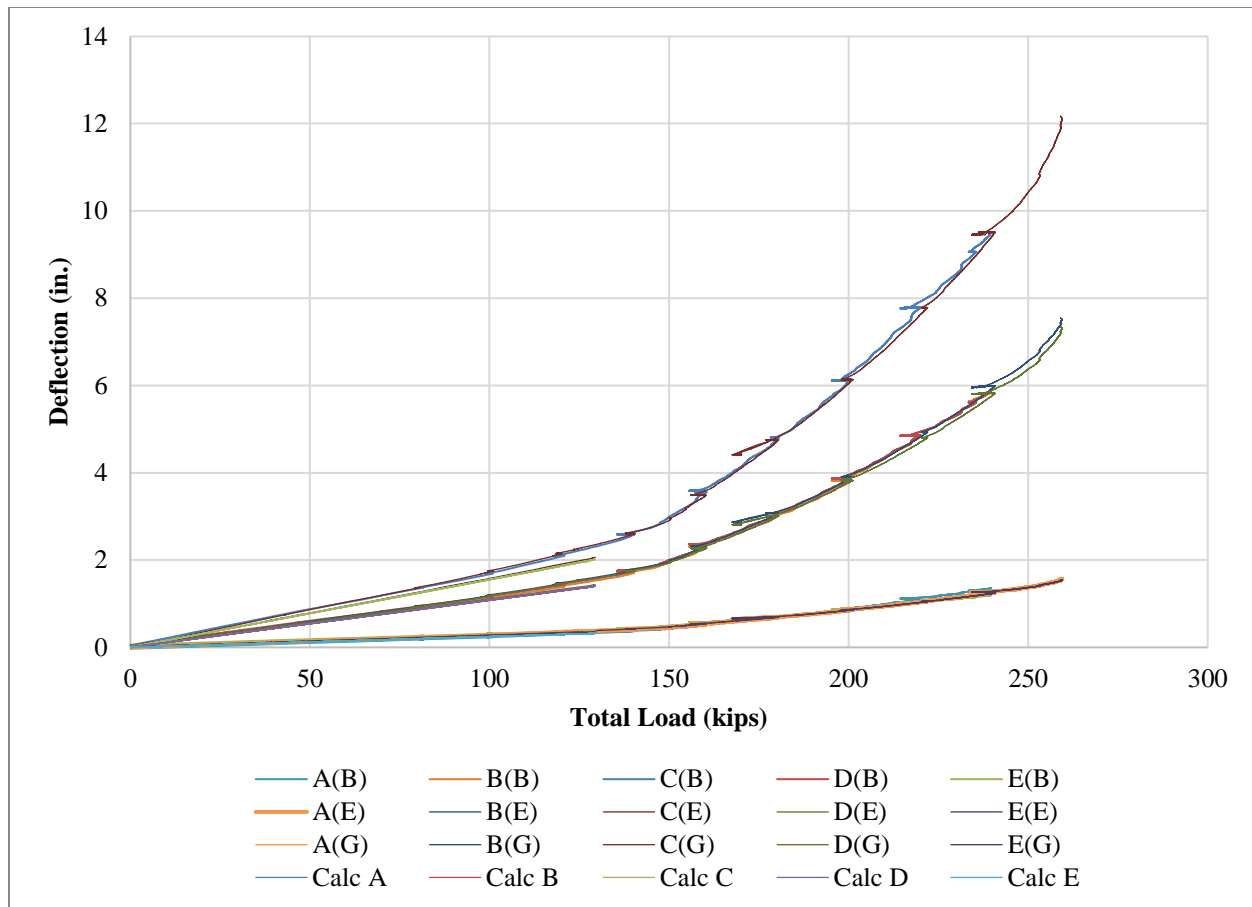
Figure 68. Combined deflection results for Girders B, E, and G

The measured deflection values for each of the three load tests were very nearly equal despite their varied conditions, similar to those for the measured strain values.

The primary objective of the load tests was to determine whether a clear difference existed in structural performance of each girder that could be correlated to their visual conditions. Despite the differences in area and depth of spalls, especially between Girder B and Girders E and G, the performance of each girder was nearly replicated from one test to another.

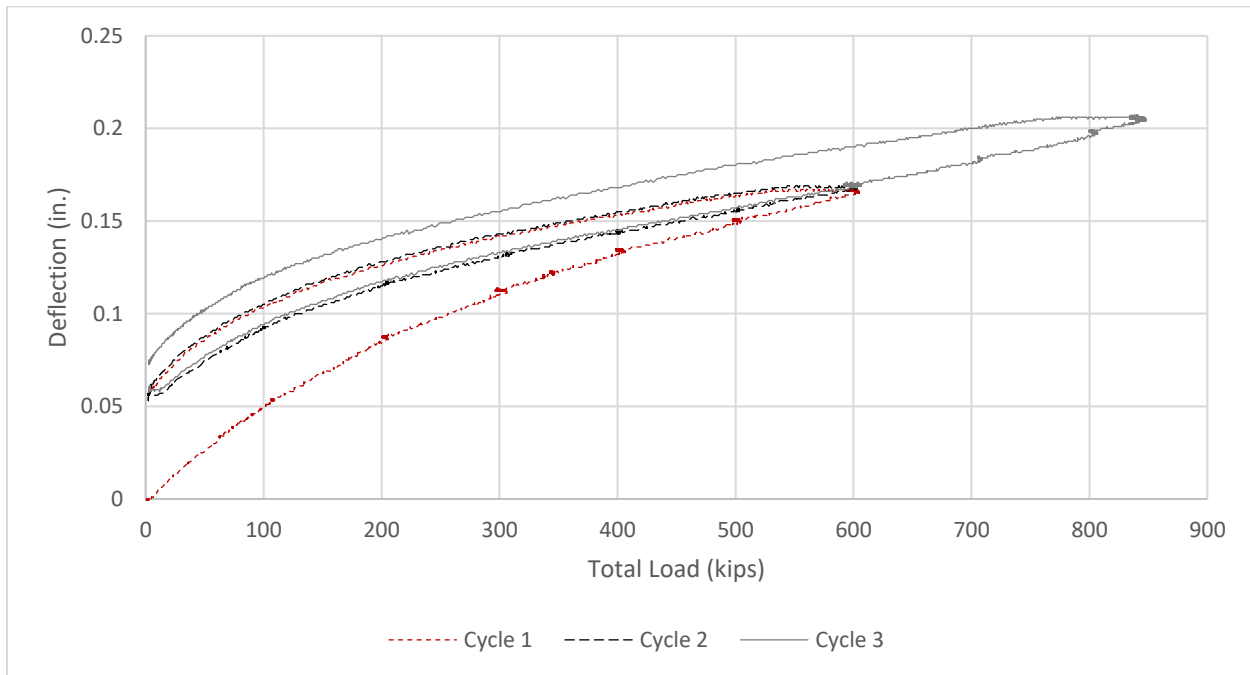
Figure 69. Deflection vs. total load for girder end shear test

The shear test on the end of Girder B was completed by applying load in three total cycles. The total load was increased to 600 kips for the first and second cycles and then to about 840 kips for the third and final cycle, resulting in a maximum shear force of 420 kips. The load effects for the first cycle resulted in a portion of the specimen becoming inelastic, as the specimen did not return to its pre-loaded deflection values. The specimen further yielded during the final cycle. The maximum deflection was 0.21 in. at the max load over the 10 ft clear span length. The results are shown in Figure 69.

Cracking noises could be heard during the last cycle as the load increased, but no visible cracks appeared anywhere on the girder. Despite the ultimate capacity not being determined, the girder exhibited shear capacity beyond what could be foreseeably seen in service.

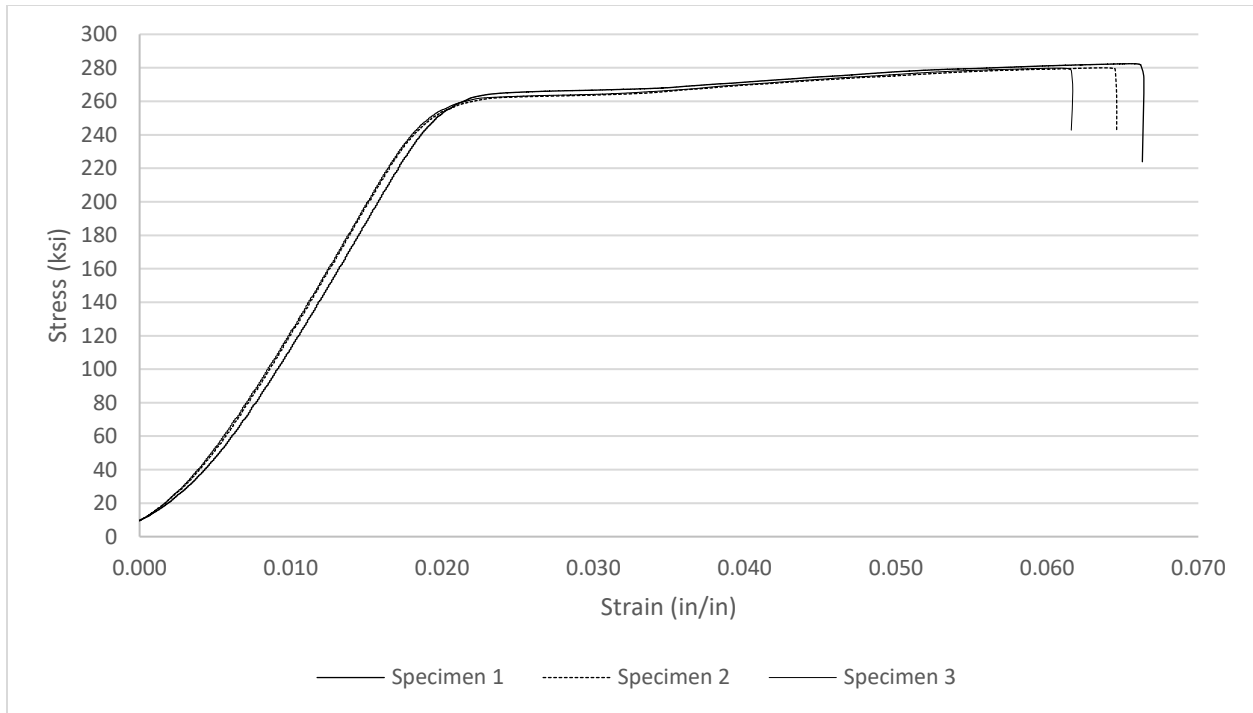
Figure 71. Reinforcement strand test results

The ultimate tensile strength for the prestressing steel strands per the contract documents was specified as 270 ksi. As shown in the graph, the strands performed consistently among the specimens with a yield strength of about 255 ksi and an ultimate tensile stress of about 280 ksi. This indicates that the prestressing steel reinforcement still achieved the specified strength requirements despite any possible effects from the fire.

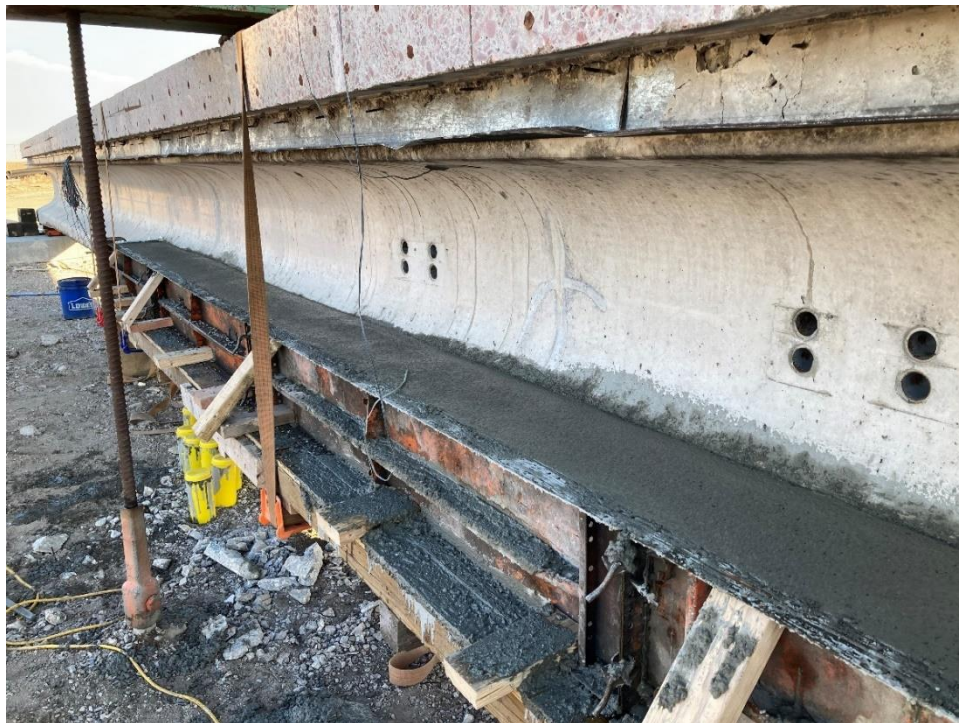
Figure 78. Placement of the SCC mix around the bottom flange

The concrete mix was then poured (see Figure 78) and allowed to harden before removing the formwork.

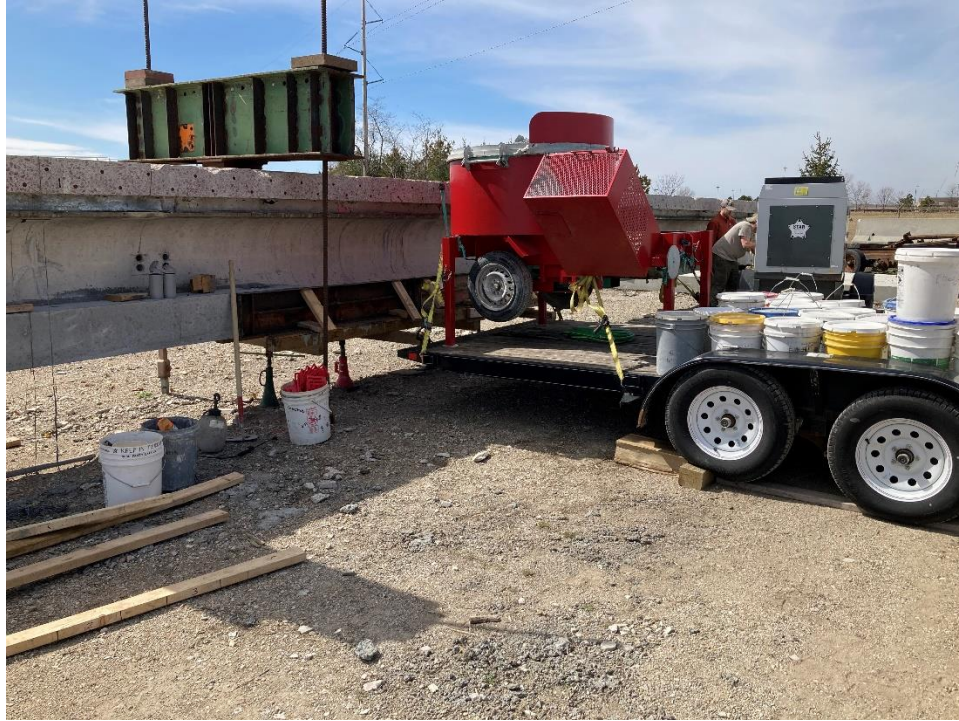
Figure 79. UHPC materials and mixer

The UHPC repair section required the materials to be batched on site. A mixer and the pre-measured material quantities were trailered to the site as shown in Figure 79.

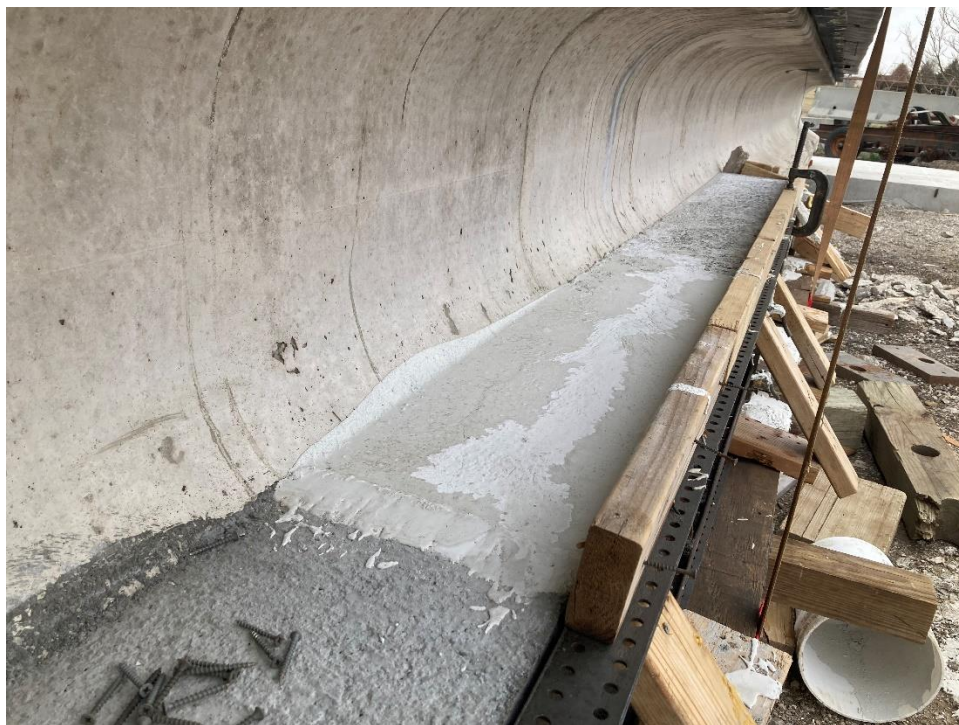
Figure 80. Placement of the UHPC section of repair

Once the mixing protocol was completed, the UHPC was poured into the forms either directly from the mixer or by using 5 gal pails (see Figure 80).

The consistency of the UHPC allowed the forms to be simply filled without the need for mechanical vibration. Even so, the material can present some challenges while mixing due to the precision of mix ingredient quantities and the timeliness required before hardening begins. It is expected that the challenges presented for a repair of this nature on an in-service bridge are simply mitigated by off-site batching and experienced work crews.

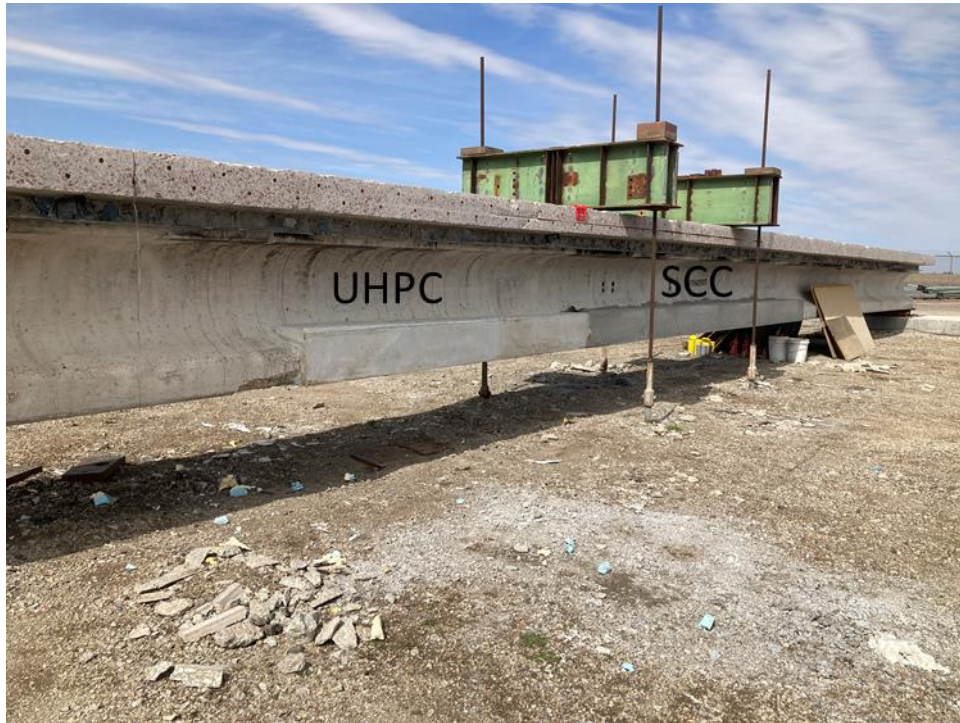
Figure 81. UHPC and SCC repair sections fully cast

Figure 81 and Figure 82 show the completed SCC and UHPC repairs and their dimensions after the formwork was removed.

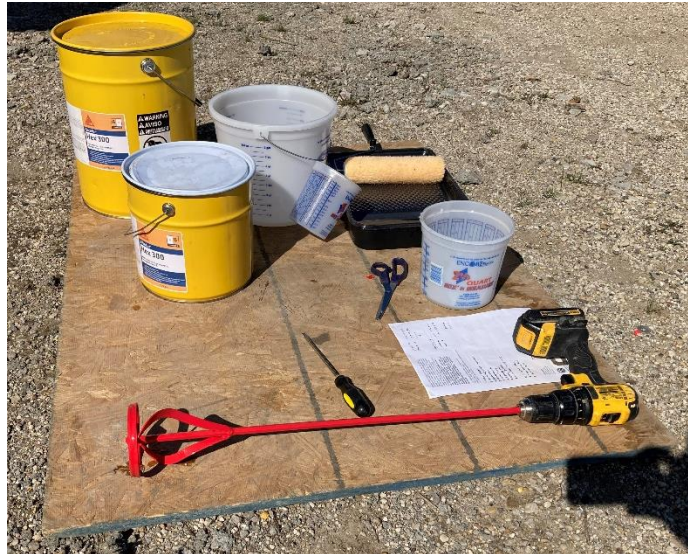
Figure 85. Preparation for mixing the FRP resin

To begin the installation process, the resin was mixed and applied to the girder using a 3/8 in. nap paint roller (see Figure 85).

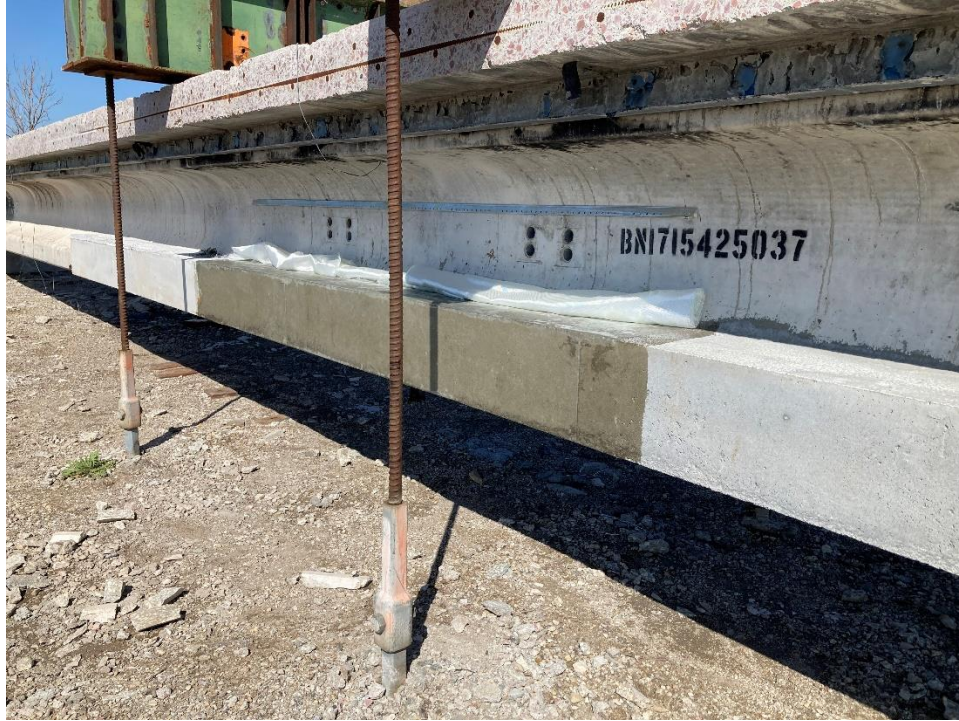
Figure 86. FRP wrap application on bottom flange repair

The FRP fabric was then placed into the resin and rolled flat to the surface (see Figure 86).

A couple of specific observations were noted with respect to the FRP wrap installation process. First, the resin product did not provide sufficient tack to hold the FRP in place in an overhead position upon initial installation; continuous rolling with additional resin was required. Secondly, the surface, although relatively smooth, requires a high-level of smoothness to bond the FRP wrap. Any surface deviation was spanned by the FRP wrap leaving a small pock of un-adhered FRP wrap. Thirdly, the FRP wrap is highly flexible, but enough rigidity remained that wrapping around 90-degree corners was difficult. Void space between the FRP was observed immediately at the corners. Some of these problematic areas are shown in Figure 87.

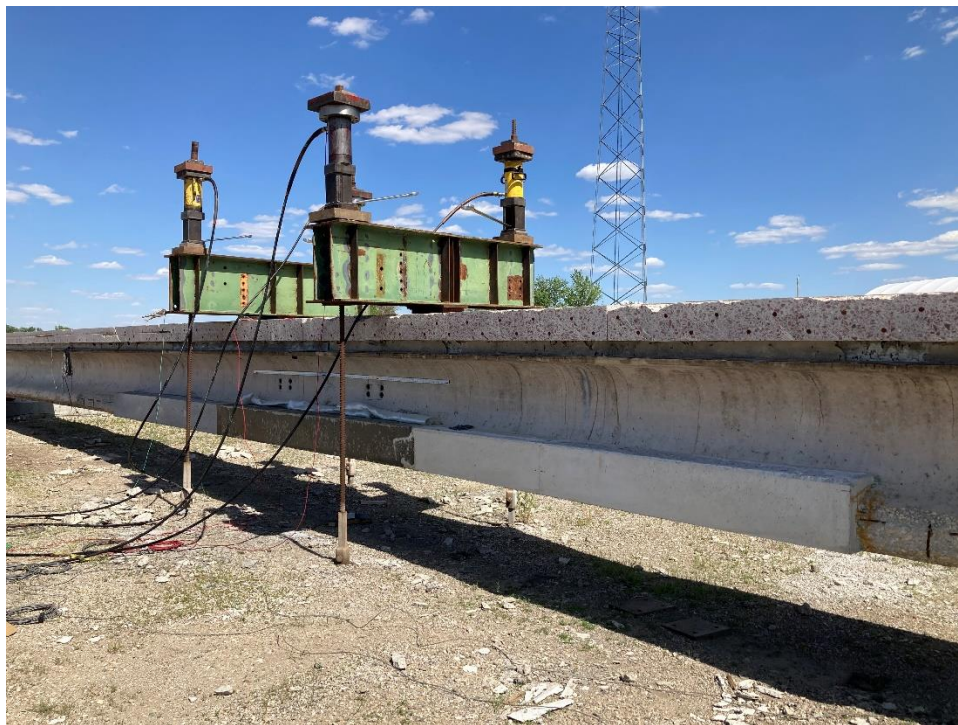
Figure 88. Load test of repaired girder

After all repair methods were completed, a two-point load test was performed in the same manner as the previous girder tests. The load test setup is shown in Figure 88.

Deflection transducers were placed at each of the five defined points (A, B, C, D, and E) to measure deflection. However, for this test, the loading was locked off at 130 kips total load (close to its elastic limit) and maintained for an extended time period. The purpose of this was to see how the girder performed under sustained loading and how this impacted the stress on the repairs.

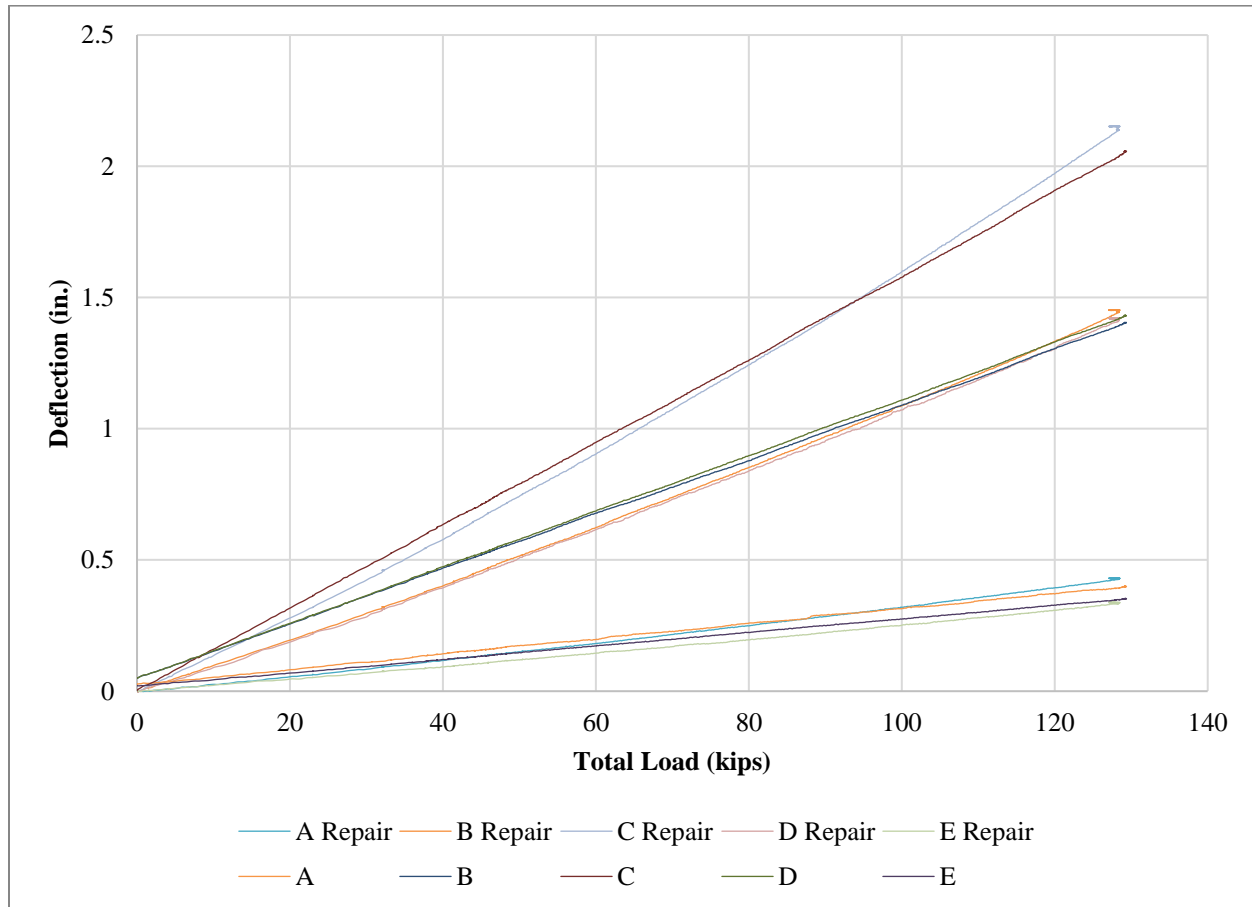
Figure 89. Comparison of repaired vs. pre-repaired Girder G deflection results

The measured deflection results were compared to those from the initial pre-repaired girder test as presented in Figure 89.

Despite the added concrete sections at midspan, the repair was not anticipated to increase the stiffness in any appreciable way. The deflection results bear this out as the results from the pre-repaired and repaired girder do not deviate in any significant way.
