Marketing and Outreach for the Safety Edge

March 11, 2011

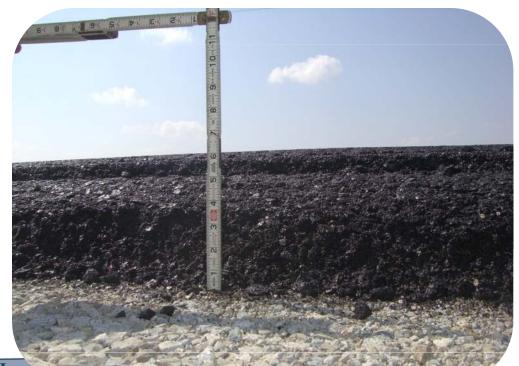
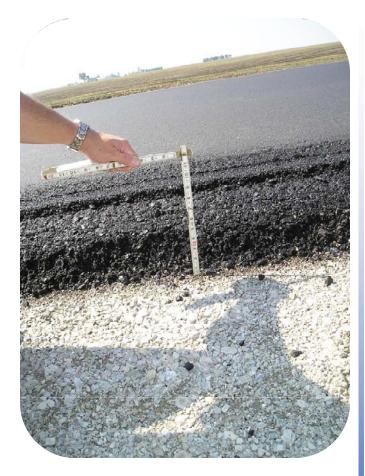
Pavement Edge Drop-off

Vertical elevation difference between adjacent roadway surfaces

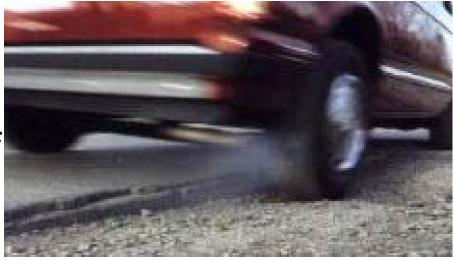
Safety Hazard

- Vehicle leaves roadway and encounters drop-off
 - Affects driver handling and stability
 - Overcompensation (loss of control)

- Scrubbing as driver attempt to return to roadway
 - driver steers to overcome friction between tire sidewall and pavement edge, loss of resistance on return to roadway causes yawing

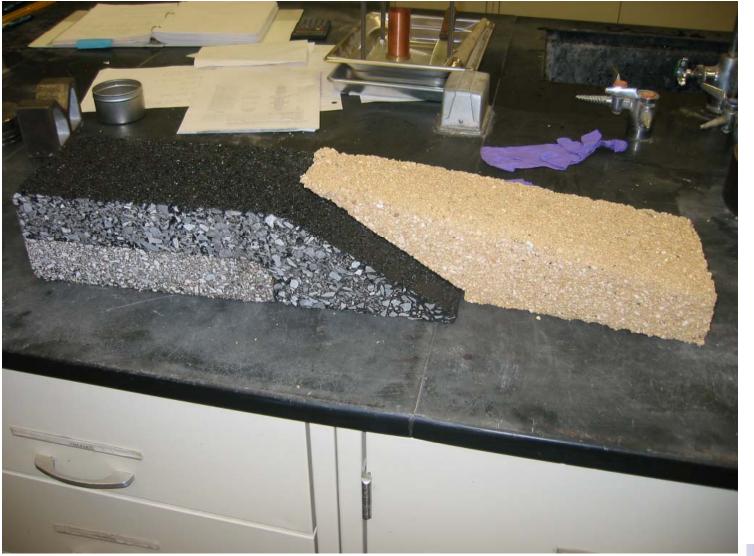
Model of Safety Edge

Safety Edge

- Design feature which creates a fillet along the outside edge of the paved section of a roadway
- Placed during Hot Mix Asphalt (HMA) paving using a device that shapes and consolidates the asphalt material at the pavement edge into an approximate 30° fillet

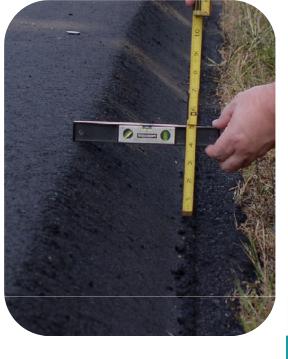
resurfacing with Safety Edge

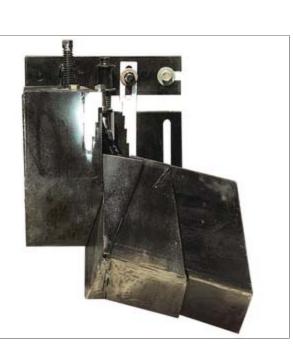
Safety Edge Equipment

• Several types of equipment available for HMA

Safety Edge Equipment

- Commercially available
- Can be removed for use on different pavers
- Most agencies in 2010 season did not have problems with install or use in general
 - One suggested mounting Safety Edge to end gate rather than paver to minimize mix accumulation behind the shoe when changing the width laid for fillets

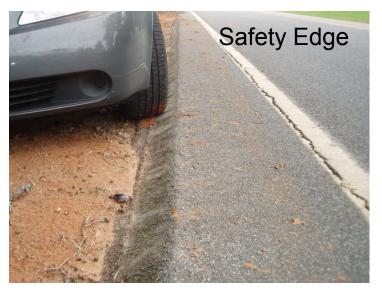
Durability of Safety Edge

- Density from compaction necessary for Safety Edge durability
- Some concern about long term durability
- Only compaction is from paver and Safety Edge Shoe
 No Safety Edge

Condition After six years in-service (Georgia Site)

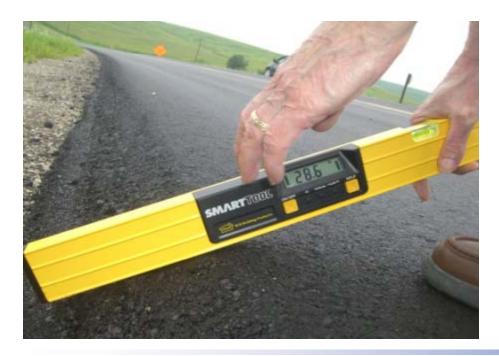
Quality Assurance of 30° Slope

- Equipment places slope appropriately but actual application varies in the field
- Team evaluated in field
- Slope varied significantly (18 to 52°)

Table 6-1: Final Slope Measurements

Site	Average Slope (degrees)
Blackhawk County D46	26
Cedar County Y26	40
Clinton County Z30	39
Delaware County D34	52
Jasper County F62	37
Jones County E34	30
Keokuk County V63	31
Kossuth County A21	36
Kossuth County P20	35
Sac County M50	36
Union County H24	18
Union County Green Valley Road	18
Webster County D46	30
Webster County P59	31
Ida-Sac County U.S. 20	31
	CONSONTION

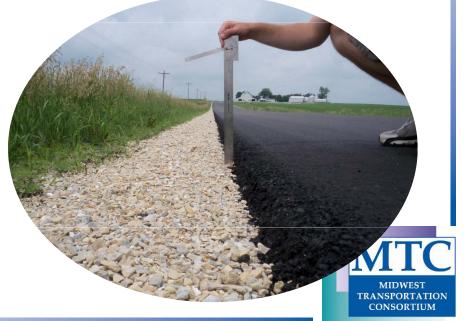
Rollover

- 30° slope distorted during compaction
- Usually results in slope > 30°
- Also noted by MN and other states
- material pushed towards edge during compaction
- Roller pattern
- Magnitude of vibration
- Mix
 - design
 - support of underlying base
 - temperature of mix
 - ambient temperature
 - lift thickness

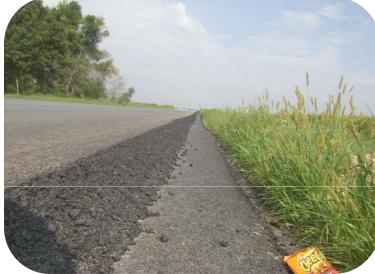
Matching Safety Edge Between Lifts

- Problem noted during field reviews and noted by contractors
- Determine nominal base width to accommodate succeeding lifts of HMA before beginning work
- Compute lift width to ensure sufficient width
- Maintain proper horizontal alignment of each

May only need to include Safety Edge in top lift or two (3 to 5")

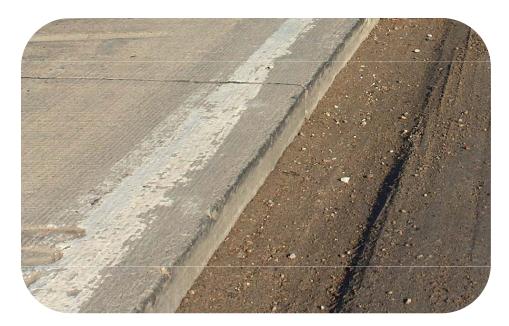
Typical face of PCC without Safety Edge

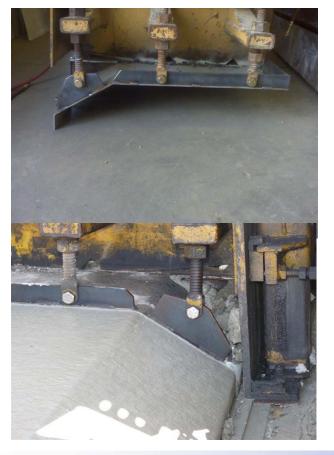
- No commercially available equipment
- Contractors fabricated Safety Slope Pan

PCC Paver modification for Linn/Jones by Horsfield Construction

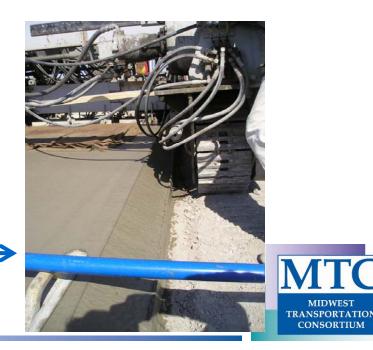
PCC Paver modification for Wicks Construction

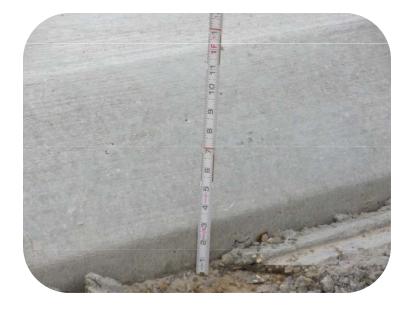
- Unlike HMA height of Safety Edge for PCC is constant (4 to 6"),
 - shape of the pavement edge will vary depending on slab thickness
 - Toe depth (vertical face at edge of Safety Edge slope) will vary

Pavement with 3 inches of vertical toe

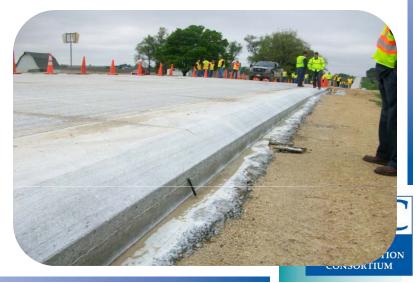
Pavement with significantly more vertical toe

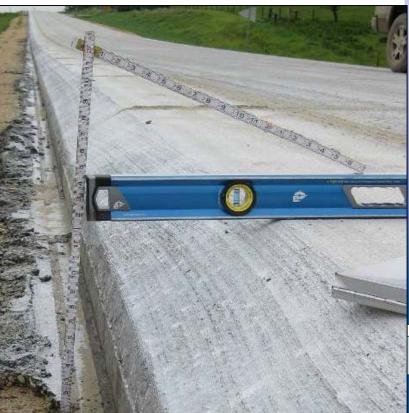
- Assessment of E-34 by FHWA
 - Slope ranged from 28.5 to 34.0° (mean 31.5°)
 - Slope face was slightly concave or convex in some locations which may have resulted from flex in paving pan or during finishing

Edge of PCC Safety Edge Showing Ridge and Bow (image source: FHWA, 2011)

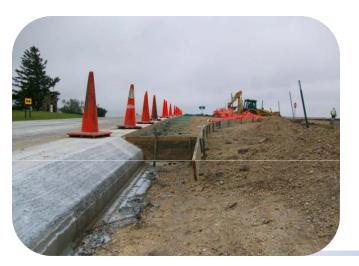
In Iowa, a reinforced joint is constructed to adequately tie the intersecting pavements together and this is accomplished with a vertical pavement edge

• Sloped edge needs to be removed for intersection tie-in

- Saw cut
- Construct formed box-out to prevent placement of Safety Edge

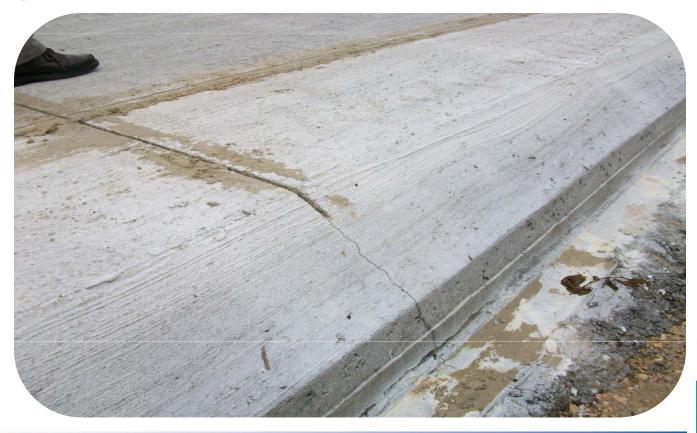
Accounting for Transverse Joints

- Saw-cut only to edge of pavement
- Cracking through Safety Edge did occur as expected

- Full width saw cutting is used in newly placed PCC to control random cracking
- Discussion with contractors about how to handle sawing through Safety Edge section
 - Challenges in operating saw on slope
 - Anticipated that crack would eventually extend through Safety Edge
